## **Albania earthquake of November 26, 2019**

### *Report on Structural and Geotechnical Damage*

November 2020

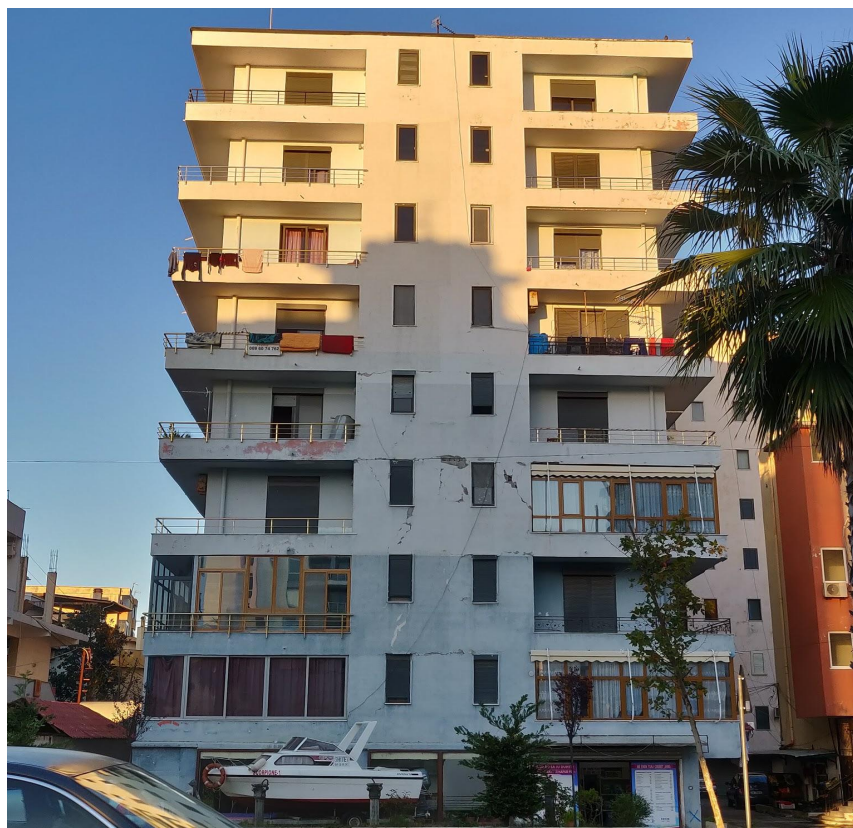
Figure 13. Light damage of an 8-storey RC building

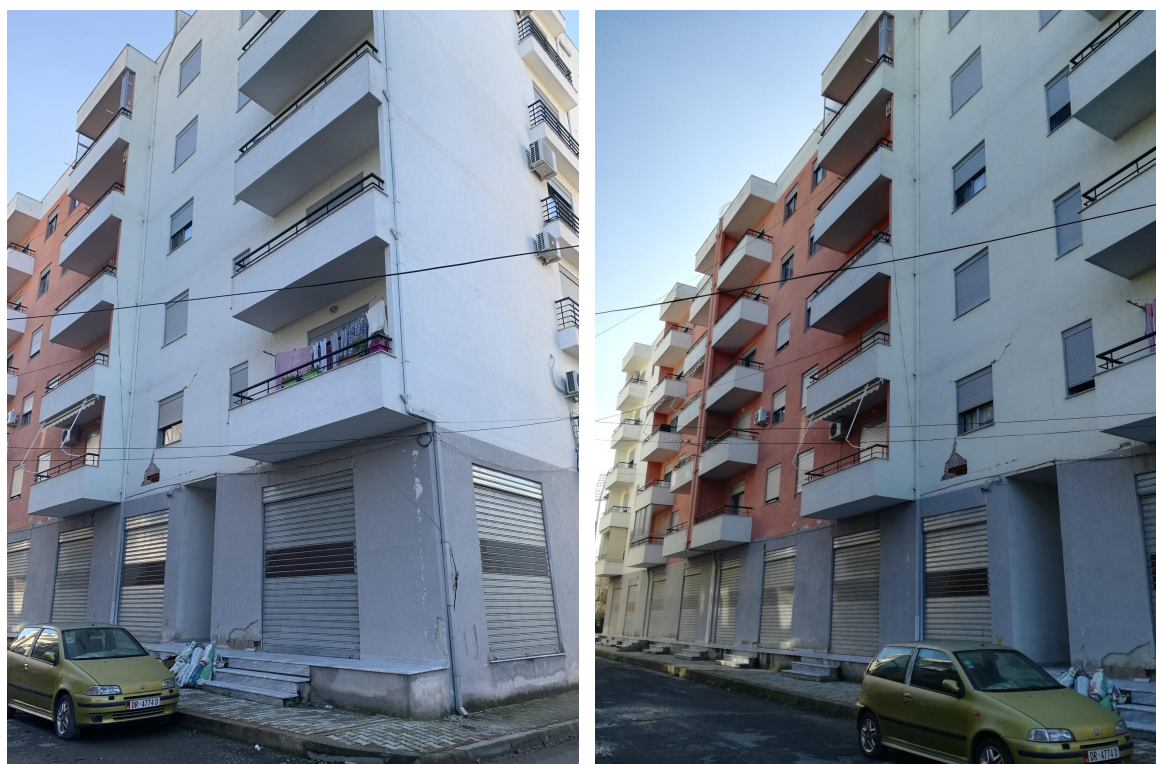
Figure 14. Moderate damage of a 5-storey RC building

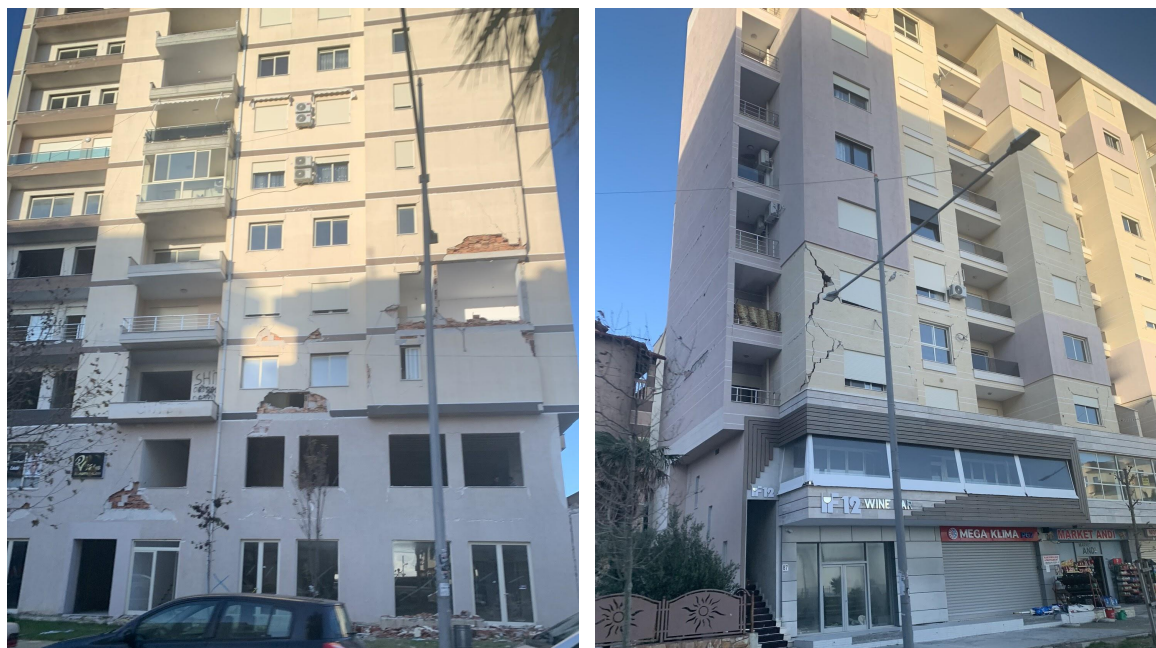
Figure 15. Moderate damage of a 7-storey RC building

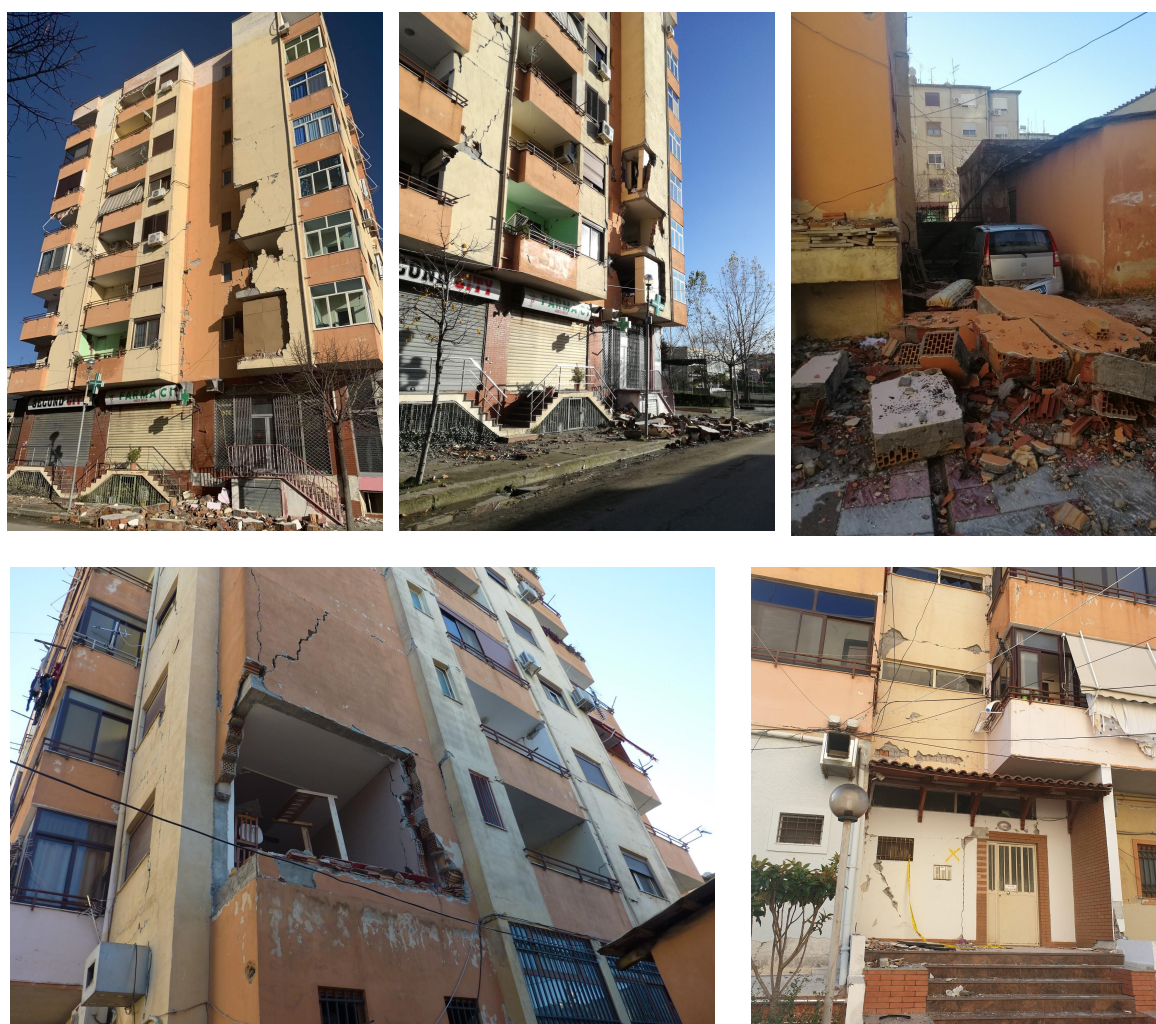
Figure 16: Major damage of an 8-storey RC building

As seen in Figure 16, masonry infills of the perimeter frames were inadequately confined by the surrounding frames due the lack of columns at the ends, which is in itself a rather unfortunate design choice. As the infill walls tend to follow the inter-storey drifts experienced by the surrounding frame during the earthquake-induced ground motion, they experience shear diagonal cracks; the absence of vertical RC elements at the edges providing some confining contact pressure to the deformed panel, makes the masonry panel extremely susceptible to out-of-plane collapse, due to the inertial forces caused by the component of floor response perpendicular to the infill's plane (Morandi et al., 2014). This type of damage is concentrated to the lower floors of the building, which is anticipated, since RC frames tend to exhibit a shear-type lateral deformation pattern, with greater concentration of inter-storey drifts closer to the ground floor.

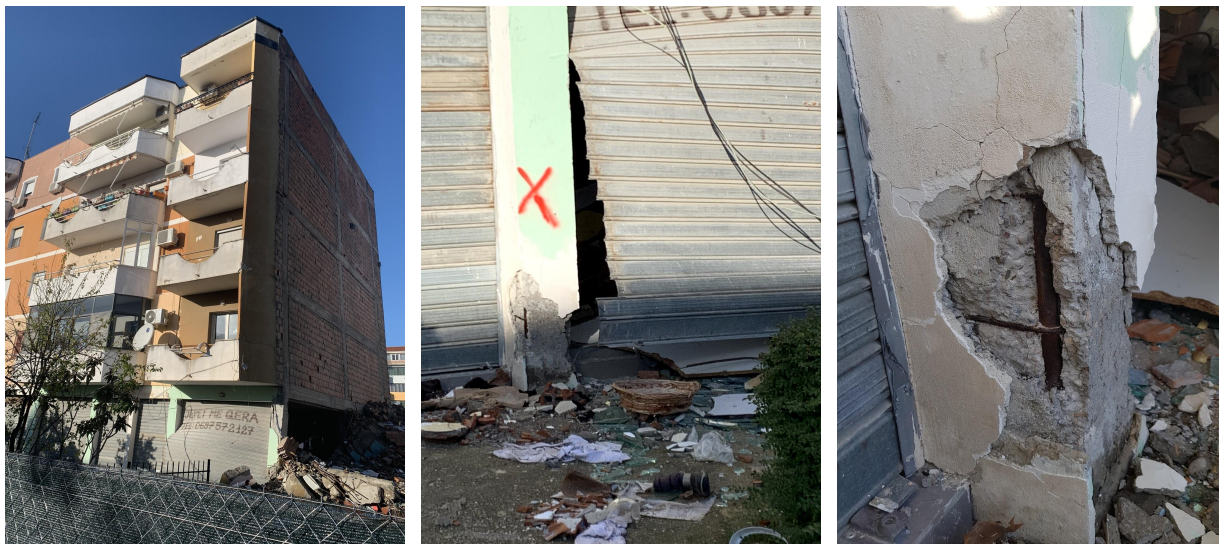
Another issue with masonry infills is the irregularity of lateral stiffness along the height of an RC frame, caused by interruption of the infills at the ground floor. This practice is often dictated by commercial use of the building at ground level and can lead to a concentration of flexural deformations at the ground floor columns (Ricci et al., 2011). Evidence of this effect can be seen in Figure 17.

Figure 17: Major damage of 4-storey RC building

In fact, flexural and shear cracks are visible at the external ground floor columns, which can be attributed to the aforementioned effect of stiffness irregularity-in-height. The out-of-plane buckling of a segmented metal-sheet garage door, also attests to the concentration of drift at the ground floor. Furthermore, the spalling of concrete cover, visible at the base of one of the columns, reveals poor detailing of transverse reinforcement; the 20 cm spacing of the stirrups is not up to par with modern seismic code ductility requirements for confinement reinforcement in columns. It should also be noted, that the adjacent building suffered collapse and had already been demolished by the time these pictures were taken; in this light, some of the damage that can be observed the outer-most non-structural elements could have been due to pounding between the two buildings during strong ground motion.

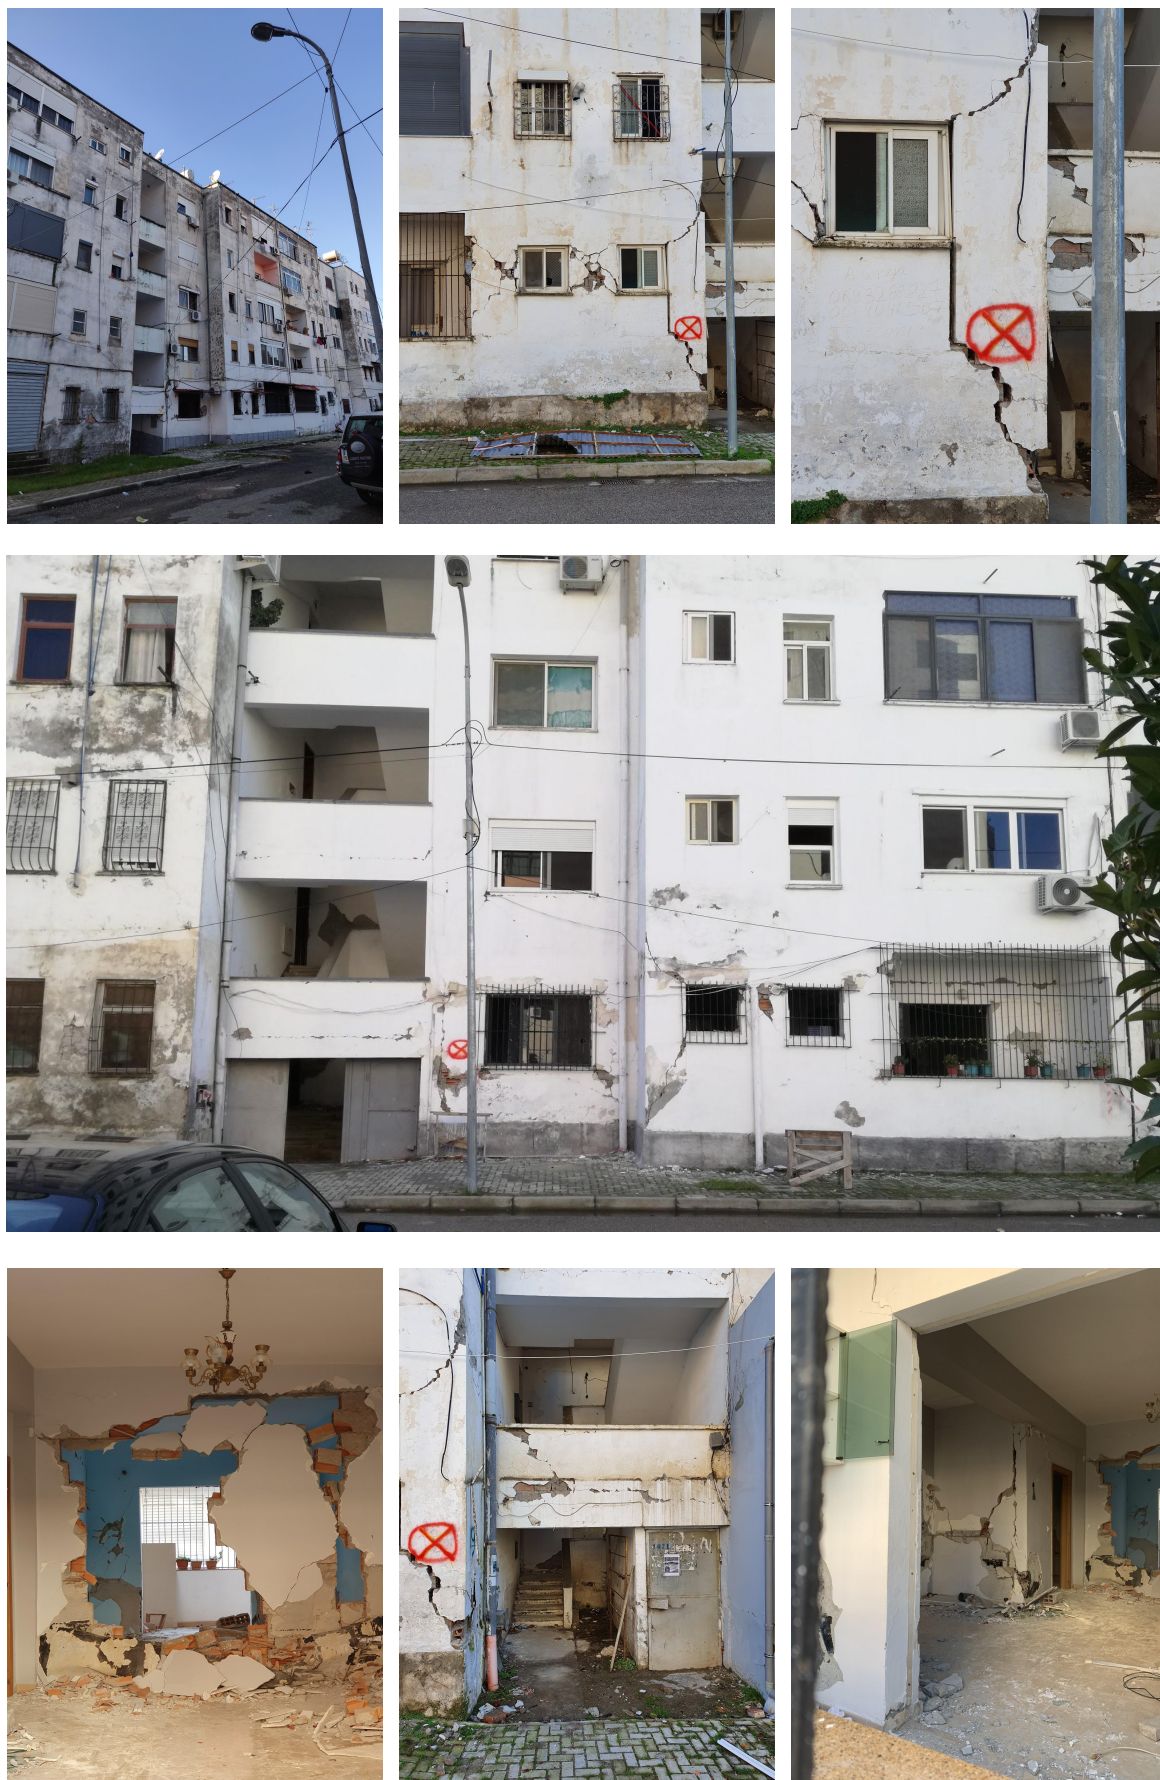
Figure 18: Major damage of 5-storey building.

Another interesting and typical structural typology that suffered extensive damage is that of unreinforced brick masonry buildings with RC slabs (Fig. 18). This typology can be characterized as a template design building, which were used for building development by the Albanian authorities until the end of the communist period in 1990 and nowadays are mainly used as residential buildings (Bilgin & Korini, 2012).

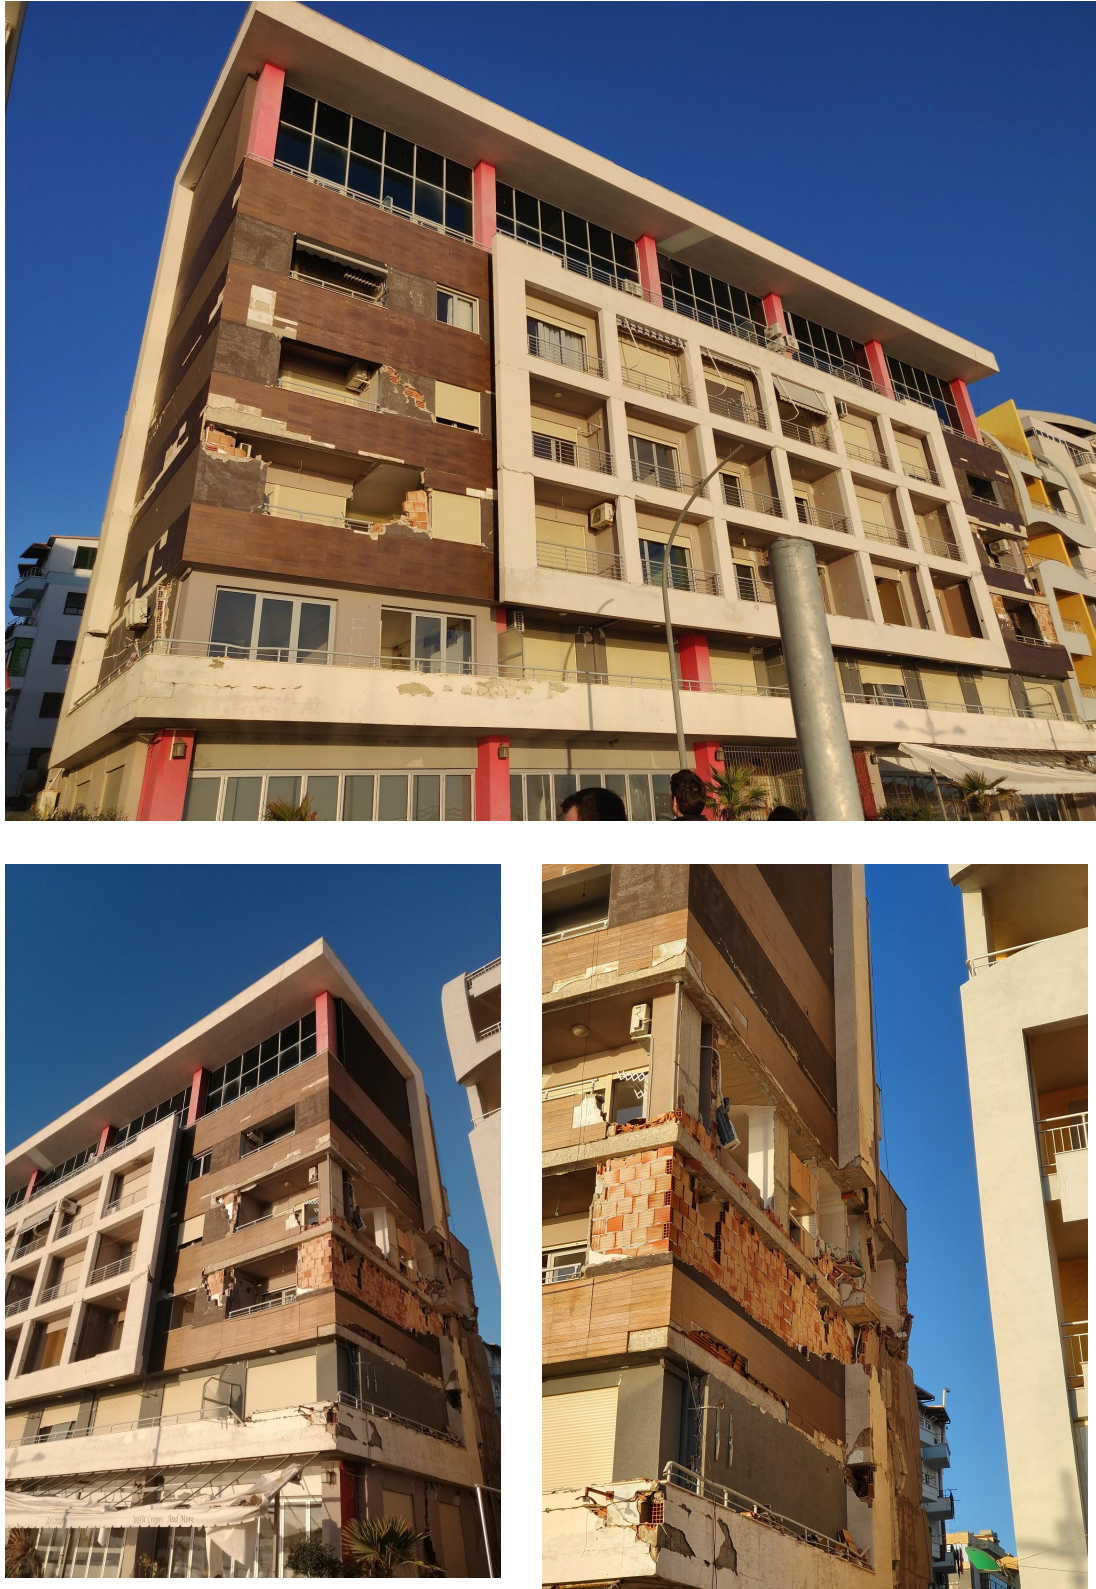
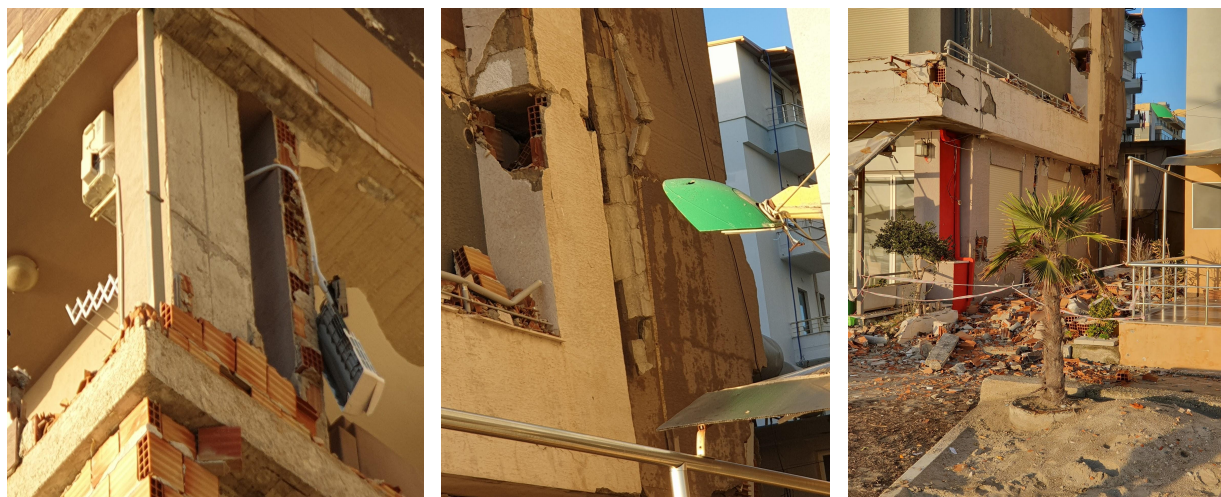
Figure 19 offers another example of a multistorey RC building exhibiting major seismic damage, where the two defects highlighted above are both present: masonry infill panels not adequately aligned with the perimeter frames and interruption of the infills at the ground floor. In fact, these issues are a recurrent theme also in the following cases examined. In this case too, out-of-plane failure of infill walls was observed in several location around the perimeter. The partial collapse of extruded volumes of unreinforced masonry, provided for aesthetic and architectural reasons, is also visible. This can be attributed to lack of adequate connection to the load-bearing RC frame between floors, as stability was apparently relying exclusively on small portions of the floor slab cantilevering out to accommodate the masonry elements.

Figure 19: Major damage of a 5-storey RC building. No confinement of the brick masonry walls to the RC frame is observed.

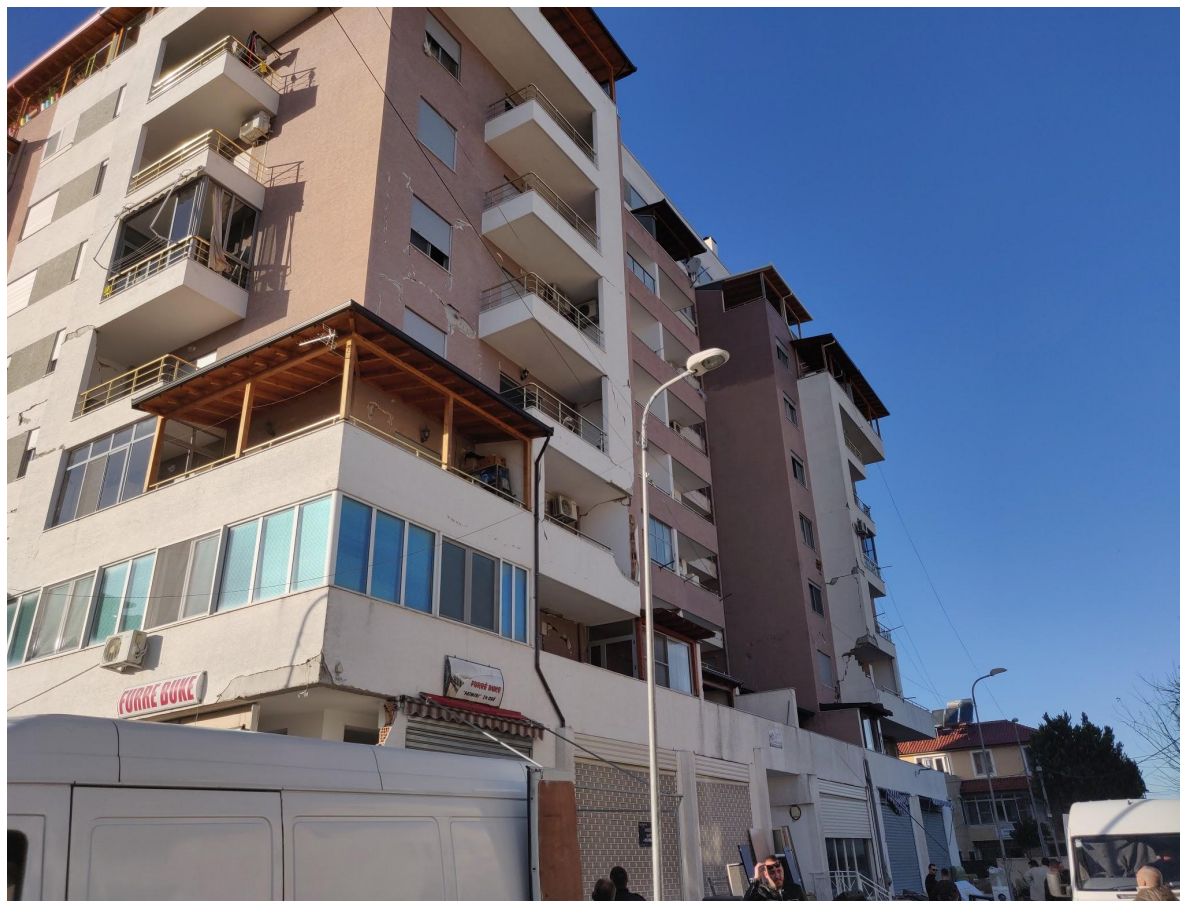
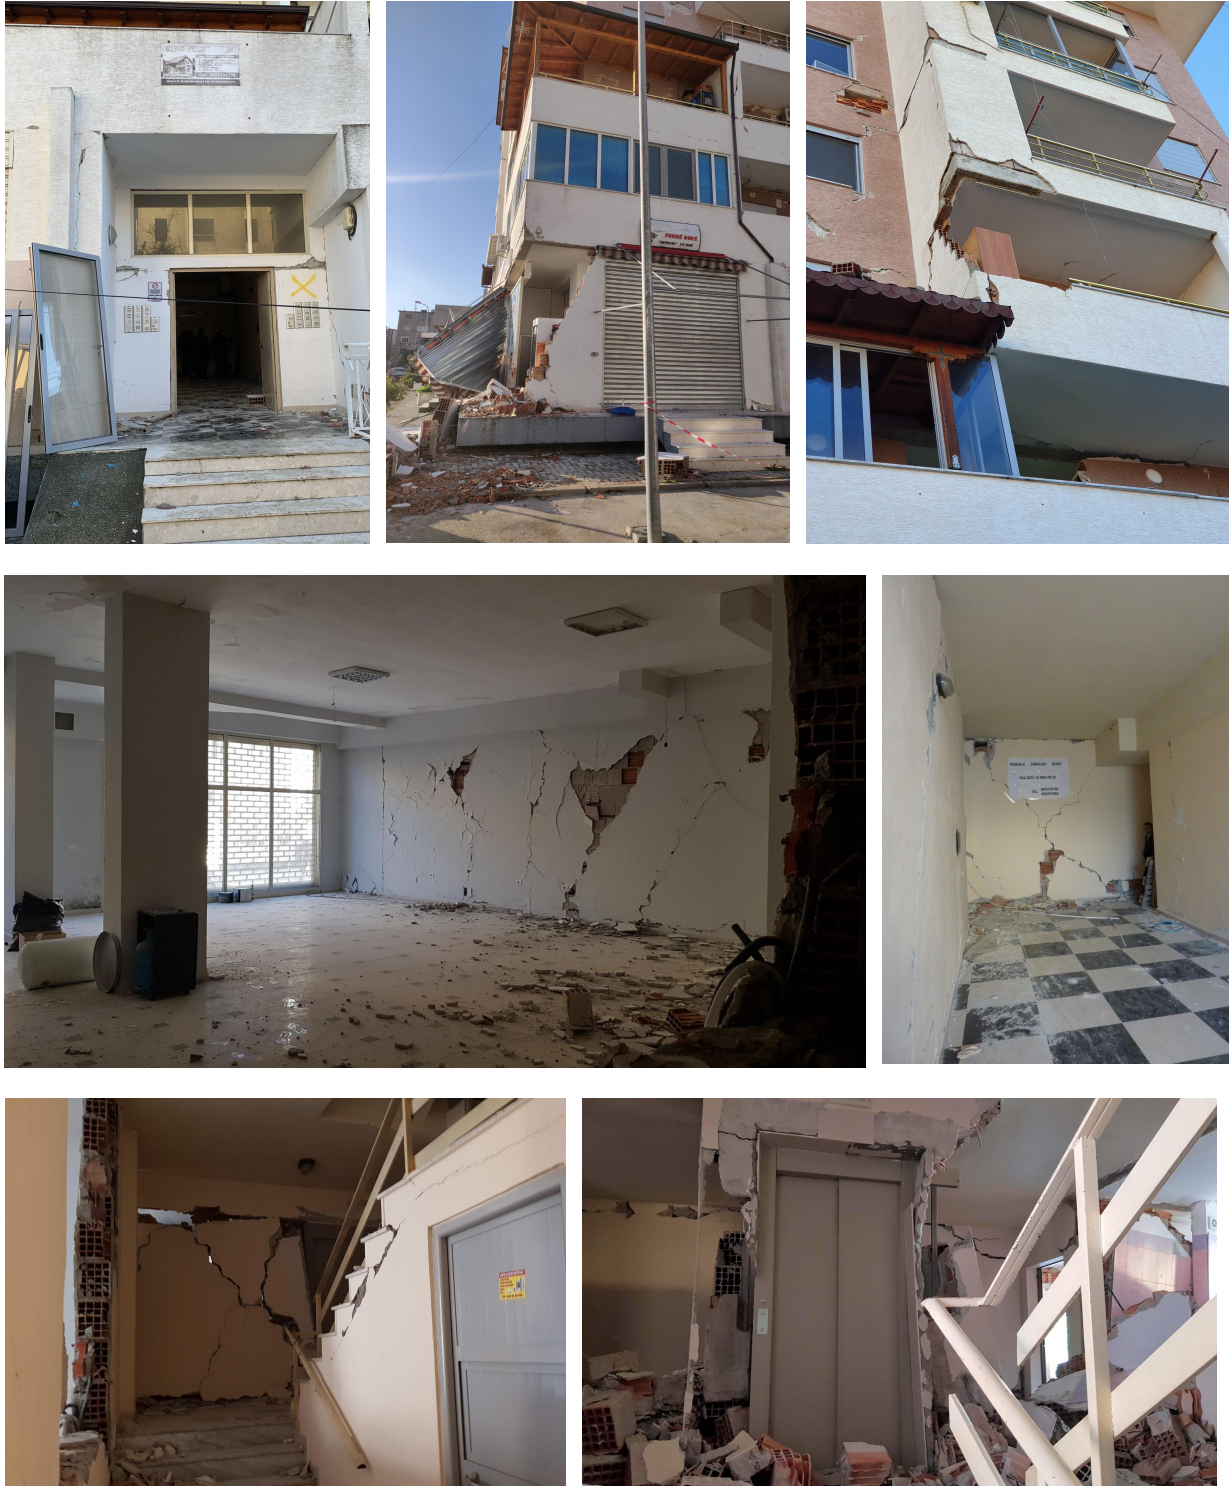
Another multistorey RC building with major damage due to the earthquake is illustrated in Figure 20. Flexural cracks and out-of-plane failure of infill walls, partial collapse of infill walls and facades, wide cracks and detachments, were observed. Significant damage was observed at the interior of the building, with wide flexural and shear cracks, mainly at infill walls and "X"-shaped cracks at infill walls around the staircase location. The absence of a RC core at the staircase and the elevator should be commented, along with the severe damage of the staircase. Similar structural pathology is depicted in Figure 21.

Figure 20: Major damage of a 6-storey RC building

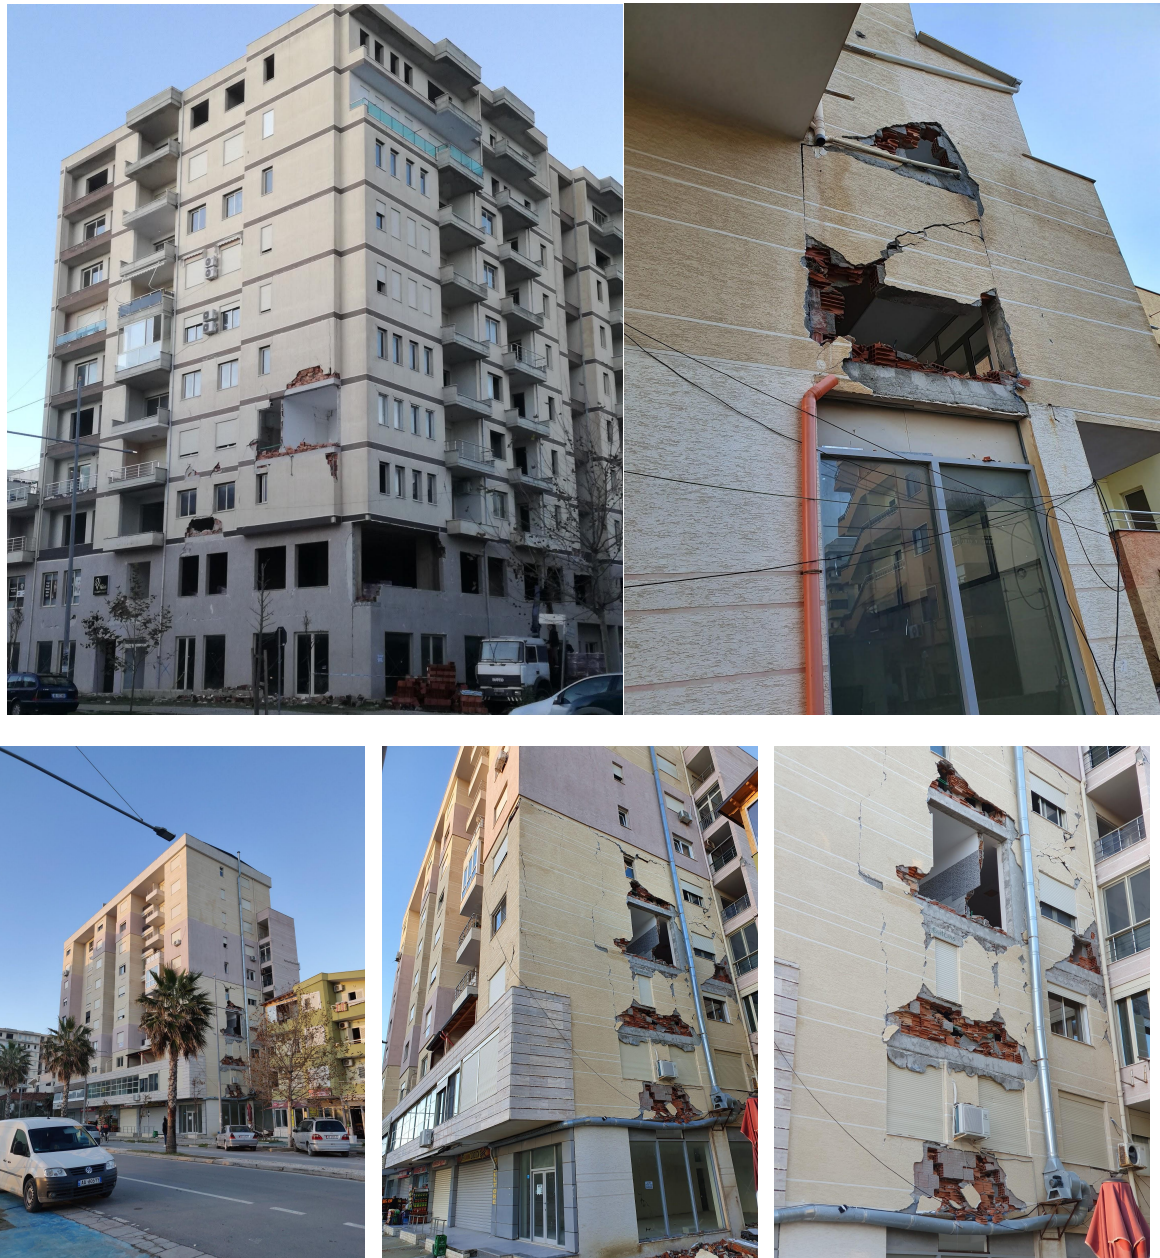
Figure 21: Major damage of a 10-storey RC building.

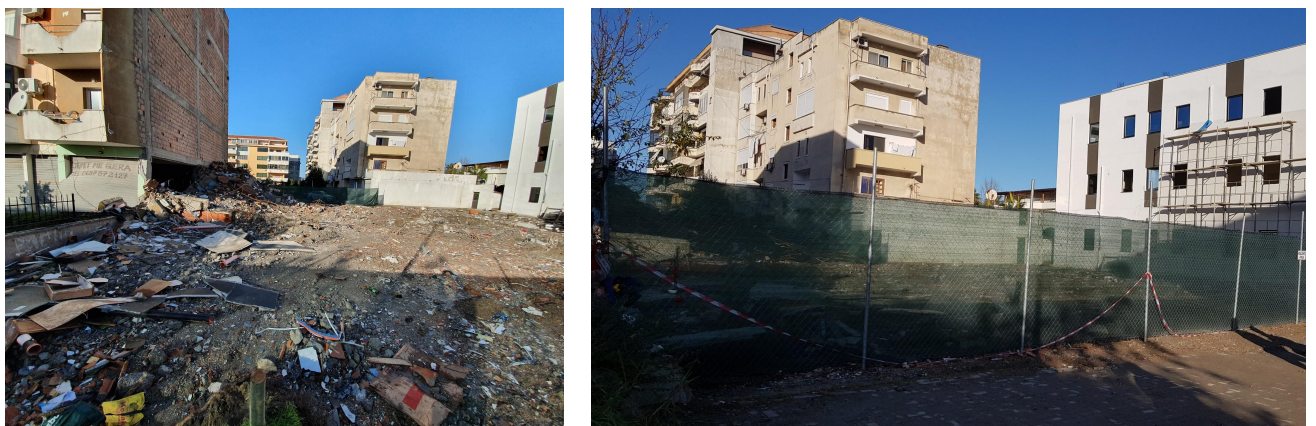
As already stated, at the time of the reconnaissance mission, the debris of the collapsed buildings had been removed and partially collapsed structures had been demolished. Therefore, it was not possible to evaluate their failure mechanism (Fig. 22). It is noted that the sites of the (fully or partially) collapsed buildings were cleaned in very short time after the earthquake event.

Figure 22: Collapsed and/or demolished buildings.

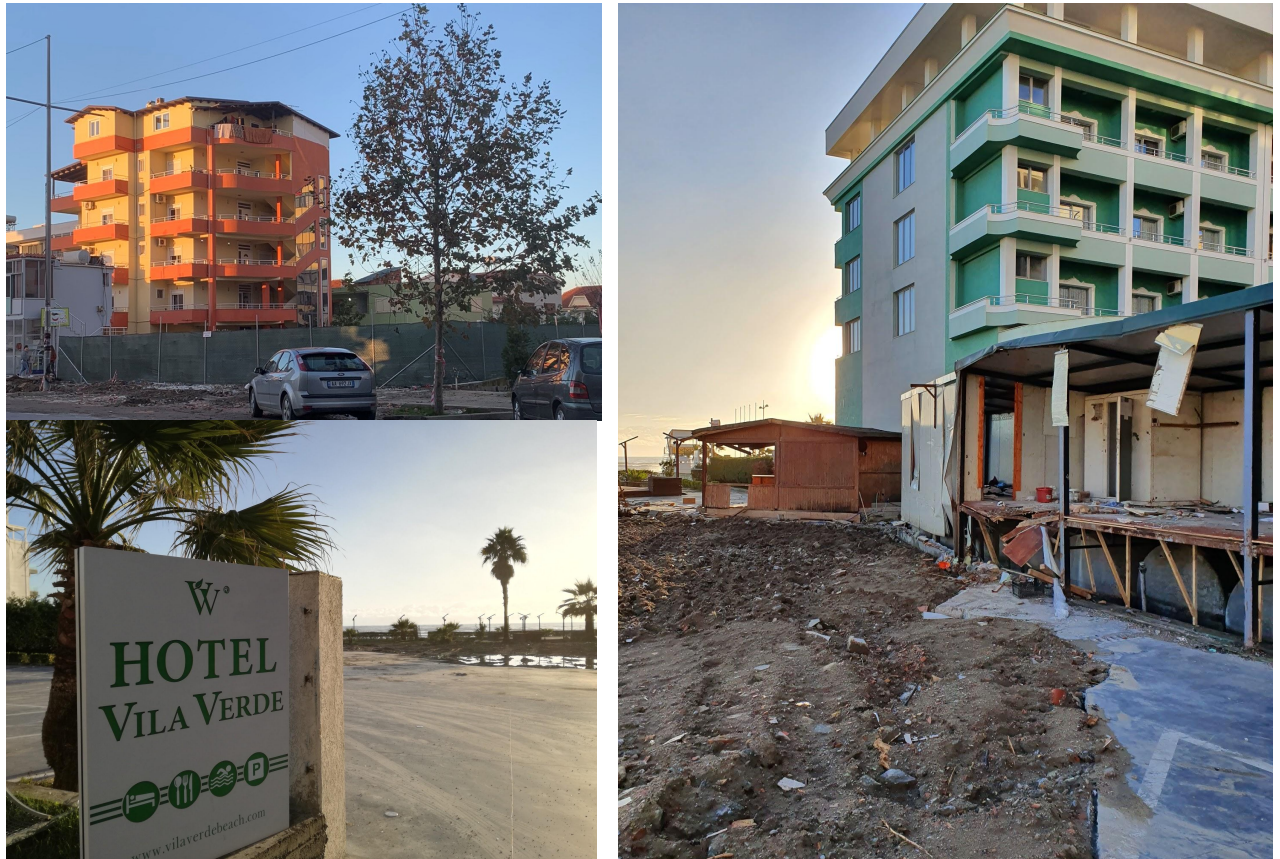
Severe damage was observed at several hotels in Durrës. Hotel Ljubljana, Hotel MiraMare and Hotel Villa Verde are some examples. As with the residential buildings, at the time of the visit the debris of the collapsed buildings had been removed (Figure 23). Light damage was observed at several hotels in the close proximity of the collapsed hotels. Flexural and shear cracks were observed, mainly at infill walls, as depicted in Fig. 24.

Figure 23: Vila Verde Hotel (left) and Lubjana Hotel (right).

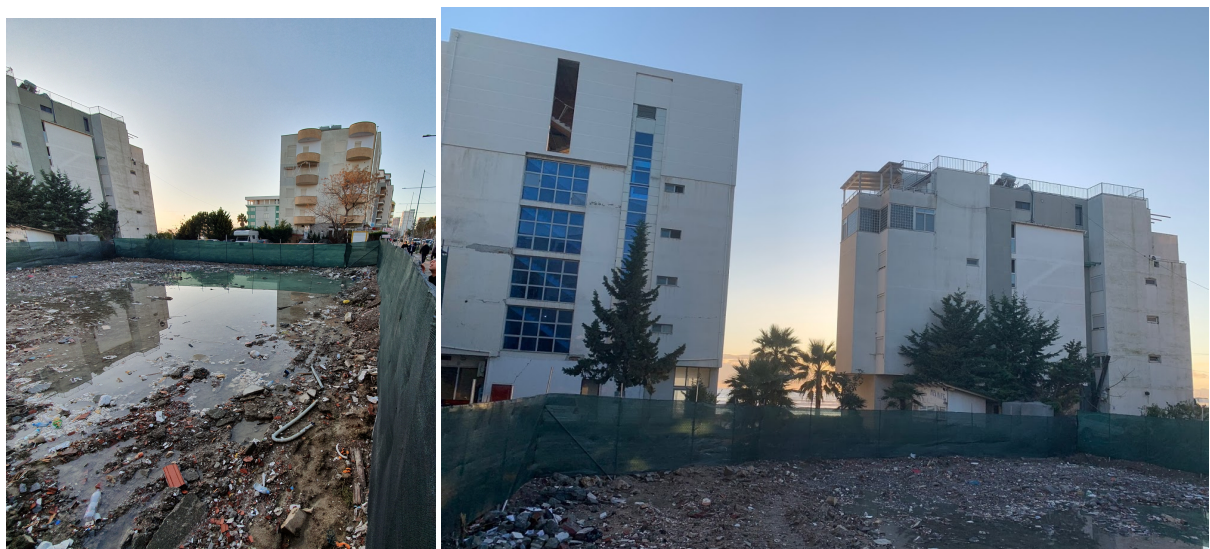
Figure 24: Photos at the location MiraMare Hotel.

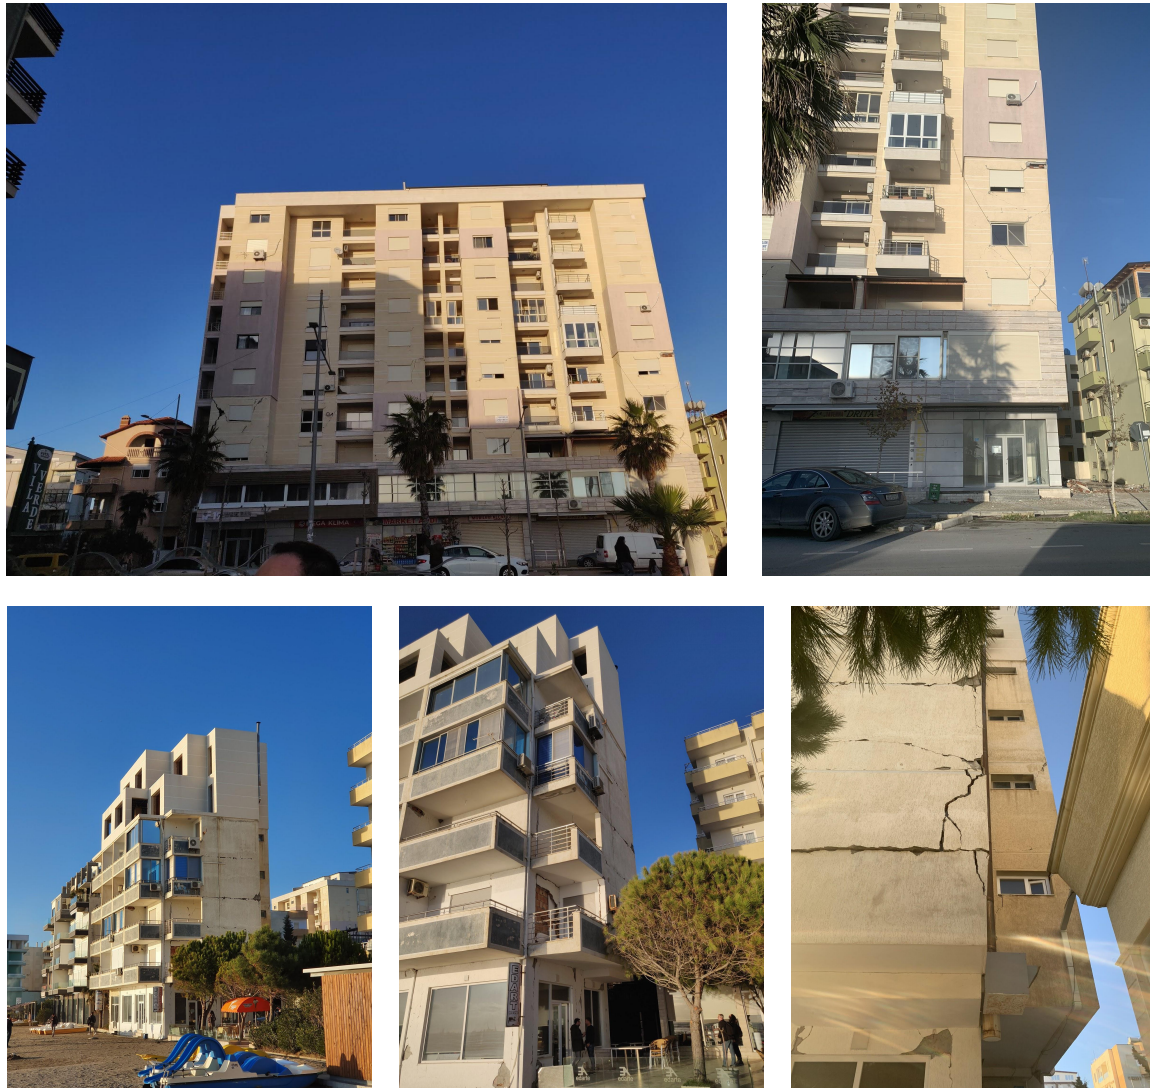
Figure 25: Light damage at hotels in Durrës

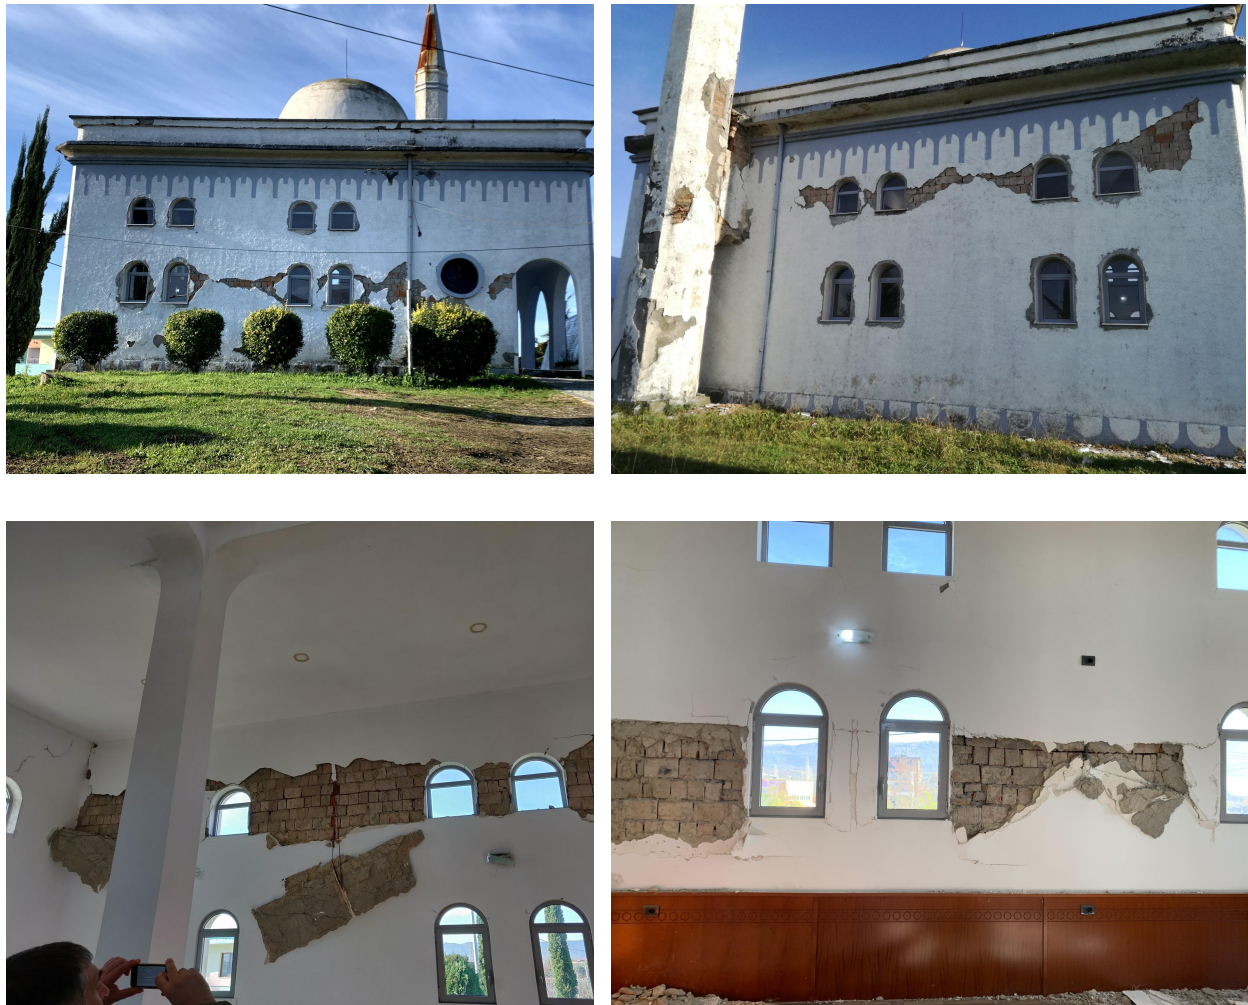
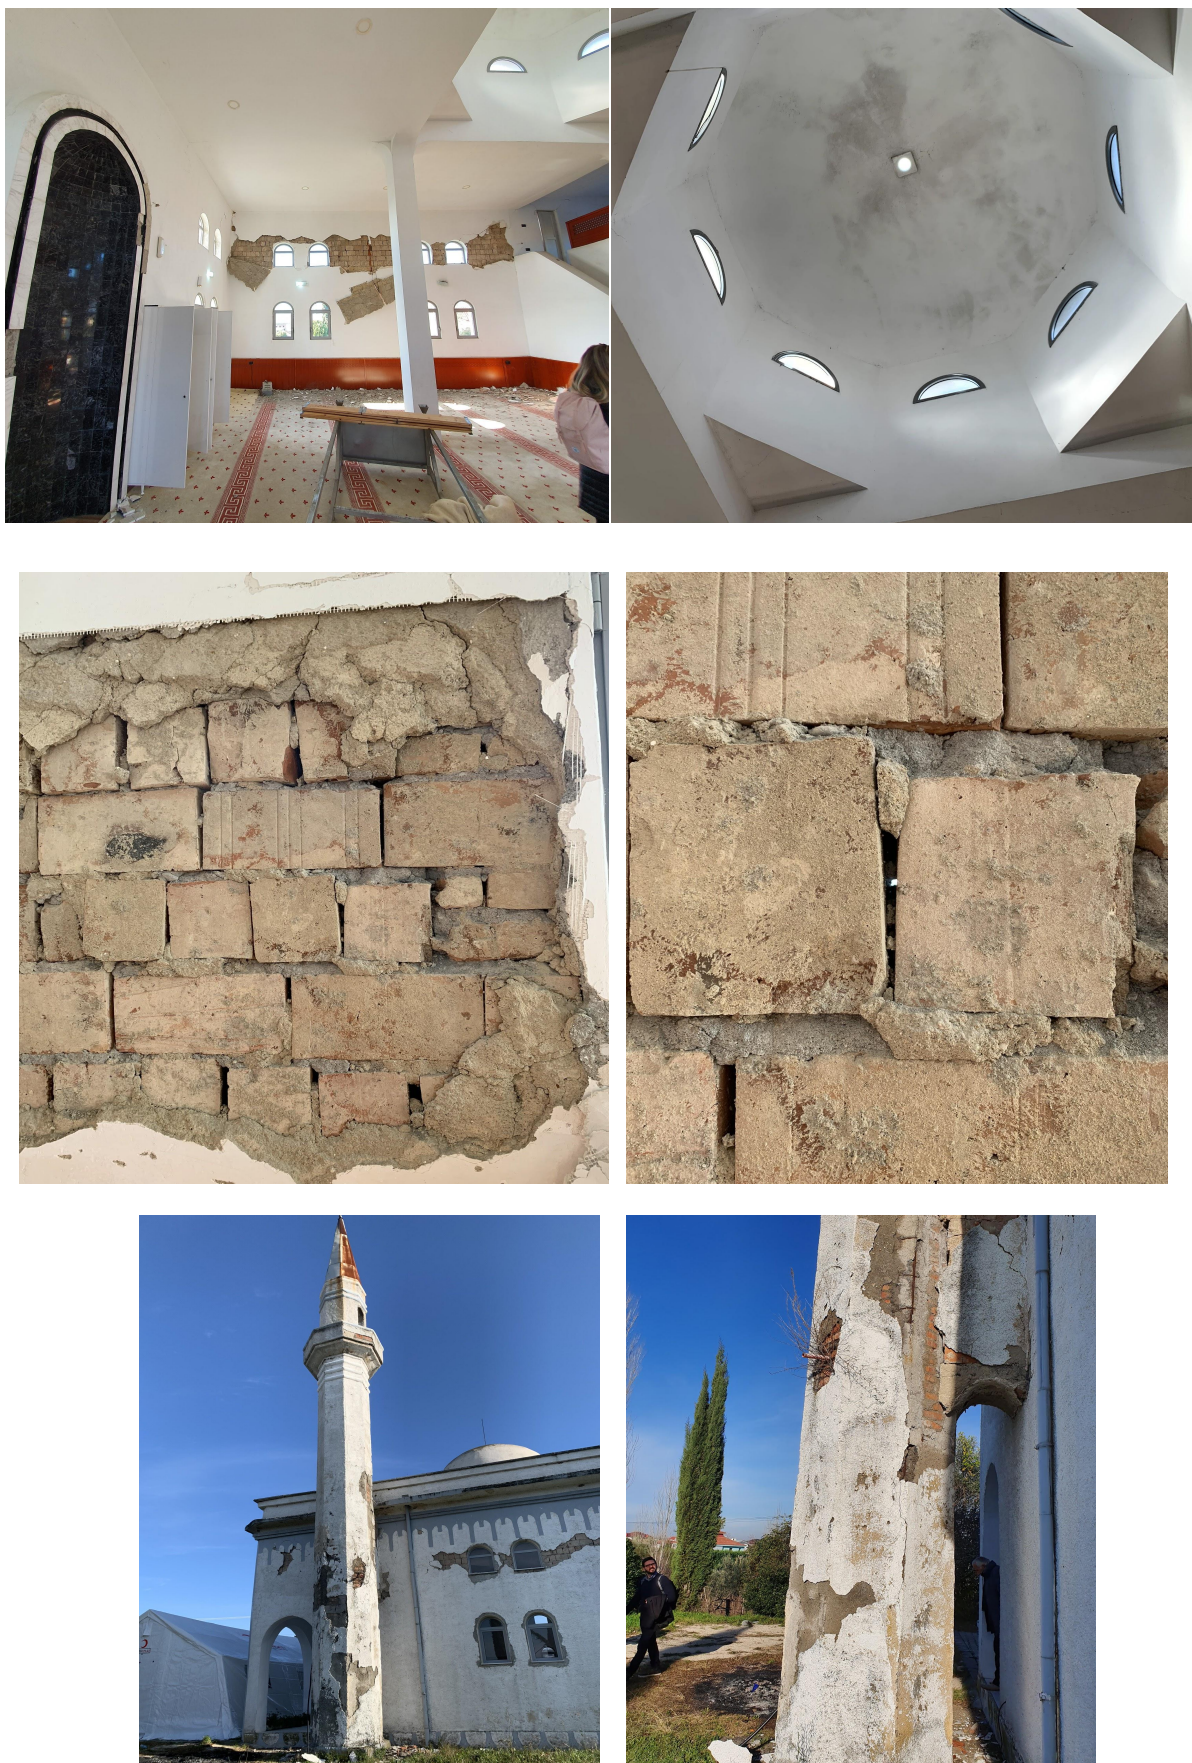
Slight to moderate damage was observed at the mosque of Thumanë (Fig. 26-27). The structural system of the mosque is mainly masonry with RC frames at the interior. The horizontal and vertical joints are irregular (in terms of shape and thickness), while the mortar thickness varies. Wide “X”-shaped cracks due to diagonal tension were observed at the exterior infill walls together with cover spalling at the interior. Small cracks were also observed at the dome as well as along the dome ring due to excessive horizontal stresses. No significant damage was observed on the interior RC frame elements. This is the result of their small stiffness compared to the stiffness of the masonry walls at the perimeter of the structure that provided the main seismic resistance. The minaret appears to have suffered moderate damage. Minarets in general exhibit seismic behavior not similar to other known structures, because of their unique characteristics in terms of slenderness and shape. The minaret has a hexagonal cross-section and it is constructed with RC columns of approximately 10x10 cm<sup>2</sup> at every vertice of the hexagon and tie-beams every 3m along its height. Extended cracking and spalling were observed, at the base and along the shaft. Cracks are also present at the connection of the minaret to the main mosque structure. These cracks are very common when minarets are contiguous and integral with the main mosque structure. They come as result of the out-of-phase vibration of the two parts of the structure due to the difference of their dynamic properties.

Figure 26: Damage of the mosque in Thumanë

Figure 27: Damage of the mosque in Thumanë

- Major damage was also observed at the mosque located in Thumanë. Extended cracking and spalling at the masonry minaret, at the base and along its height.

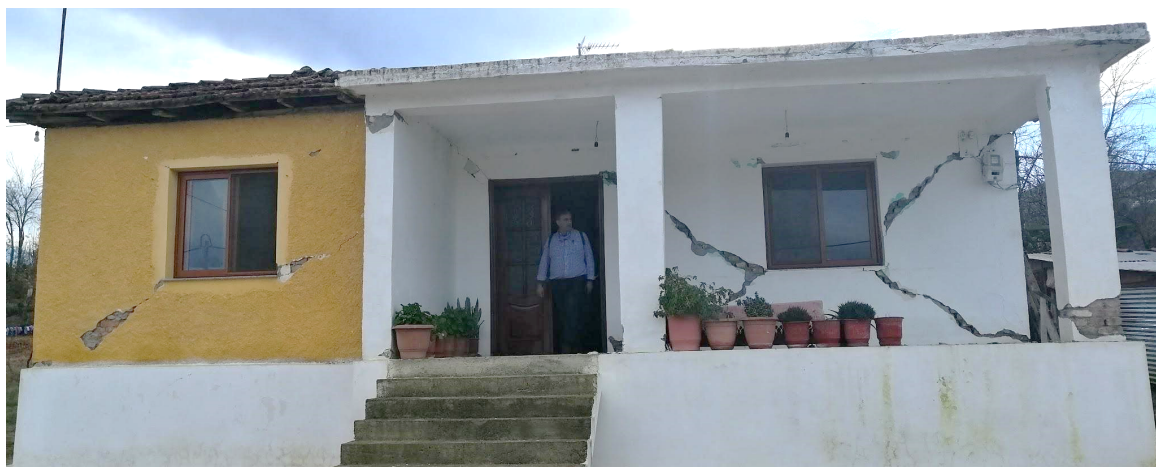
Most buildings in Thumanë developed moderate to major damage, if they did not collapse either partially or totally. An example of light-to-moderate damage is the single-storey masonry building with clay bricks shown in Figure 28. “X”-shaped, wide cracks due to diagonal tension at masonry walls were observed, along with cracking and spalling at the base of slender vertical load bearing elements. The in-plane diagonal cracking is related to the shear failure of the masonry piers and spandrels due to excessive stresses induced by in-plane vertical and horizontal forces. Similar extent of damage is presented in Figure 29 followed by a three-storey RC building irregular in elevation in Figure 30. Figures 31-33 illustrate a three-storey, irregular in elevation, masonry building with RC slabs and confined masonry walls that was heavily damaged. The walls were thick enough, but masonry was constructed using low-strength clay bricks (partially fired or unfired). A detachment of the external staircase, wide cracks and failure at the corner and partial collapse of the timber roof were also observed. In addition, the vertical concrete members were constructed with an attempt to follow an Italian and South American practice from the 1970s for concrete beams utilizing a welded steel-truss type reinforcement (Colajanni et al., 2017) instead of a regular arrangement of longitudinal reinforcement bars and transverse. Regarding poor concrete quality, rounded large-size gravel aggregates were observed in the concrete mixture.

Figure 28: Moderate damage of single-storey building in Thumanë
