## **Albania earthquake of November 26, 2019**

### *Report on Structural and Geotechnical Damage*

November 2020

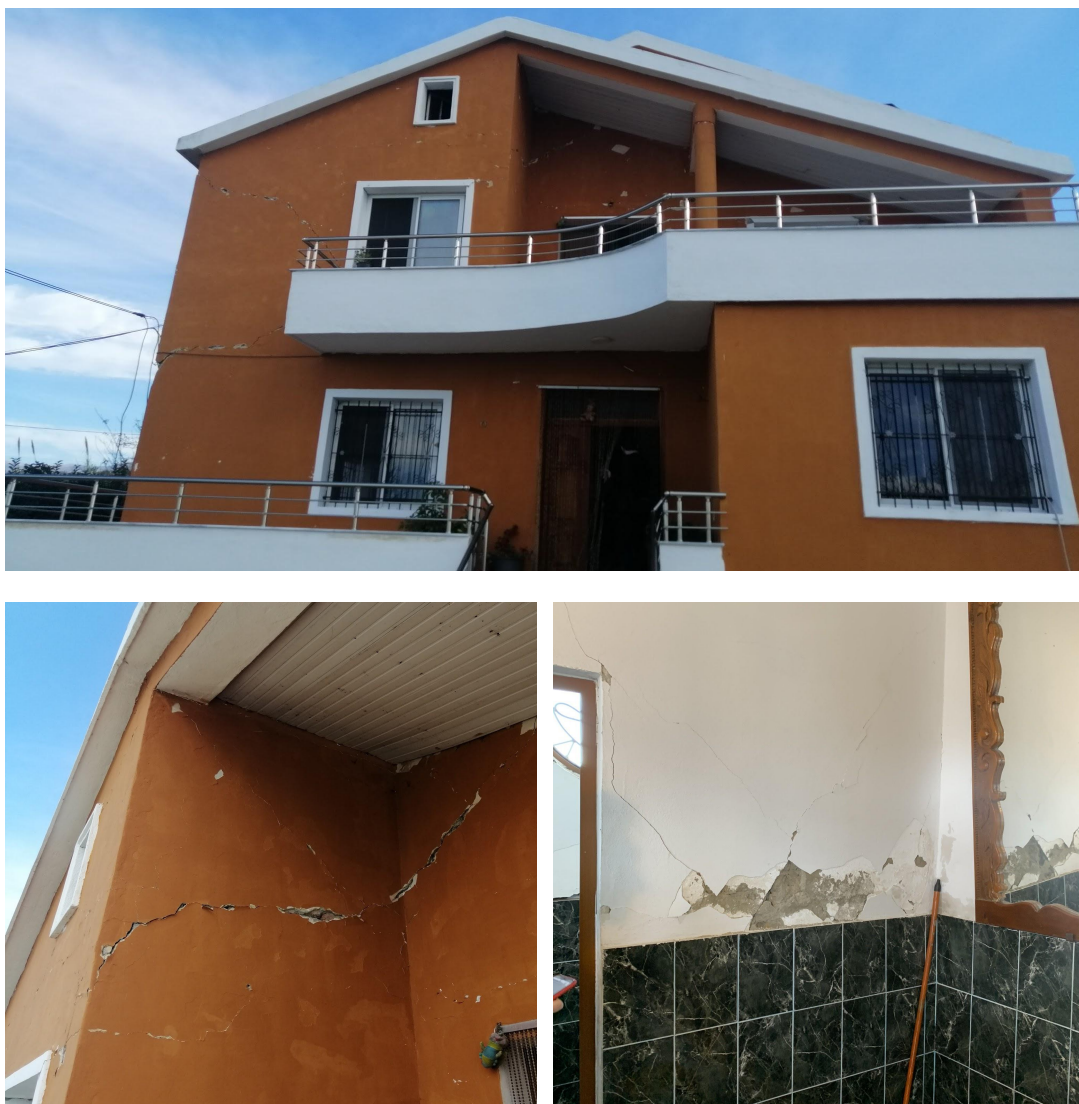
Figure 29: Moderate damage of two-storey building in Thumanë

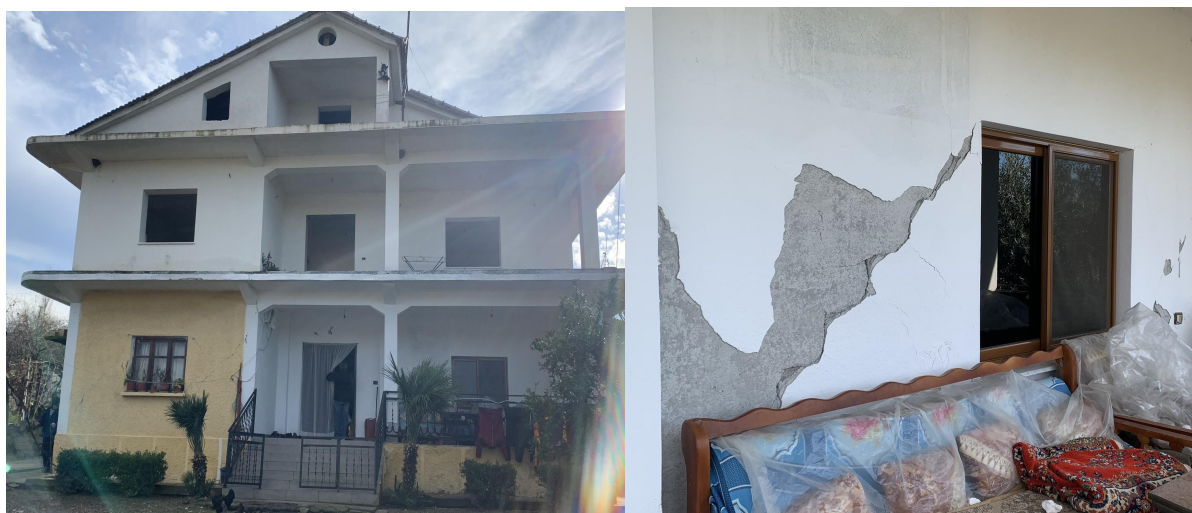
Figure 30: Moderate damage of three-storey building in Thumanë

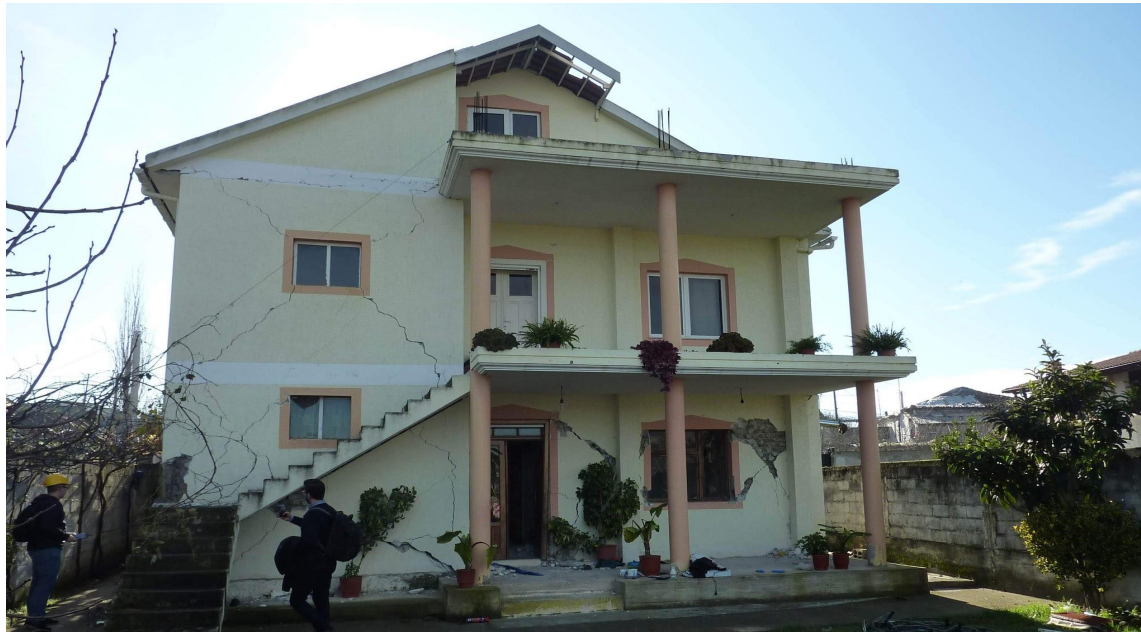
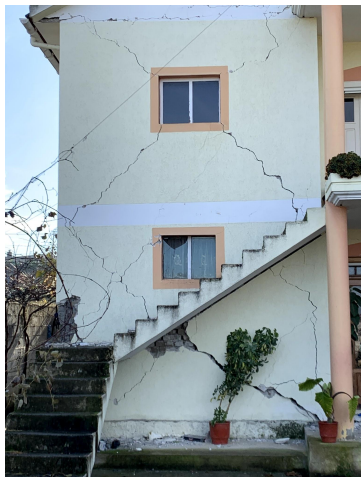
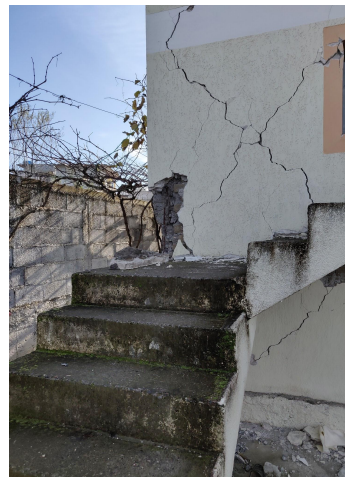
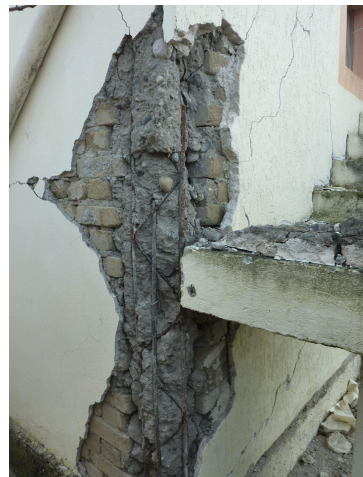
Figure 31: Major damage of three-storey confined masonry building in Thumanë.

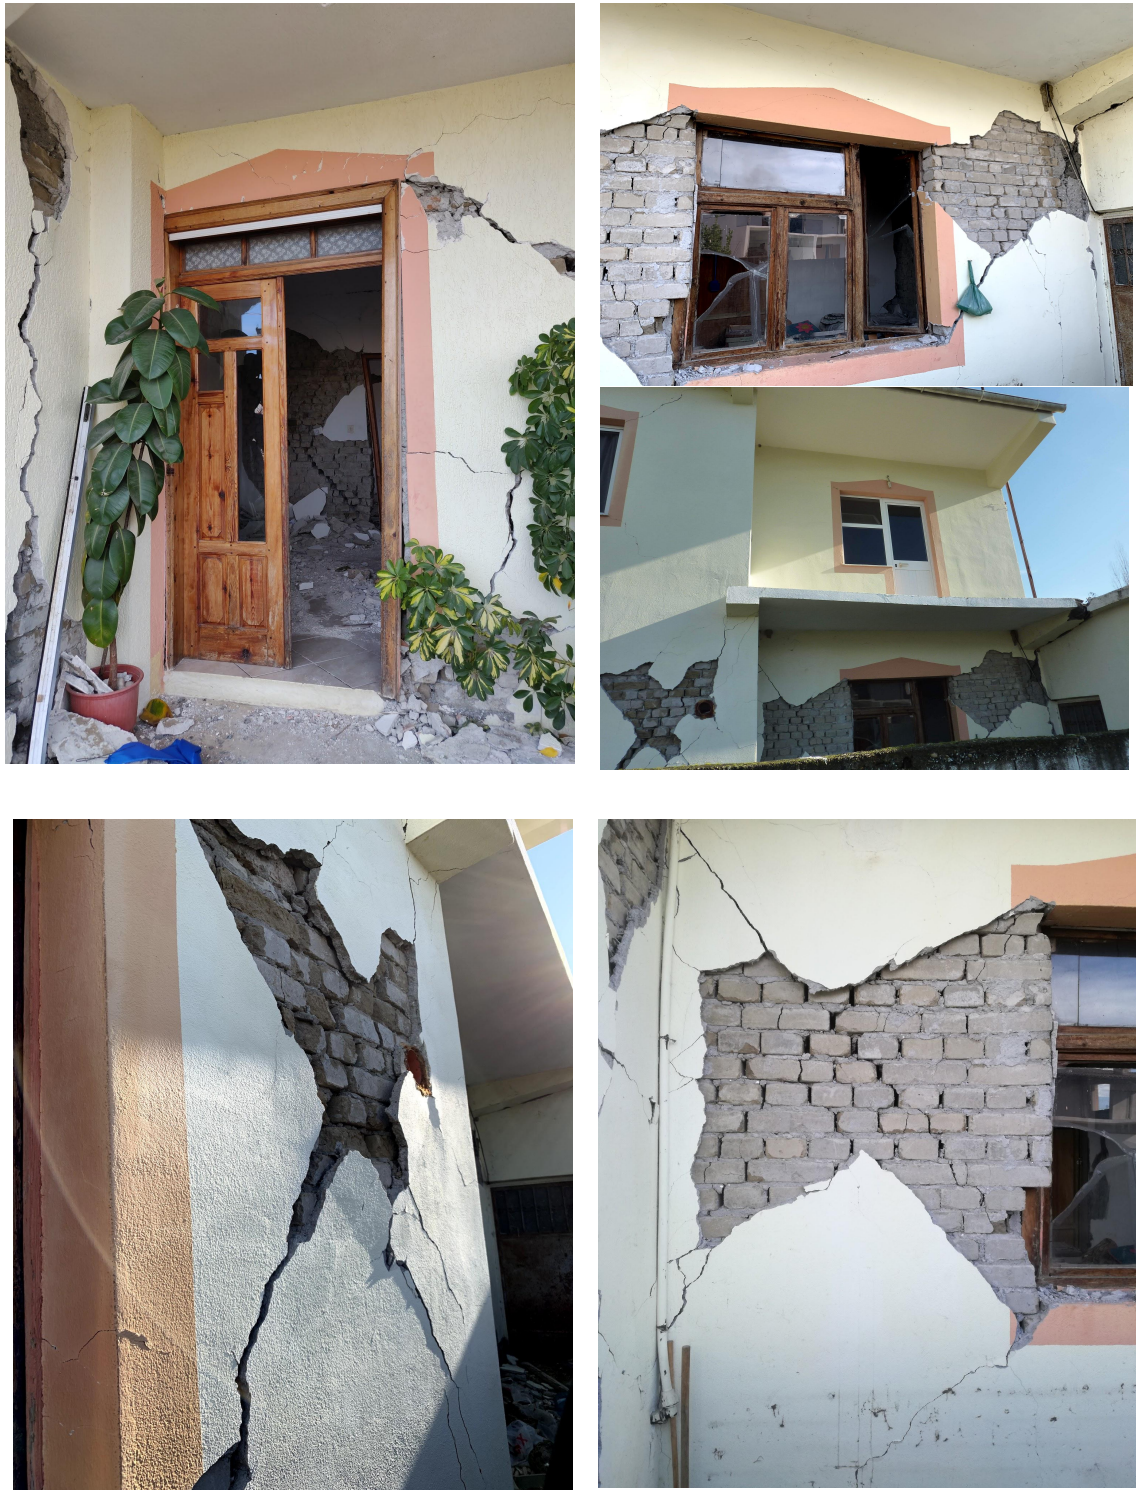
Figure 32: Major damage of three-storey confined masonry building in Thumanë.

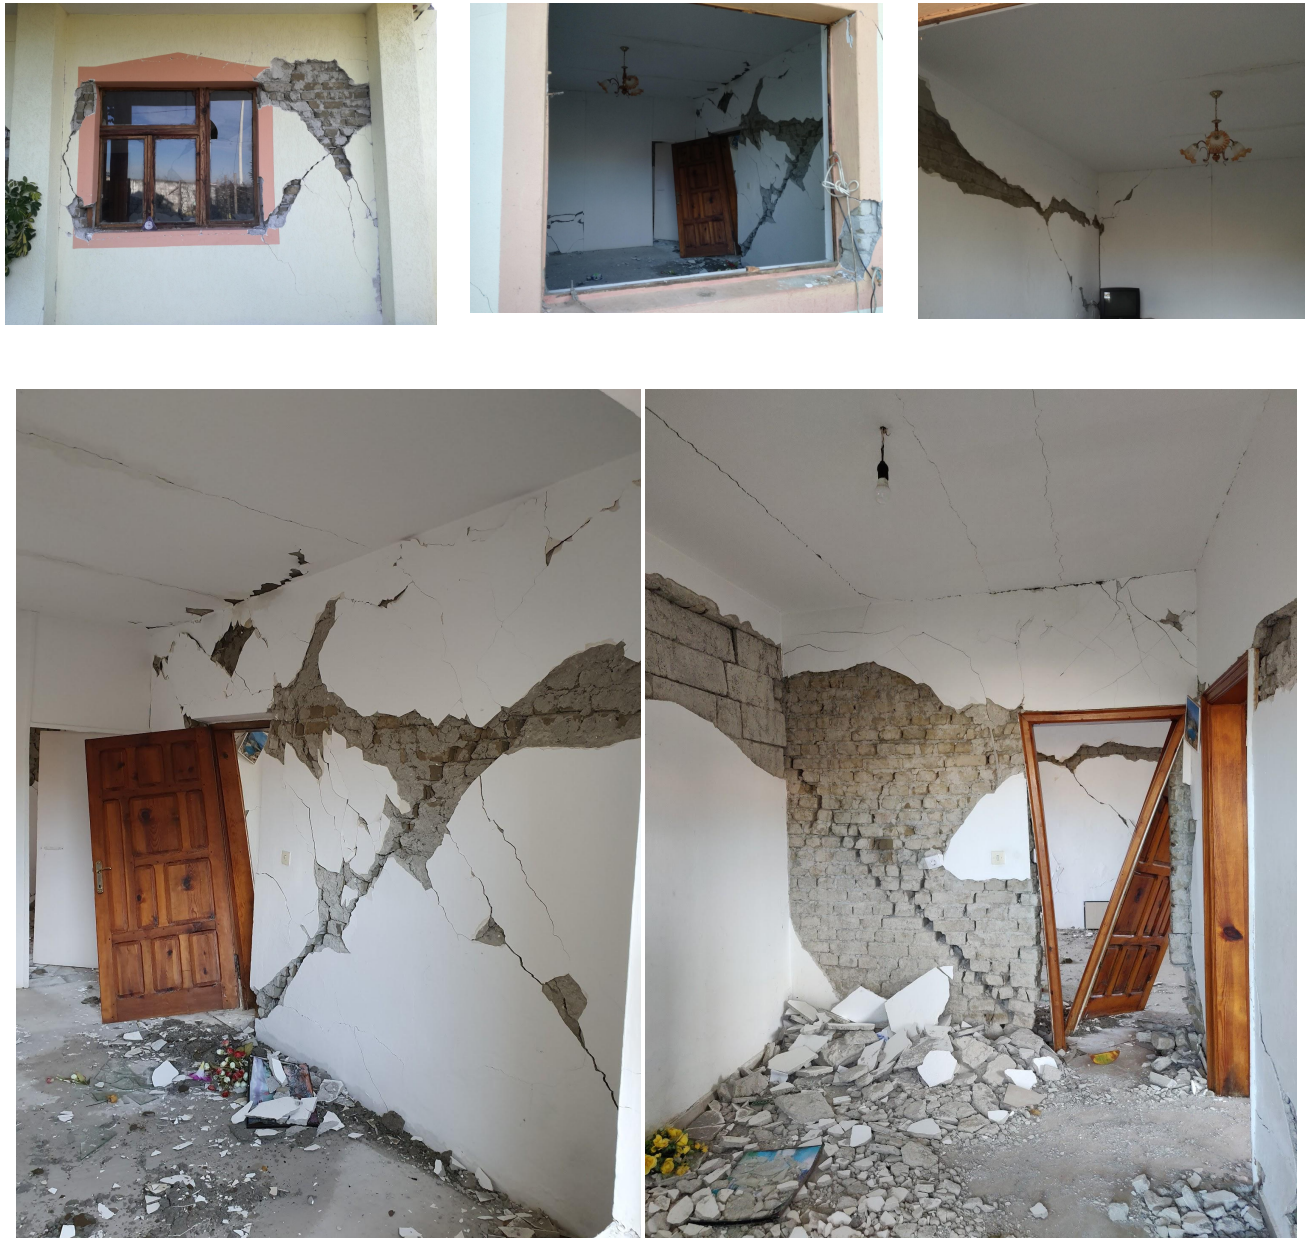
Figure 33: Major damage of three-storey confined masonry building in Thumanë.

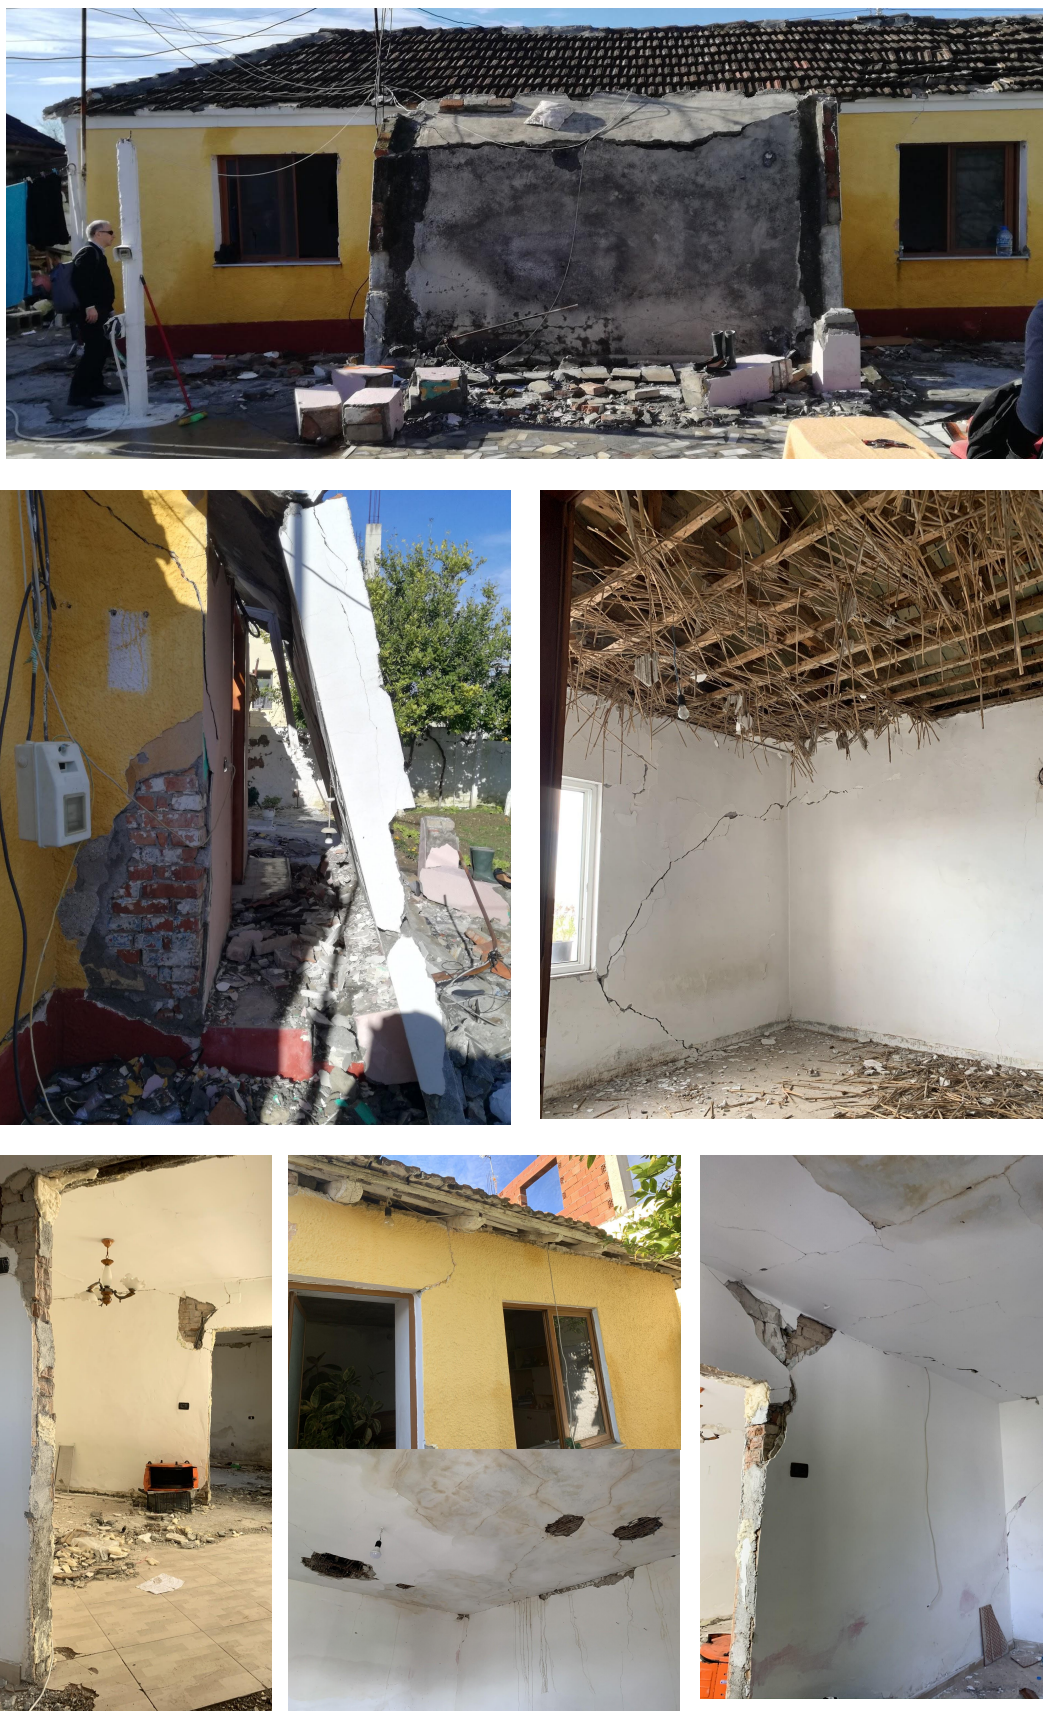
One-storey masonry building with RC slabs and masonry columns is also shown in Figure 34, with major damage and complete collapse of the masonry-RC frame porch in front of the house. The collapse of the masonry columns at the entrance resulted in the collapse of the RC roof slab. Apparently, this part was built at another construction phase and was not properly connected to the building in order to transfer loads safely. Wide diagonal tension cracks at masonry external and internal walls and “X”-shaped cracks between openings were observed, along with the partial collapse of the timber roof.

Figure 34: Major damage of single-storey building in Thumanë

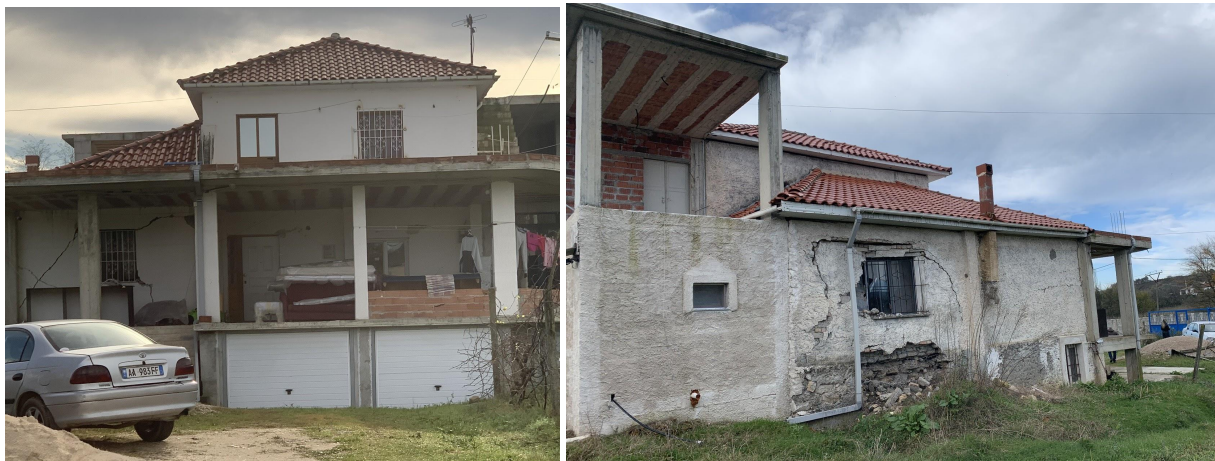
A two-storey masonry building with stone bricks, extended in plan with R/C frames, with severe moderate damage of the older masonry part of the structure is shown in Figure 35. The new RC frame part of the structures suffered no damage at all. It should be pointed herein, that the owner built the RC frame section on his own, falling back to his experience working in the construction industry abroad, without any structural design and supervision by licensed professional engineers. Diagonal tension cracks mainly at masonry walls, partial failures of bricks, wide cracks and detachments, were observed, as well as partial failure of mortar and bricks at the base of masonry walls.

Figure 35: Moderate damage of two-storey masonry building with stone bricks, extended in plan with RC frames in Thumanë.

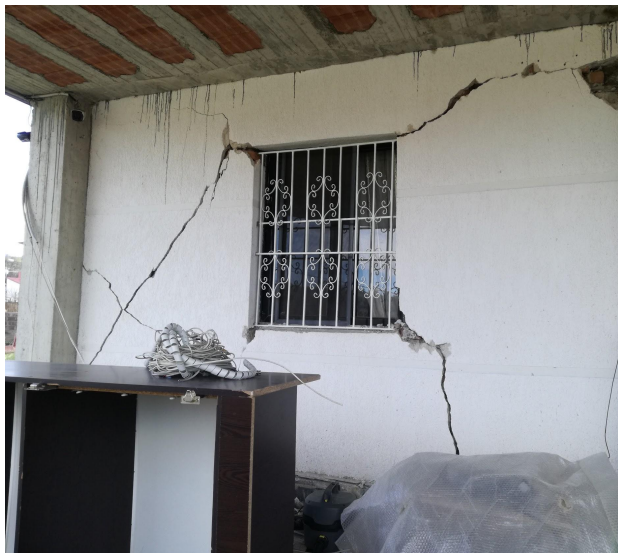
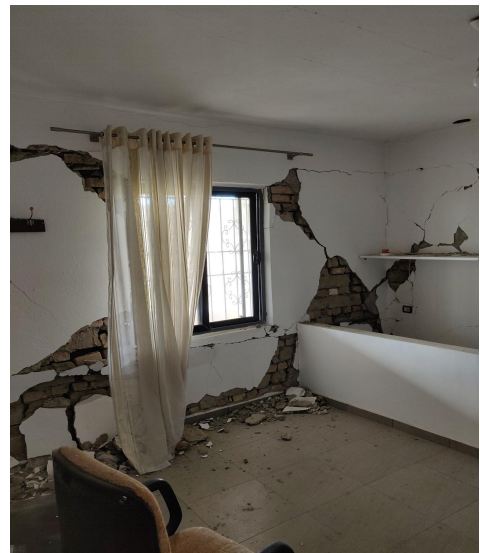
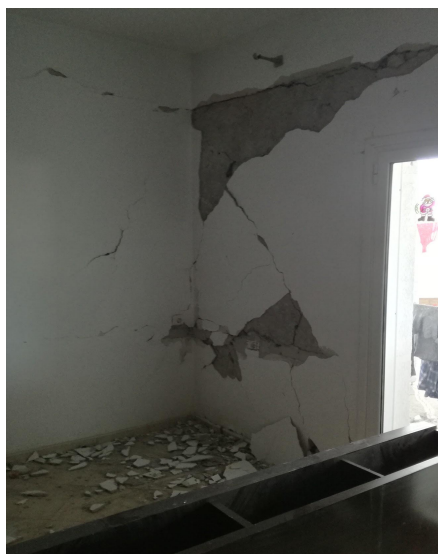
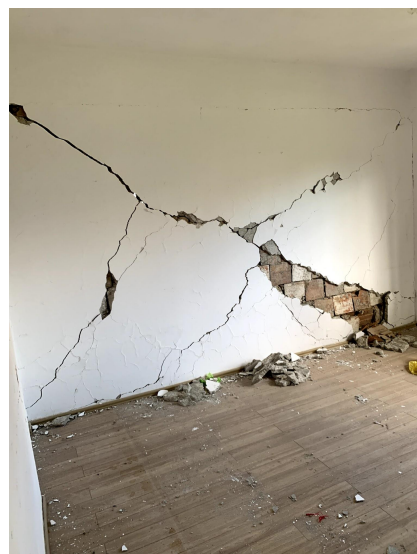
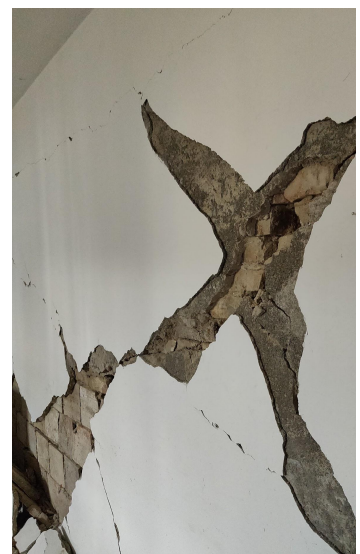
Figure 36: Major damage of two-storey RC building in Thumanë

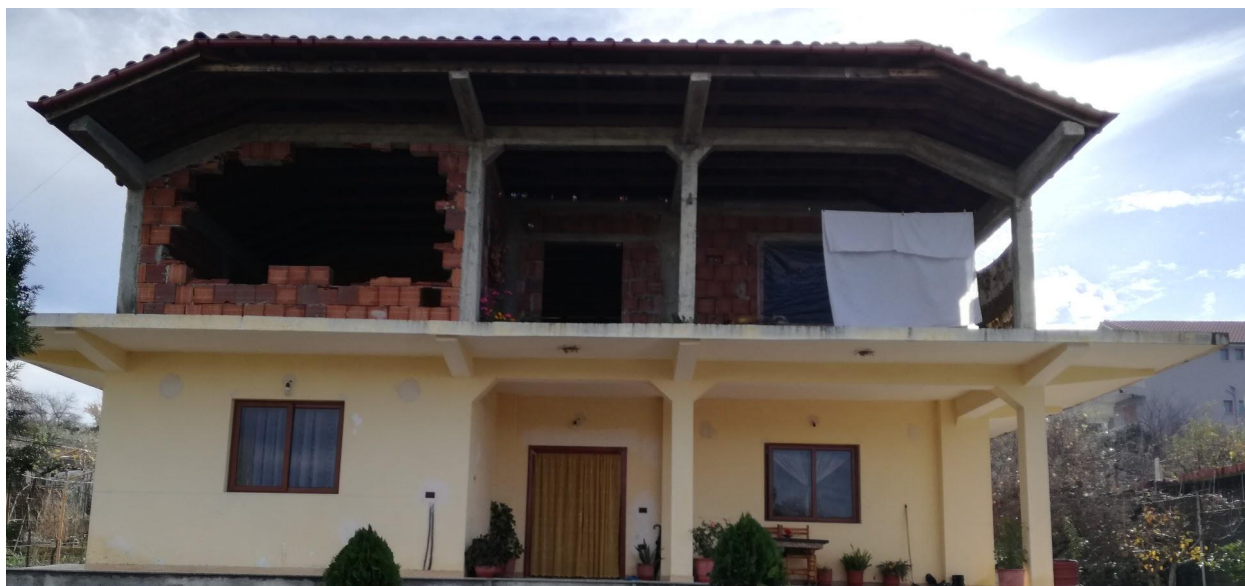
Figure 37 illustrates a two-storey RC building that suffered significant damage in the infill. Shear cracks due to diagonal tension are observed around the openings, as well as out-of-plane failure, partial collapse of infill walls, wide cracks and detachments. Concrete spalling is observed at external columns along with corrosion of longitudinal reinforcement. Despite being built rather recently the lack of quality control during the construction of the building (or the lack of compliance with up-to-date standard provisions during the design) is evident from the large and irregular spacing of the hoops in the RC columns revealed after spalling.

Figure 37: Major damage of two-storey building in Thumanë

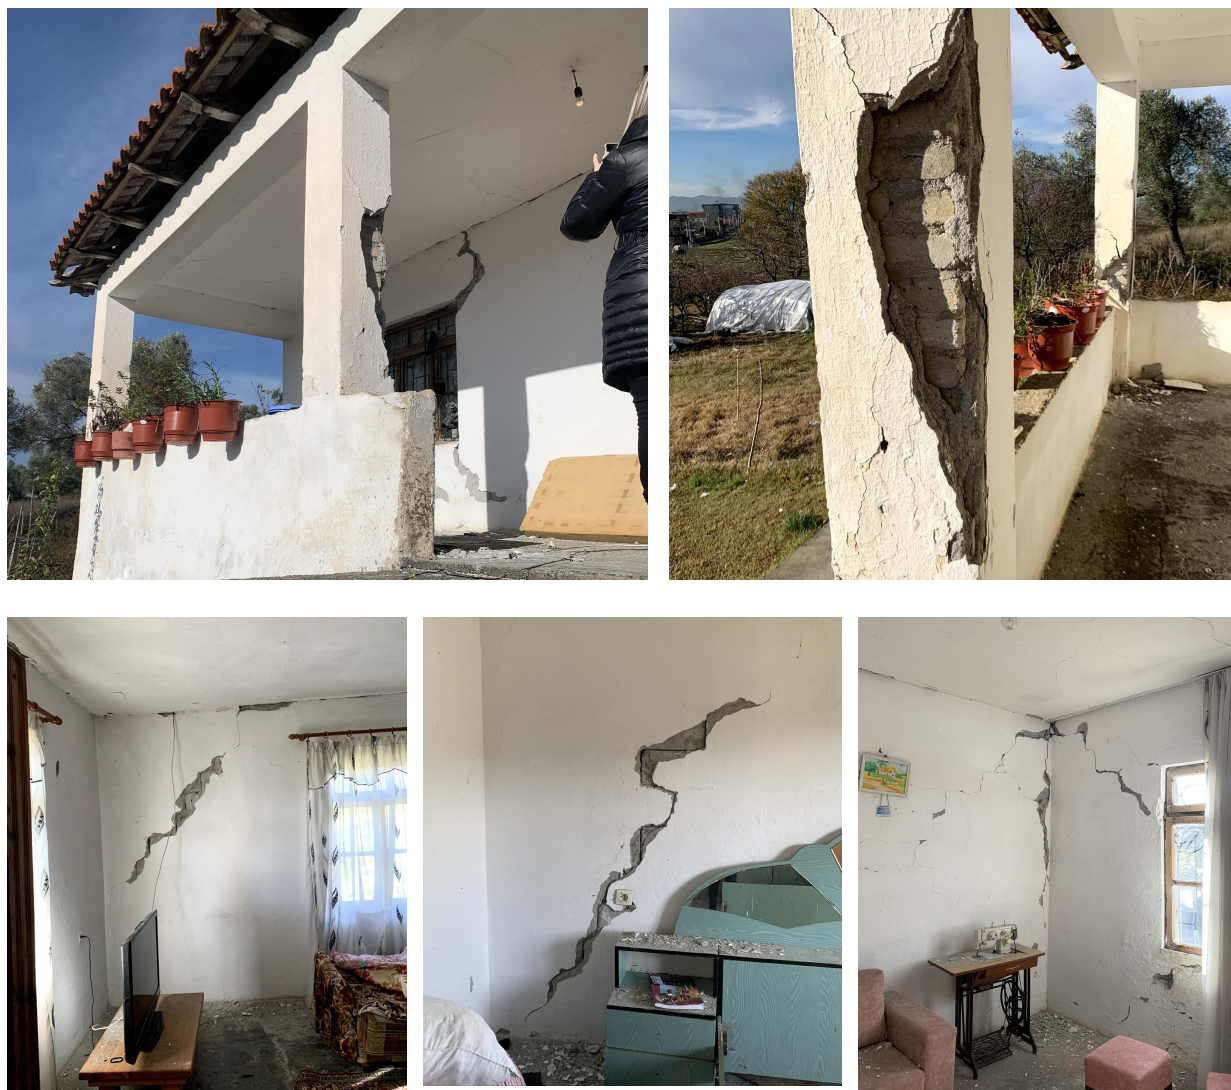
Figure 38: Major damage of single-storey building in Thumanë

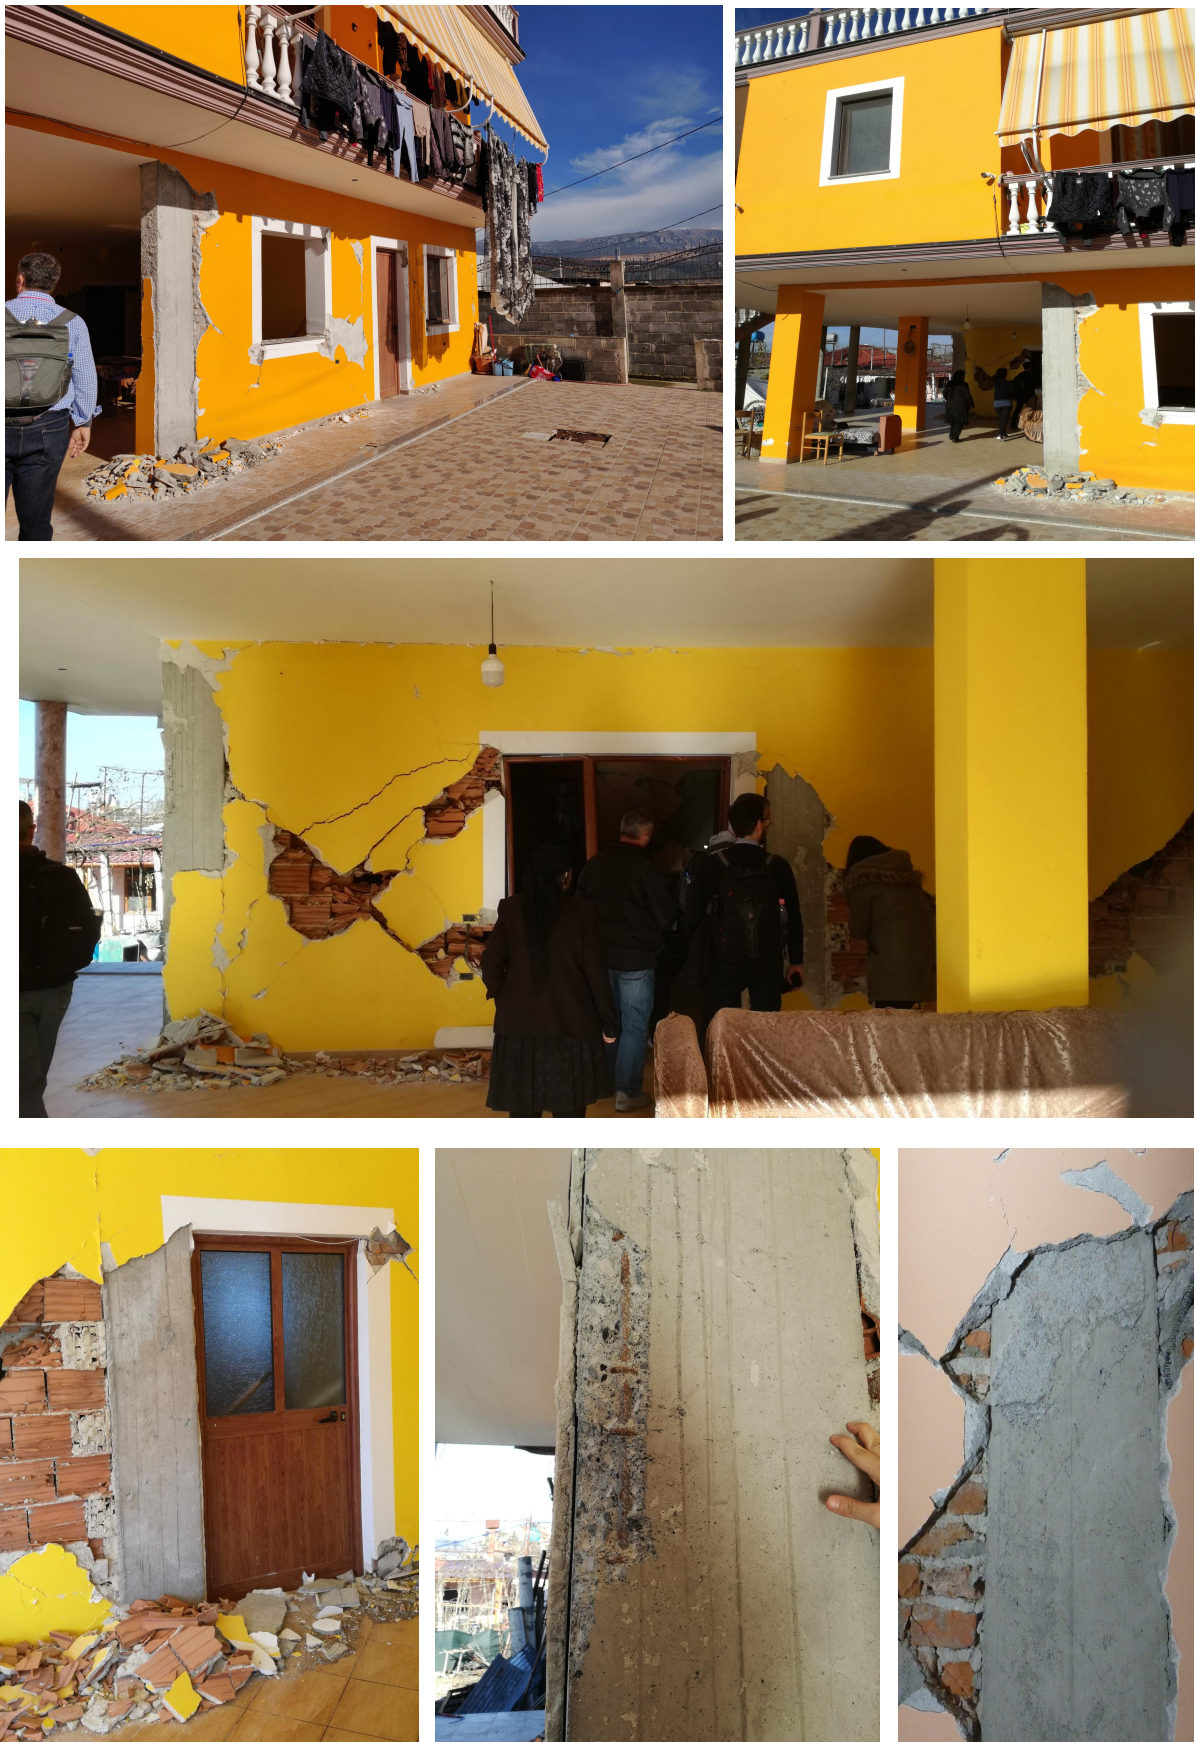
It is worth mentioning that with the exception of the heavy damage observed in the RC building presented in Fig. 39, very few RC buildings performed poorly in Thumanë. The latter is either due to the small number of RC buildings that exist in Thumanë (a rural area with a building inventory dating back to the 1950s) or due to the superior performance of the RC buildings in the seismic event. It is recalled that in old buildings with extensions of RC systems, damage was only observed in the older part of the building, whereas the RC part remained undamaged.

Figure 39: Major damage in the infill brick walls of a two-storey building in Thumanë.

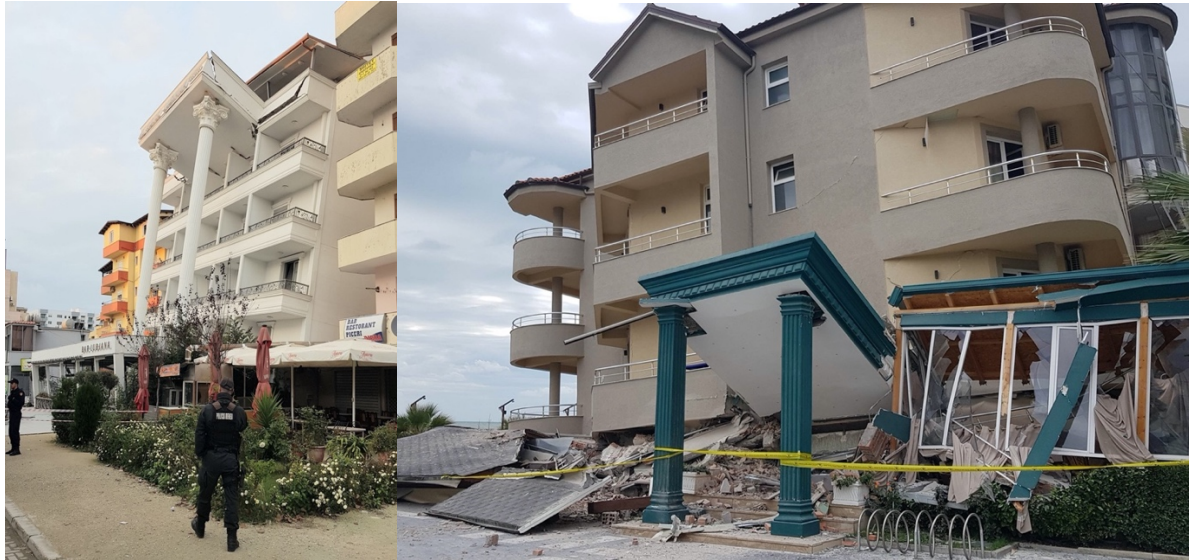
The Hotel Lubjana situated at the seafront of Durrës, was one of the structures that experienced such extensive tilt due to soil liquefaction as shown in Fig. 46. The damage was beyond repair and it was demolished during the first weeks after the seismic event. The Villa Verde Beach Hotel was also located in the high risk for liquefaction area. Although the main cause of its collapse seems to be the development of a soft-storey mechanism, the soil conditions may have contributed to the failure.

Figure 46: Tilting of Hotel Lubjana due to soil liquefaction and resulting settlement (left). Collapse of the Villa Verde Beach Hotel (photos courtesy of J. Psaropoulos)

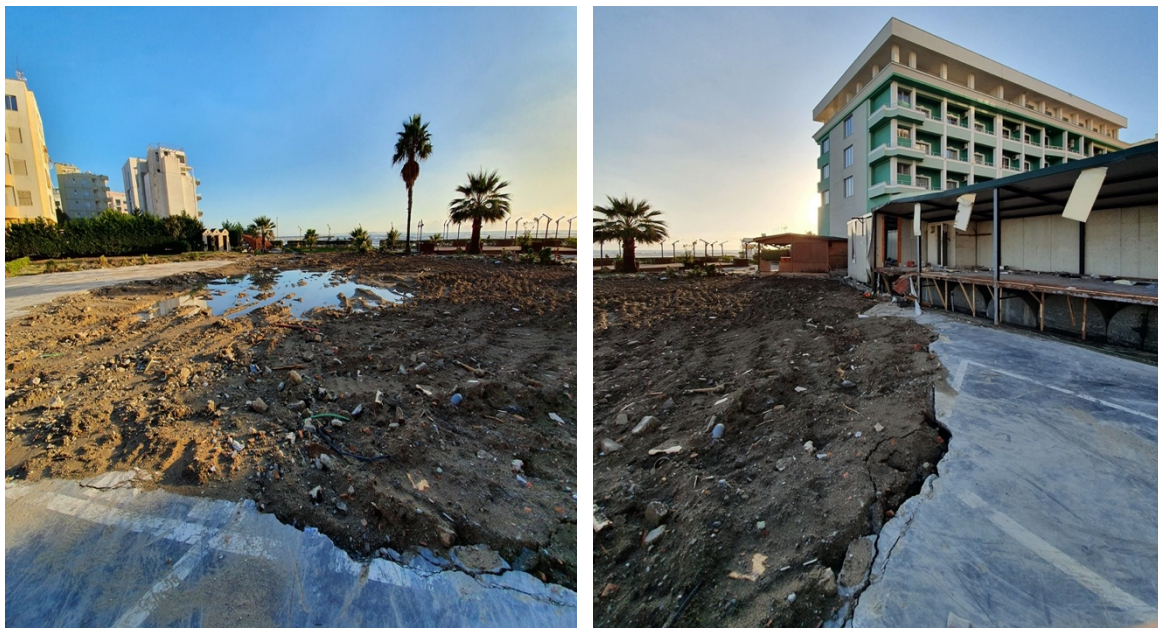
Figure 47: Permanent ground displacements.

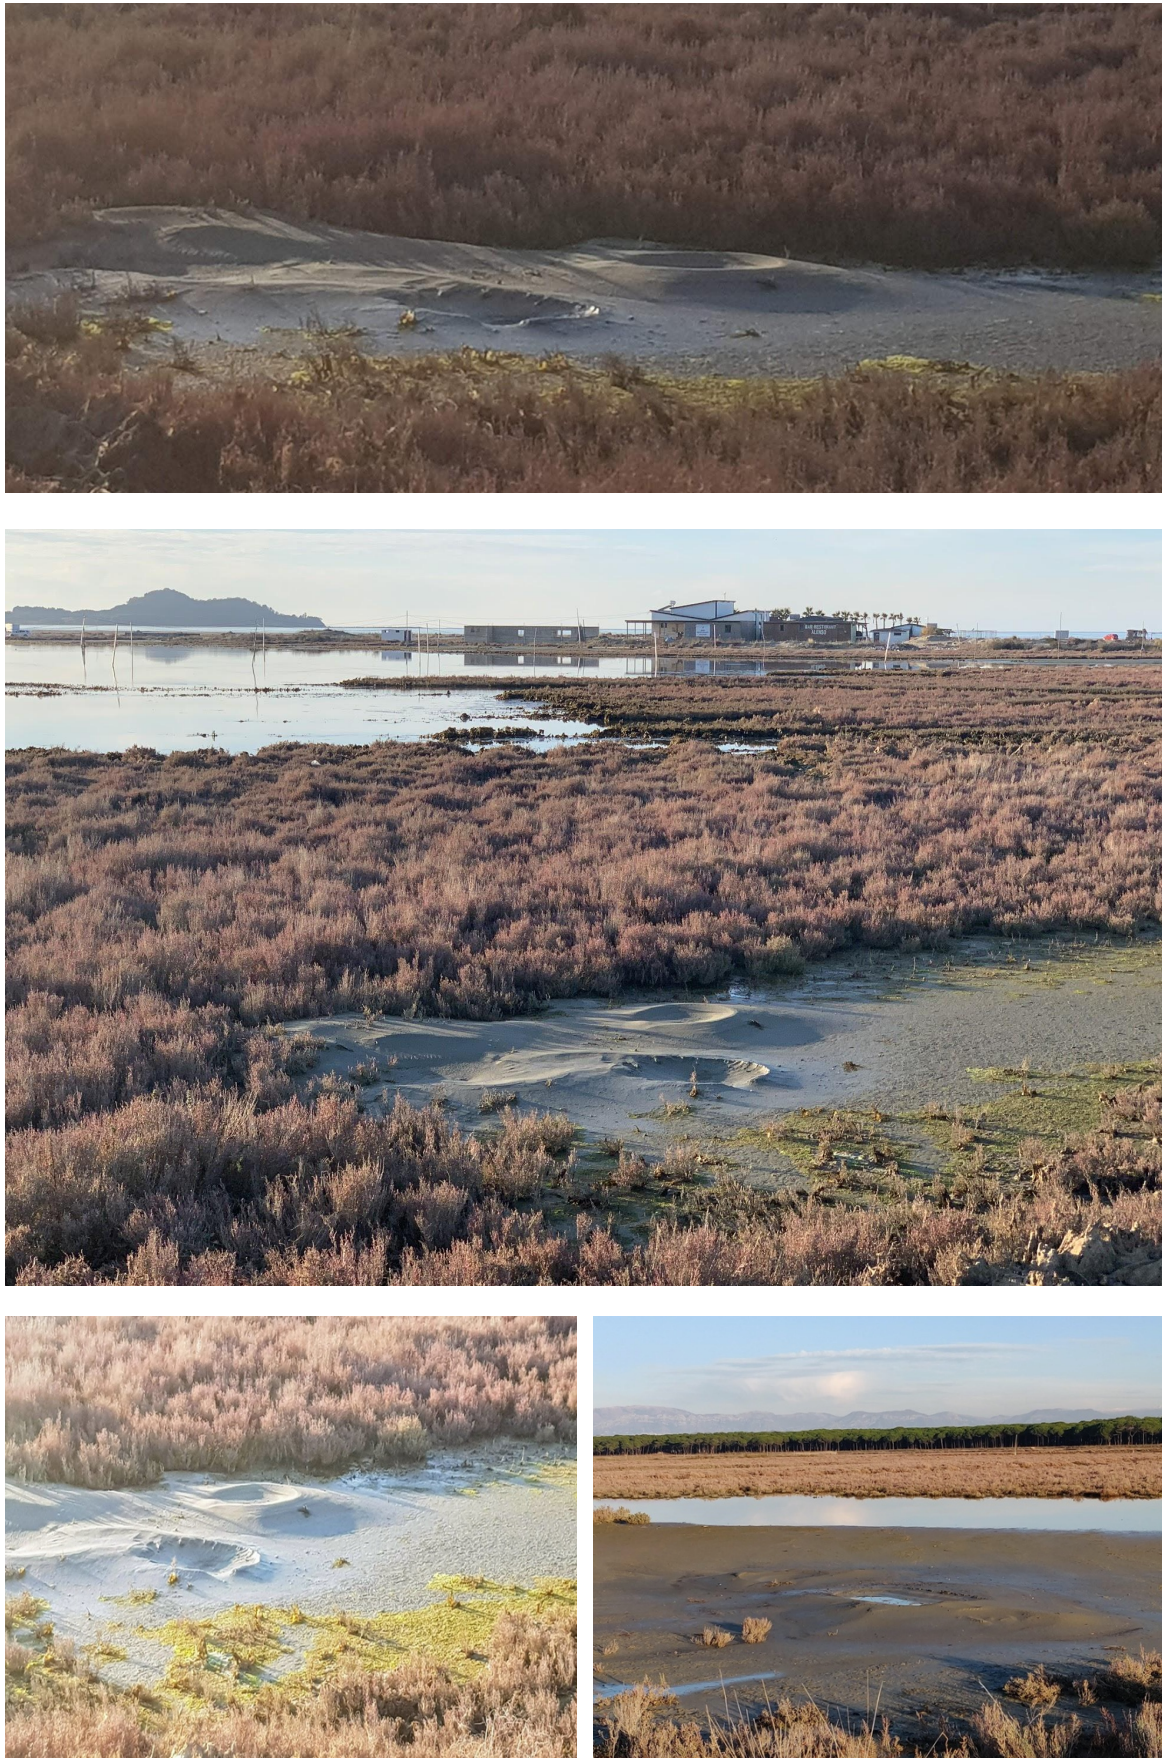
Soil liquefaction, resulting in the ejection of the liquefied material through cracks, due to increased pore water pressure, affects loose saturated cohesionless soils especially if the cyclic loading has a large intensity and long duration. Large parts of the coast line of Albania from Vlora to Velipoja are susceptible to liquefaction (Daja et al., 2016). An example of such liquefaction phenomena observed in the bay of Porto Romano (10km from Durrës) is shown in Figure 48 with several sand boils and craters extending across a large area.

Figure 48: Sand boils and craters due to soil liquefaction in the bay of Porto Romano.

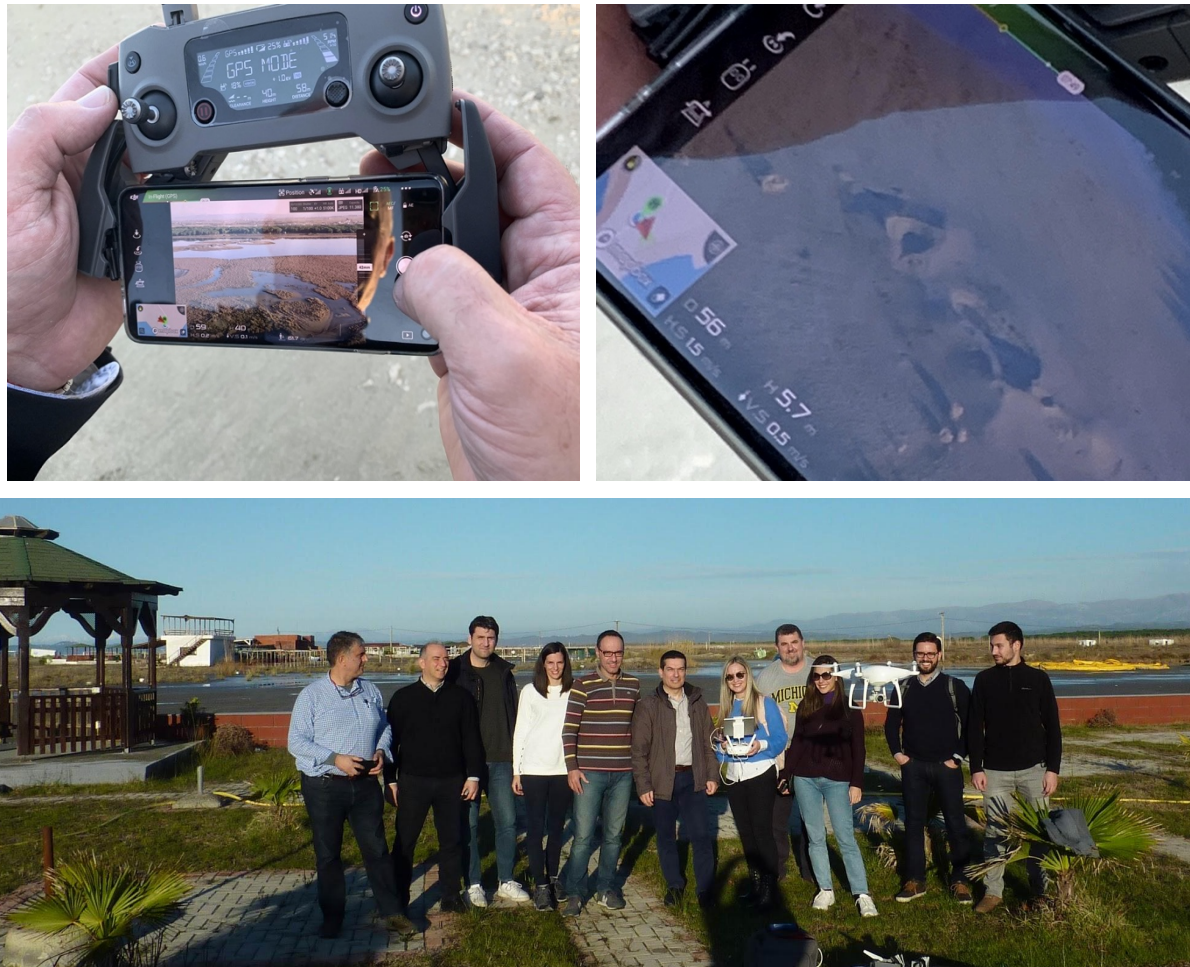
For the visual inspection of liquefied soils at Porto Romano Bay, two flying drones were used and the relevant photos were saved and evaluated (Fig. 49). It should be outlined, that despite the fact that liquefaction phenomena were evident at the Port, no damage was reported.

Figure 48: Drone images of liquefied soils (top). Field mission of the Hellenic Association for Earthquake Engineering (bottom).
