NATIONAL  
TECHNICAL  
UNIVERSITY  
OF ATHENS

# The February 6<sup>th</sup> Kahramanmaraş earthquake sequence in Türkiye

*Technical Report*

Aristidis Papachristidis, Anastasios Sextos

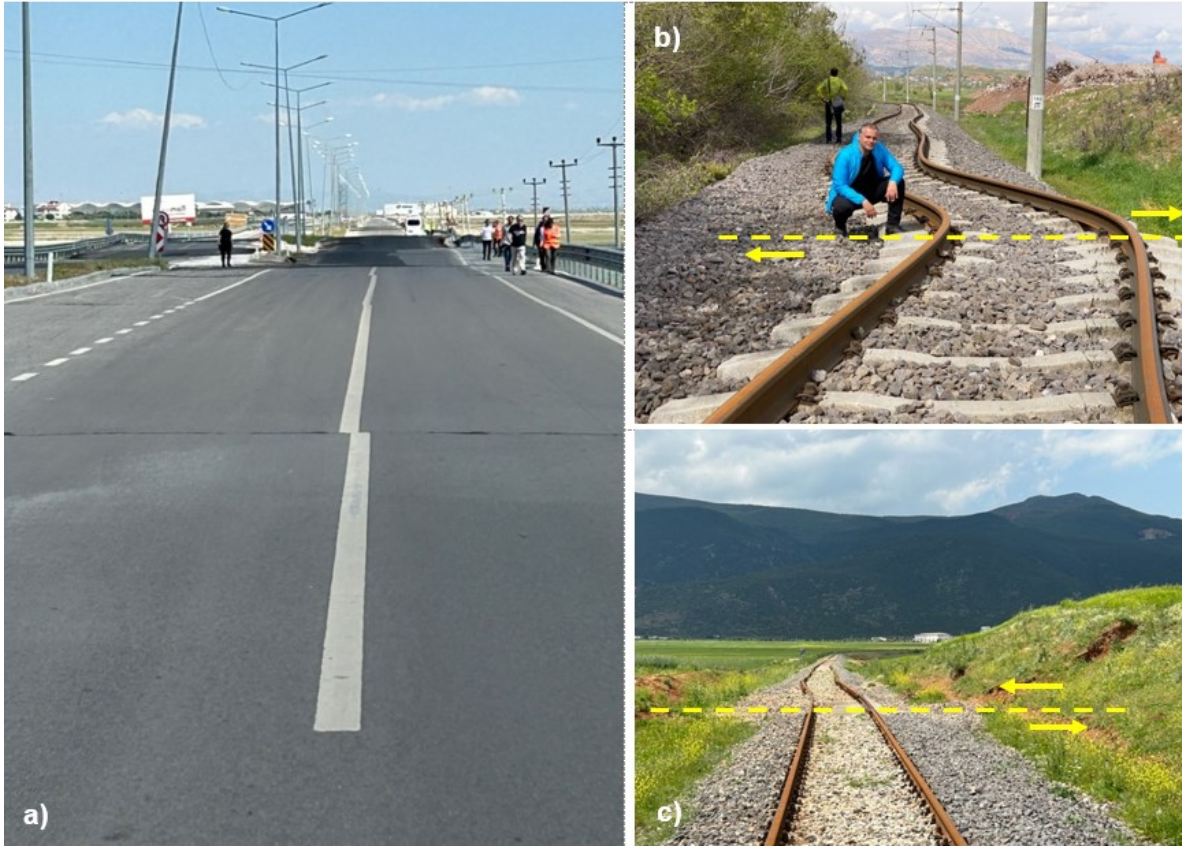
Figure 3.5 Surface ruptures in a) Antioch Airport area, b) Gulbasi c) Osmaniye.

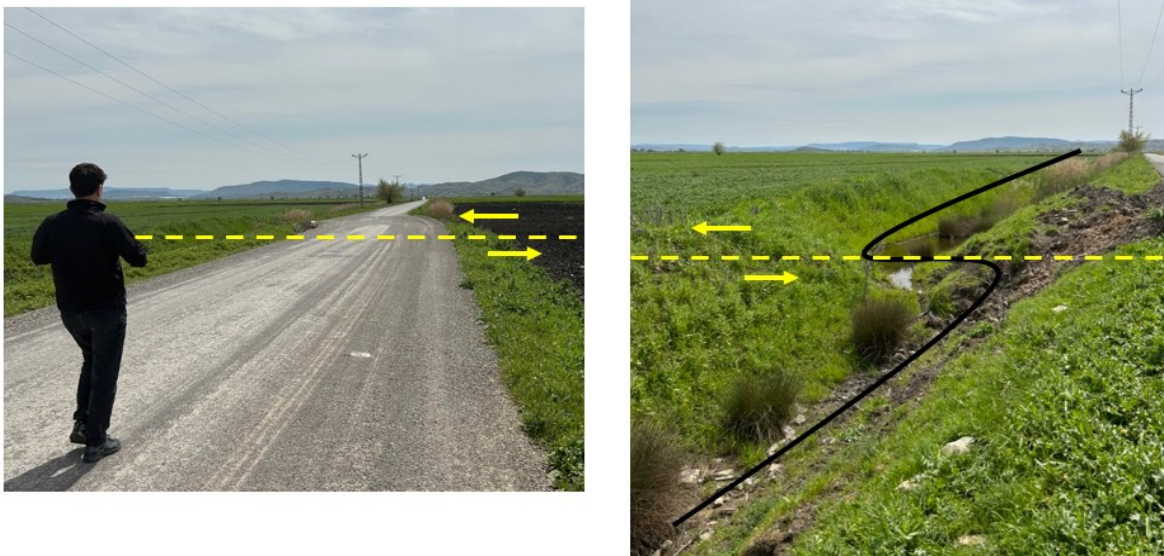
Figure 3.6 Surface ruptures in Turkoglu area.

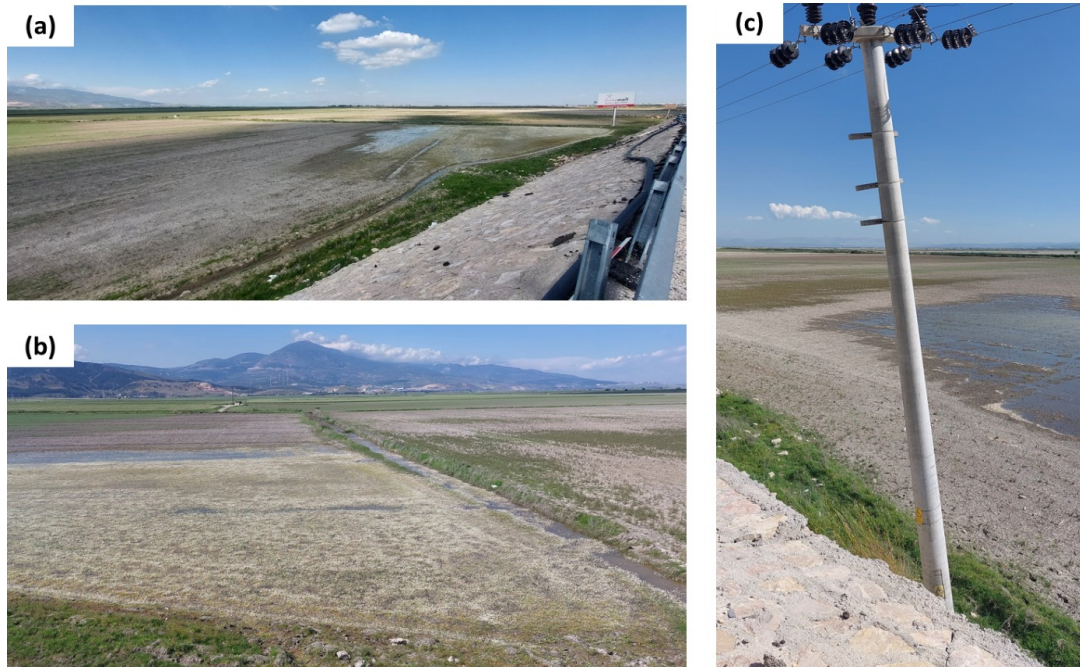
Figure 3.22 to Figure 3.27 depict soil liquefaction in Antakya and Gölbaşı and lateral spreading at Gölbaşı whereabouts. When liquefaction occurs close to waterfronts, usually lateral spreading is caused: the liquefied soil, unable to resist any shear excitation, is deformed laterally, creeping along any stiffer layer sitting above it. This process opens cracks running parallel to the waterway (Youd 1993).

**Figure 3.22** (a)-(c): Photos of the widespread liquefaction near Hatay International Airport (36,370148N, 36.260592E).

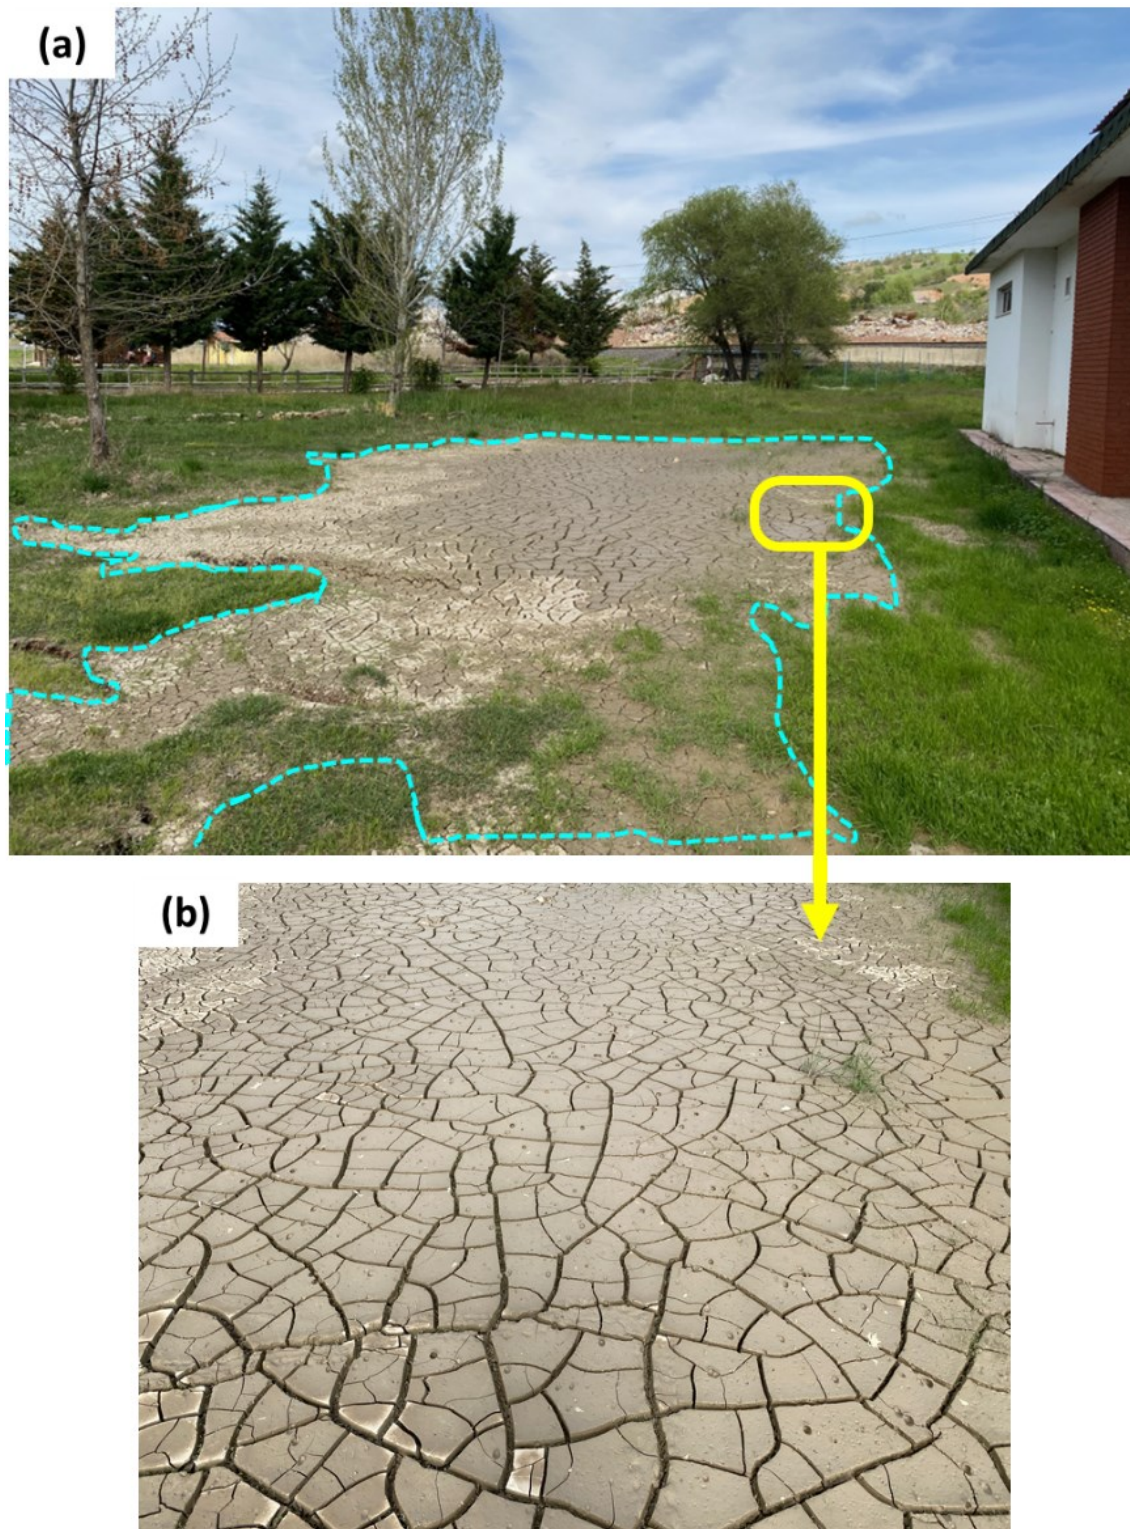
**Figure 3.24** Remnants of soil liquefaction at Gölbaşı (a). The drying cracks (b) pattern is a clear manifestation of cohesive material existence in the soil ejecta (37.798553N, 37.662833E)

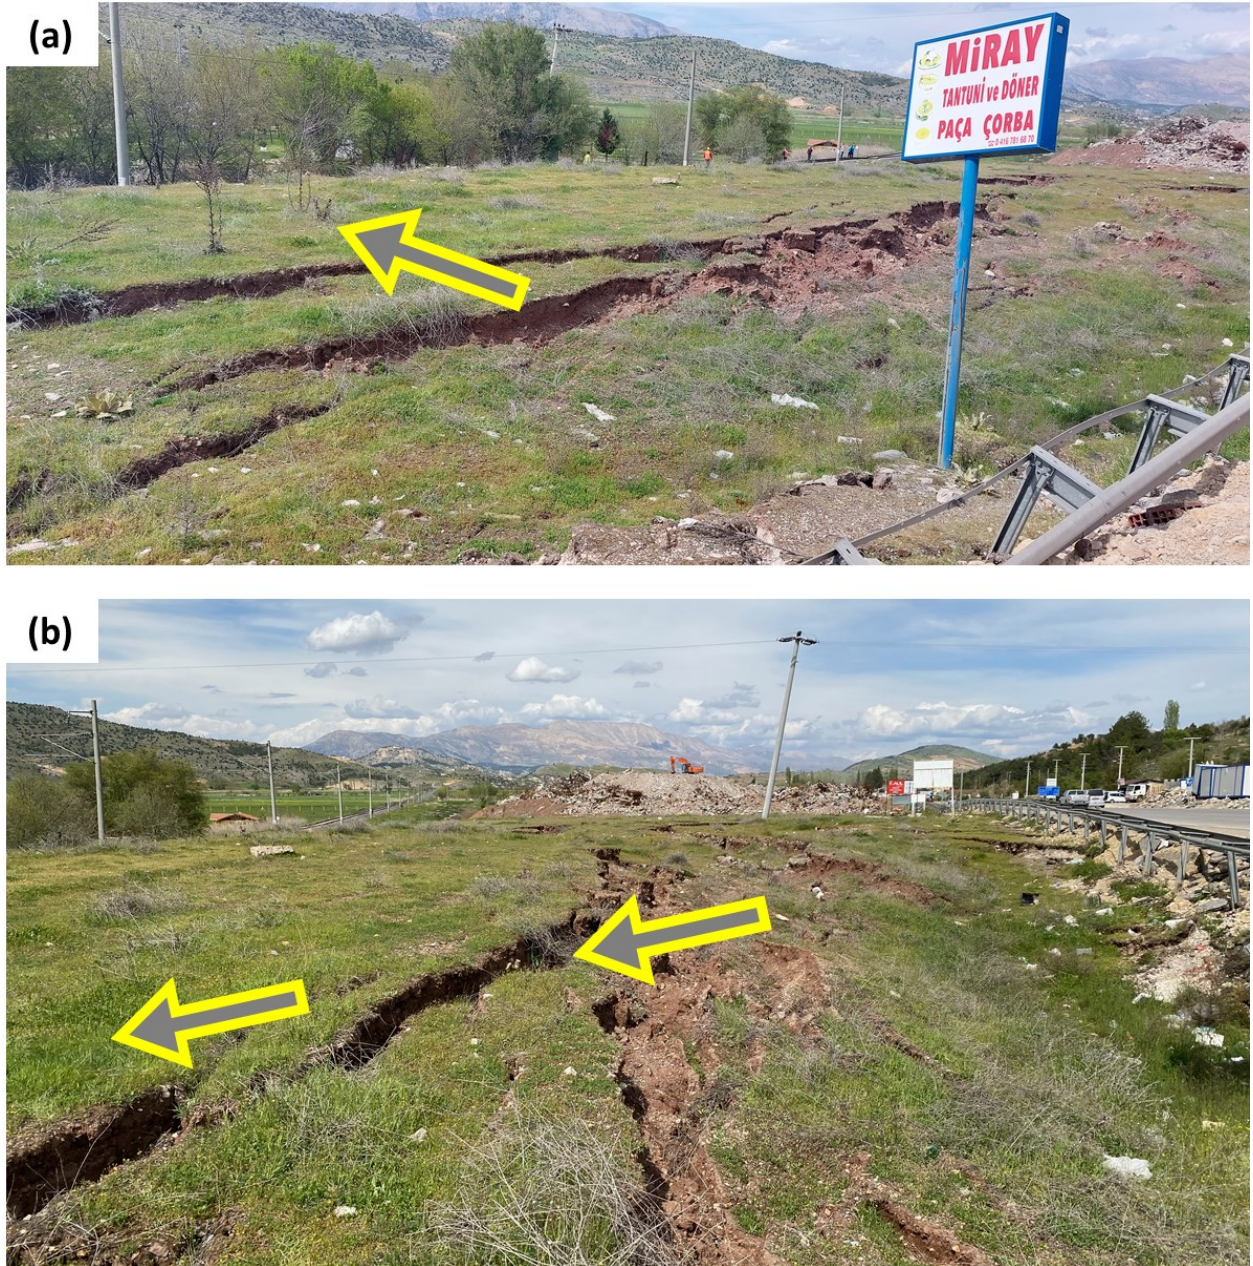
Figure 3.25 (a),(b): Lateral spreading at a slope near the Gölbaşı Lake (37.797857N, 37.6633.7E)

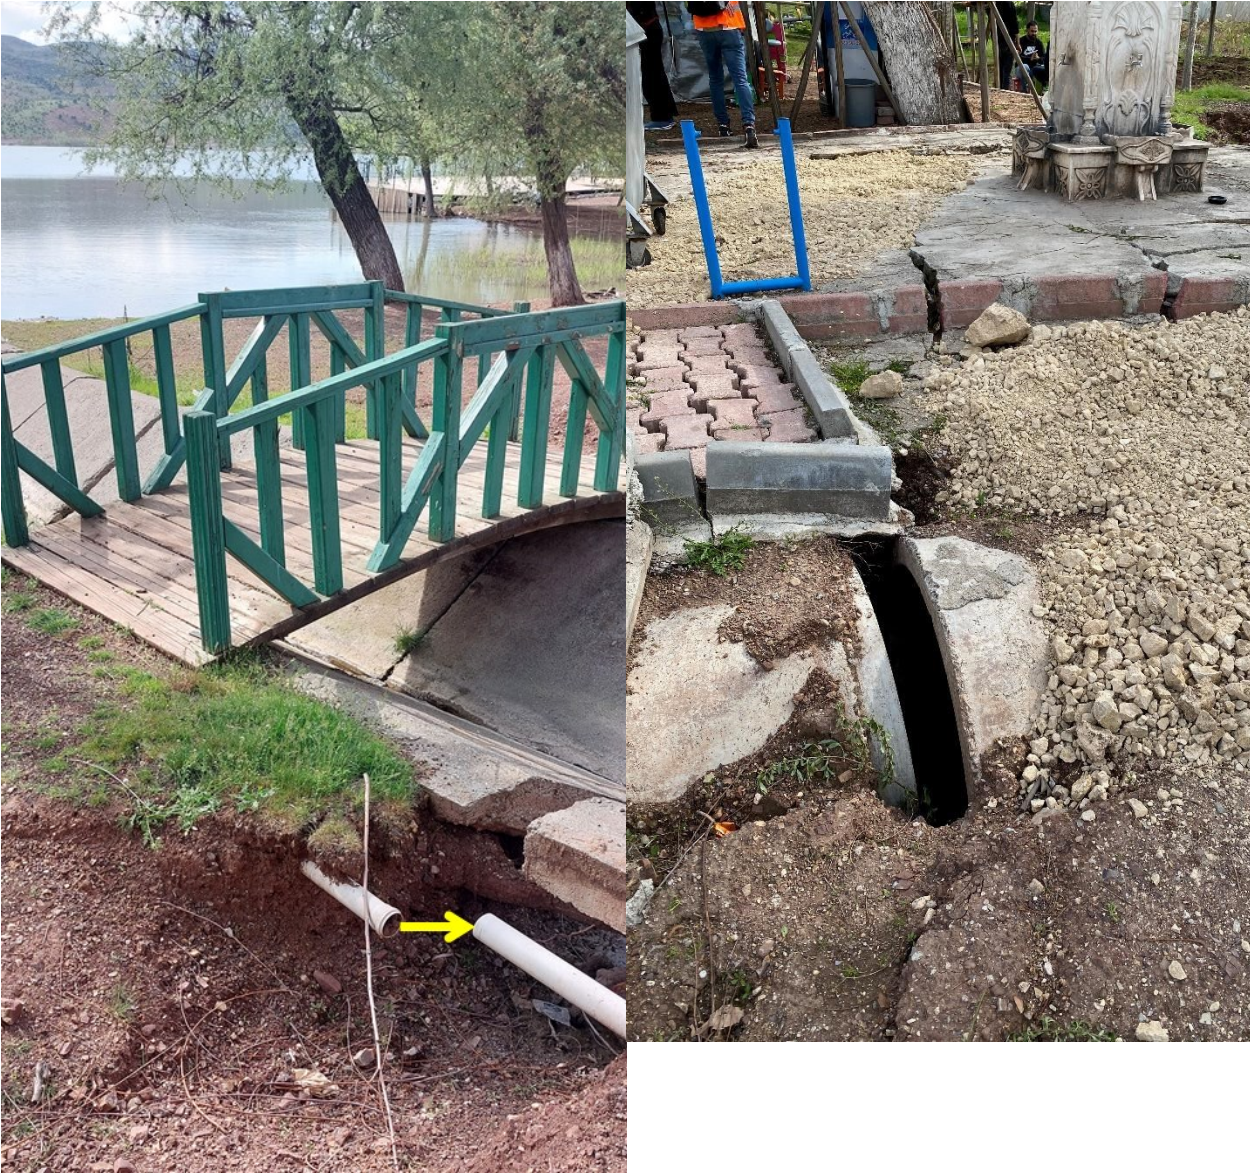
**Figure 3.27** Lateral translation of the pipes at their joints because of lateral spreading close to Lake Gölbaşı (37.798226N, 37.662083E)

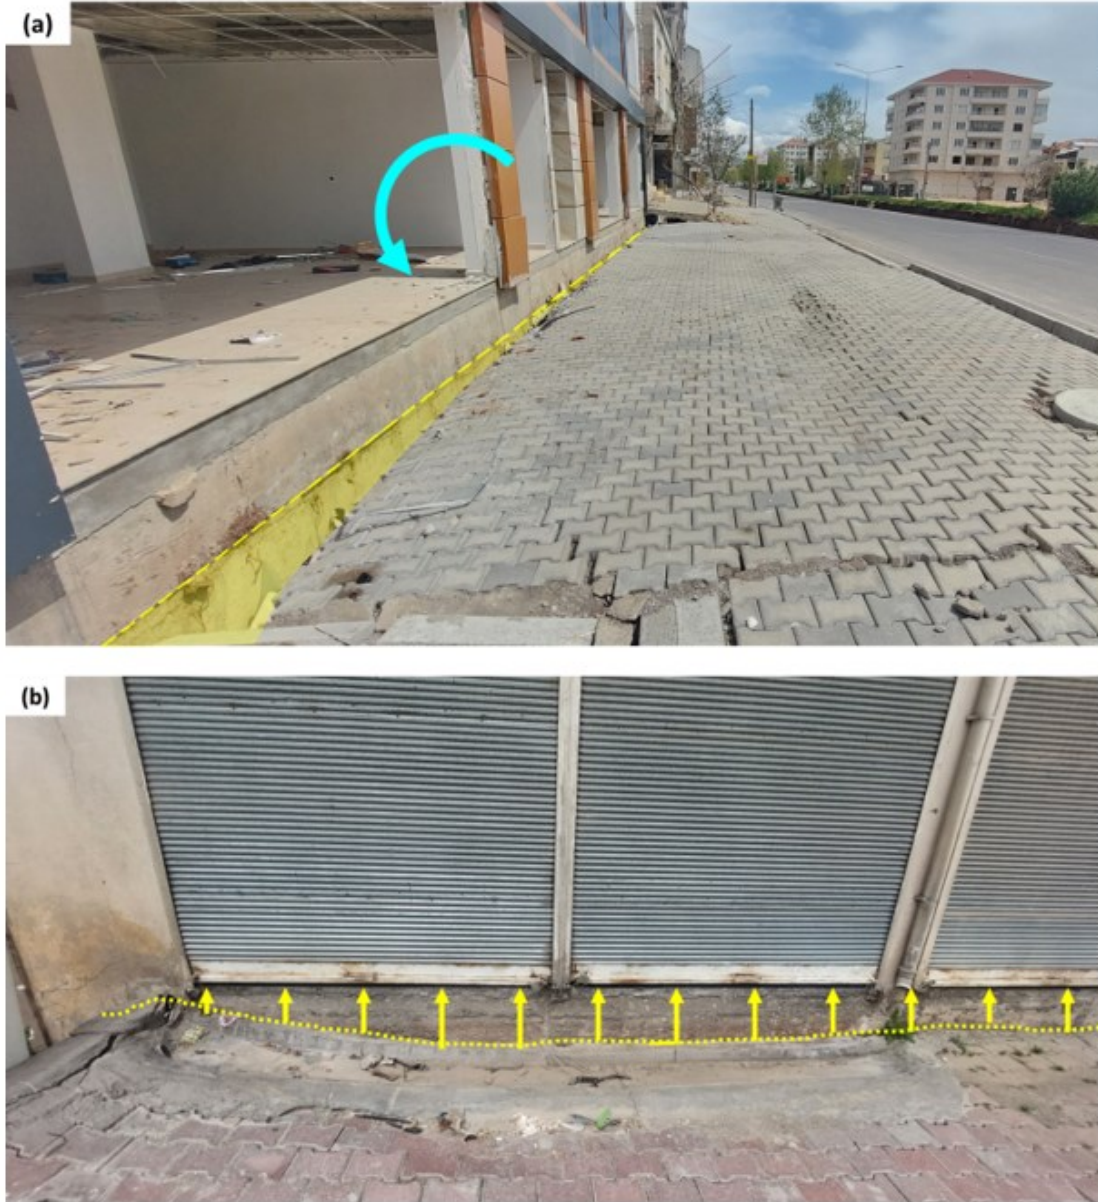
**Figure 3.32** a), (b): Cases of permanent tilting of buildings in Gölbaşı city, due to rocking oscillation that results in uplifting displacements in the front side of the structures (37.788762N, 37.649529E).

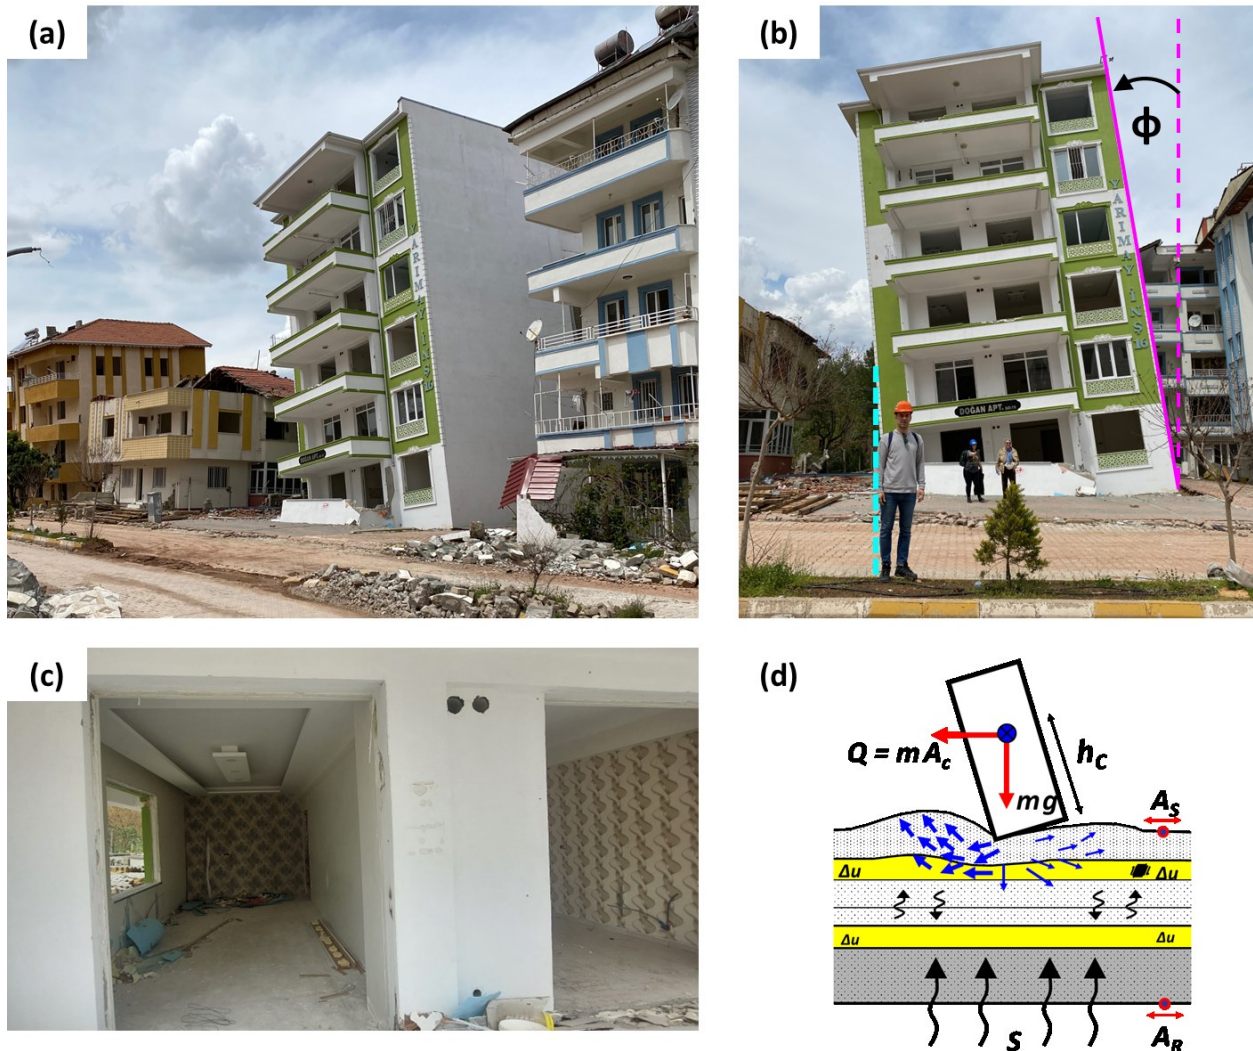
**Figure 3.38** (a),(b): 6-story RC building which suffered permanent tilting of approximately 8 degrees to the west; (c): View of the ground-floor interior, revealing no visible signs of structural damage. (d): Sketch of the likely mechanism of foundation bearing-capacity failure leading to the building's permanent tilting (or even toppling) (37.788455N, 37.646016E)

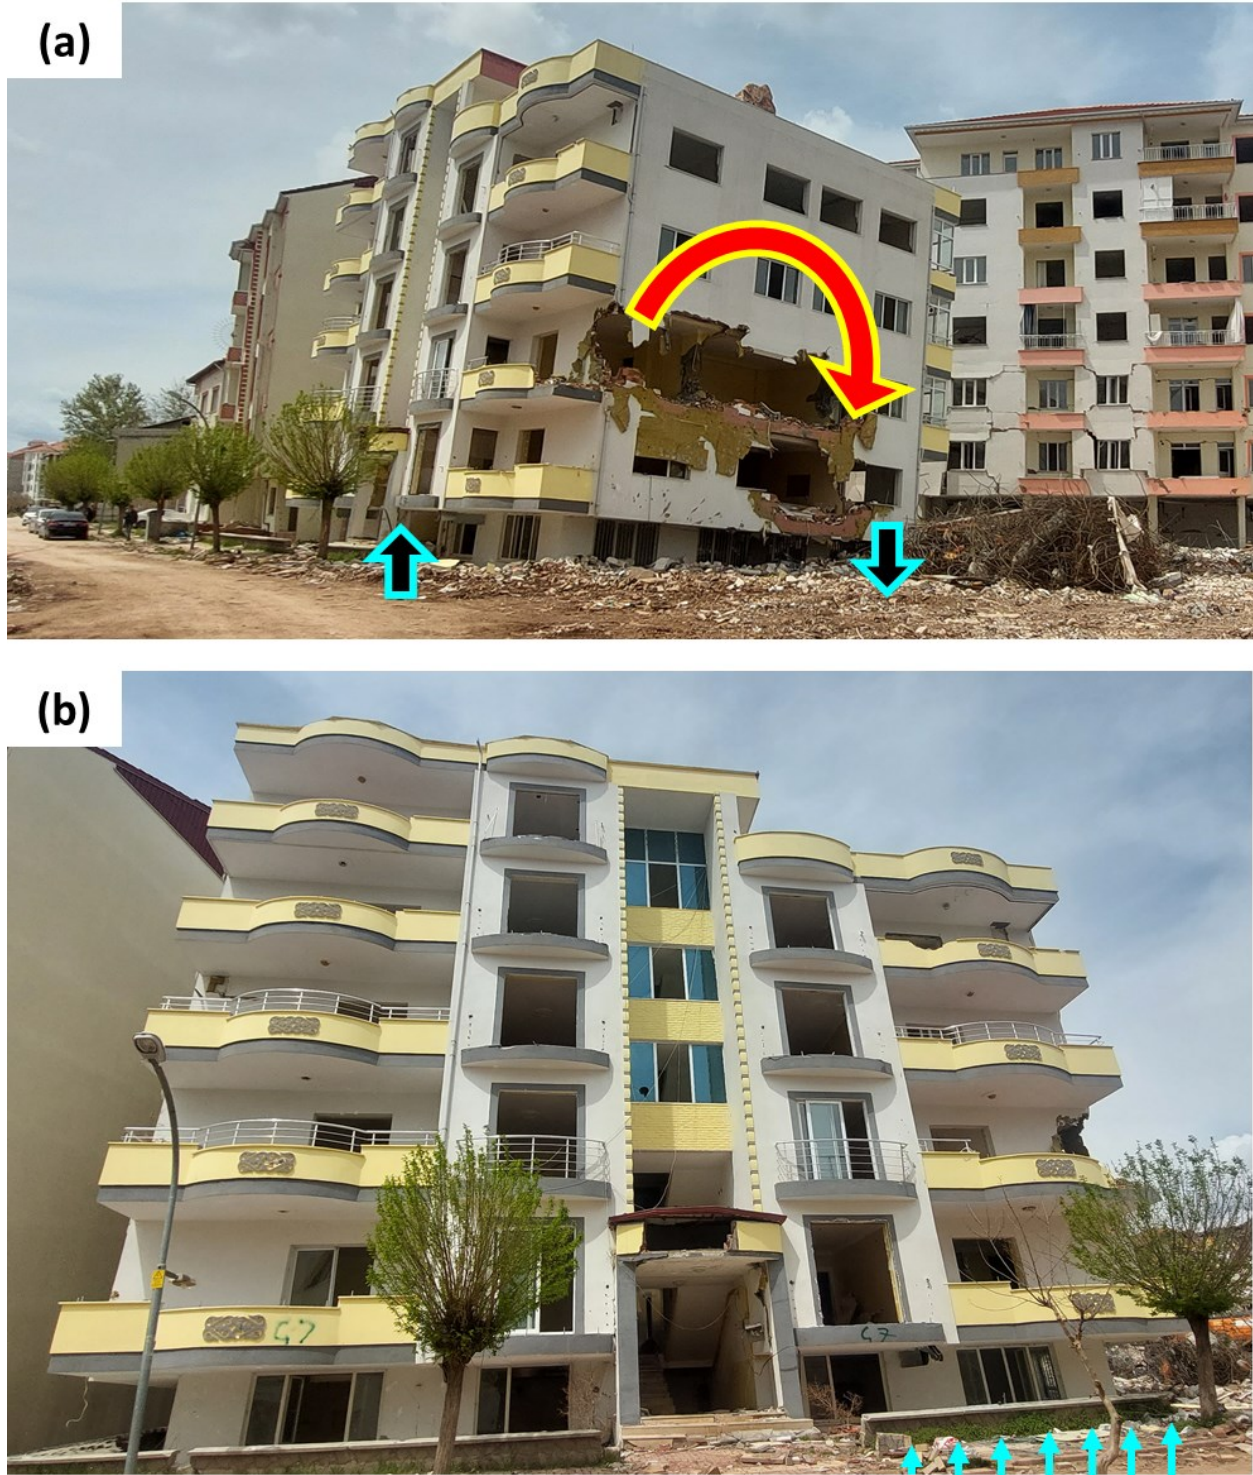
**Figure 3.39** (A 6-story residential apartment in No. 92 Gazi Street: (a) The building roof settlement at the southeast corner was estimated as 31 cm and at the southwest corner as 12 cm. The measured tilt at the building's front (south side) was 5 degrees towards the north (37.788007N, 37.643913E)

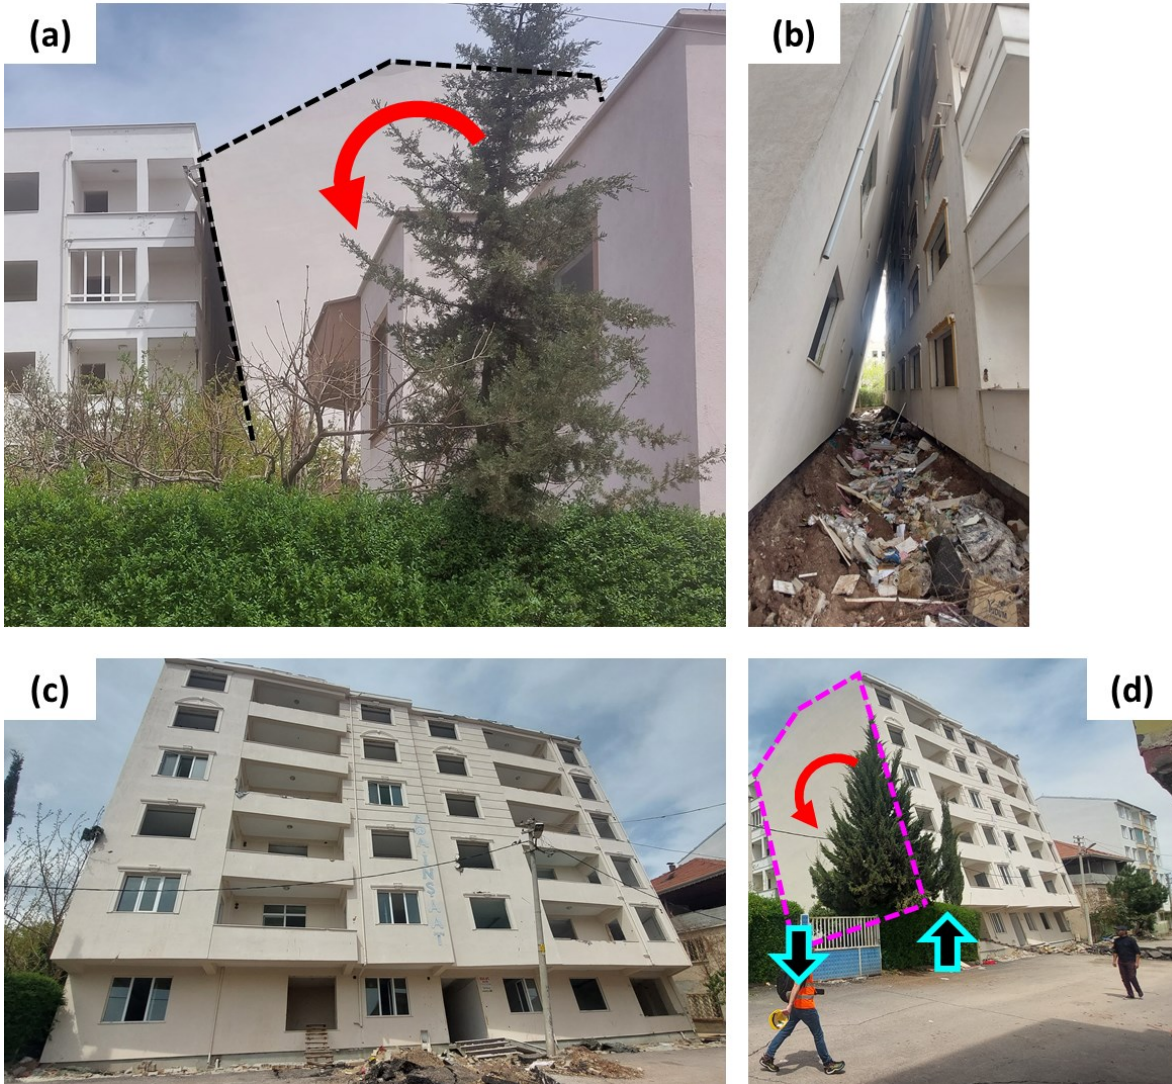
**Figure 3.40** (a)-(d): Views of the essentially toppled to the north (resting at the neighboring building) 6-story RC building in Ada İnşaat, Gölbaşı, likely because of soil bearing capacity failure (37.787765N, 37.6433365E)

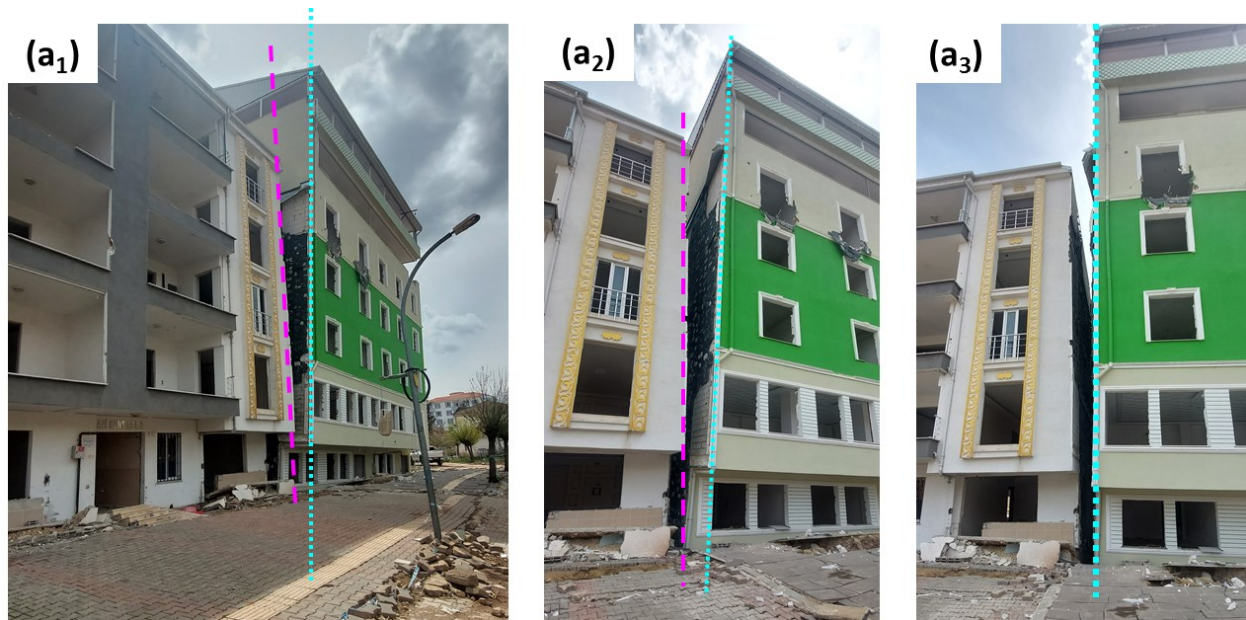
Figure 3.42 (a<sub>1</sub>-a<sub>3</sub>): Views of two adjacent residential buildings in Gölbaşı. Both are tilted, probably because of soil bearing capacity failure, but with different permanent rotation angles (37.787491N, 37.642797E).

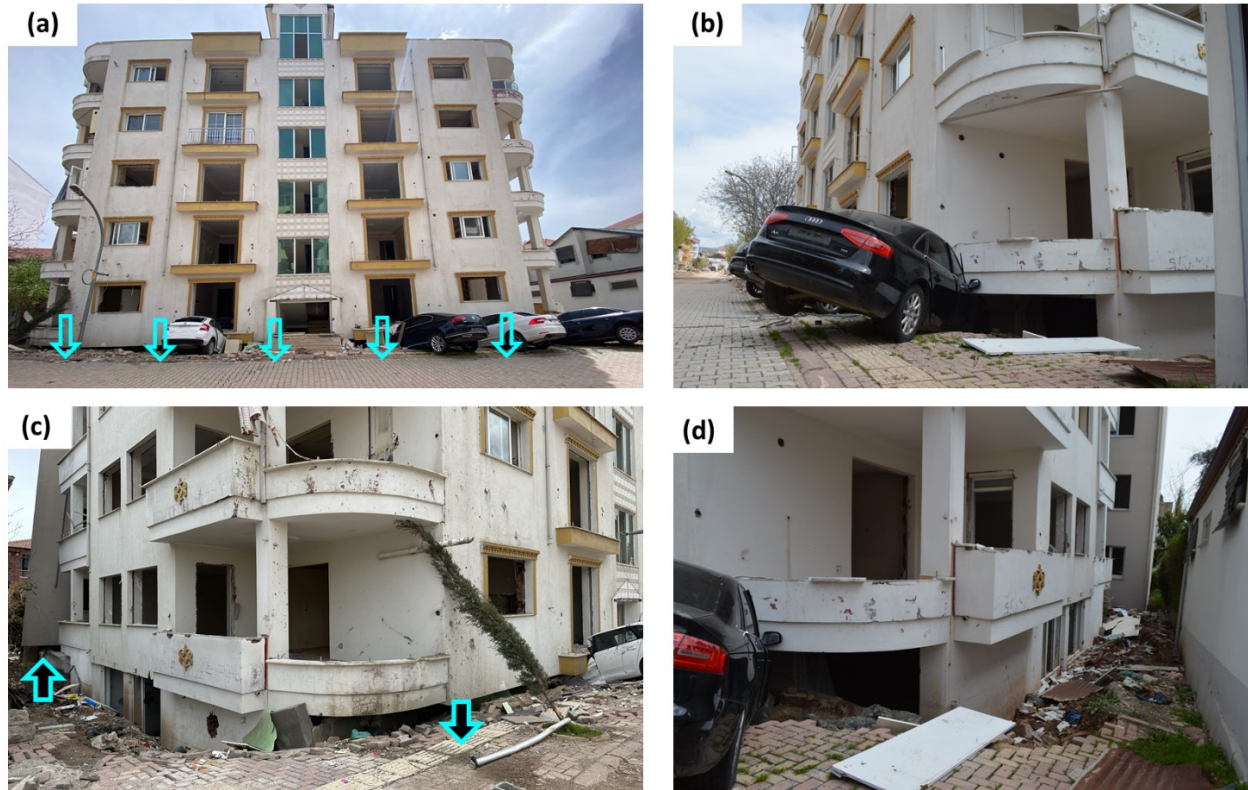
**Figure 3.43** Another characteristic case of a tilted residential building in Gölbaşı (37.787491N, 37.642797E).

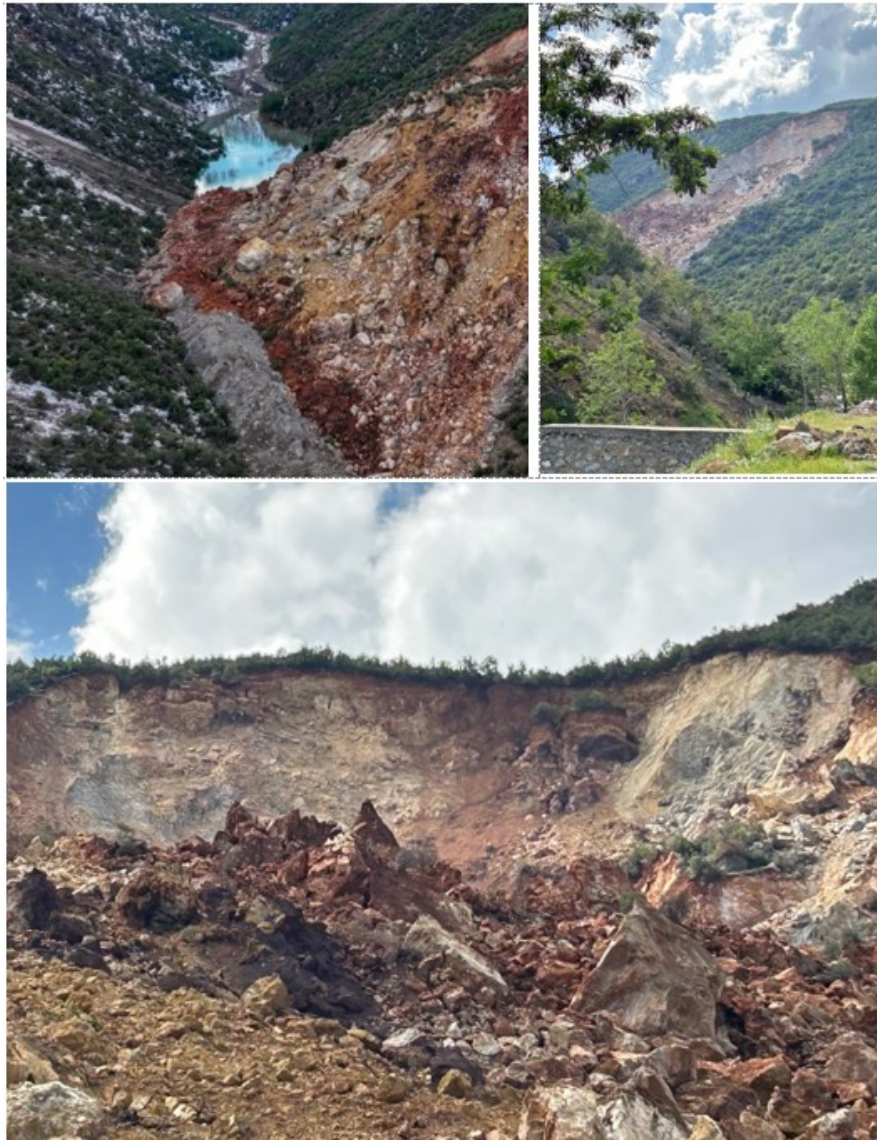
Bedrock rotational slides are common in the study area, especially in the north. They were mainly triggered within pre-existing landslides and on areas, where the rock mass is heavily fractured. A deep-seated landslide was identified in Islahiye region, where millions of m<sup>3</sup> have slid and blocked the river creating a dam behind the fallen mass (Figure 3.48). The rock mass is highly karstified and brecciated with a high presence of clayey infilling material around rock fragments and along fractured certain sub-vertical zones (Figure 3.49).

**Figure 3.49** The rock mass is highly karstified and brecciated with high presence of clayey infilling material around rock fragments and along certain fractured sub-vertical zones.

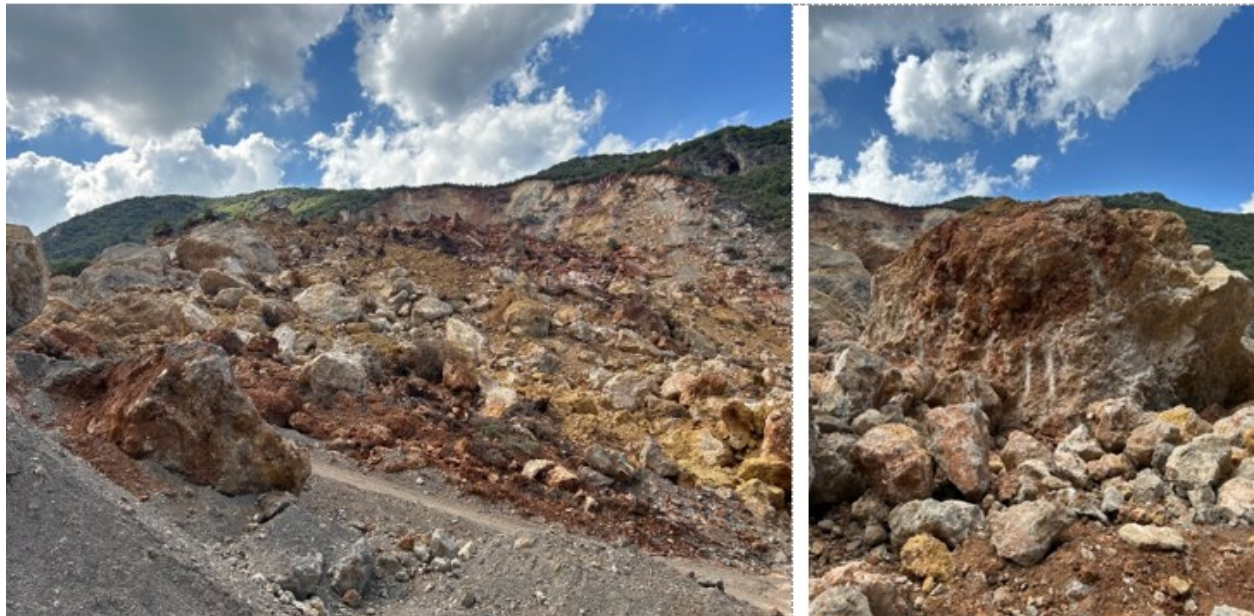
Other significant landslides that were triggered by the earthquakes are the translational ones. In Tepehan village near Altınözü, Hatay, there is an illustrative case of a translational landslide. This landslide, covering an area of approximately 1.3 km<sup>2</sup>, occurred in an area characterized by marl and clay-rich limestone. The landslide resulted in the formation of deep cracks along undulating hillslopes (Figure 3.50). Here, the upper bedding surface of a clay-rich limestone unit slid along the interbedded marl. This unit is intensely weathered in the upper sections and varies in thickness from 10 to 30 meters (Sümer et al., 2023).

**Figure 3.50** A rotational landslide in Tepehan village, Altınözü, Hatay (N36 9'39.3"; E36 13'17.9"). A clay-rich weathered limestone mass slide along the interbedded marl

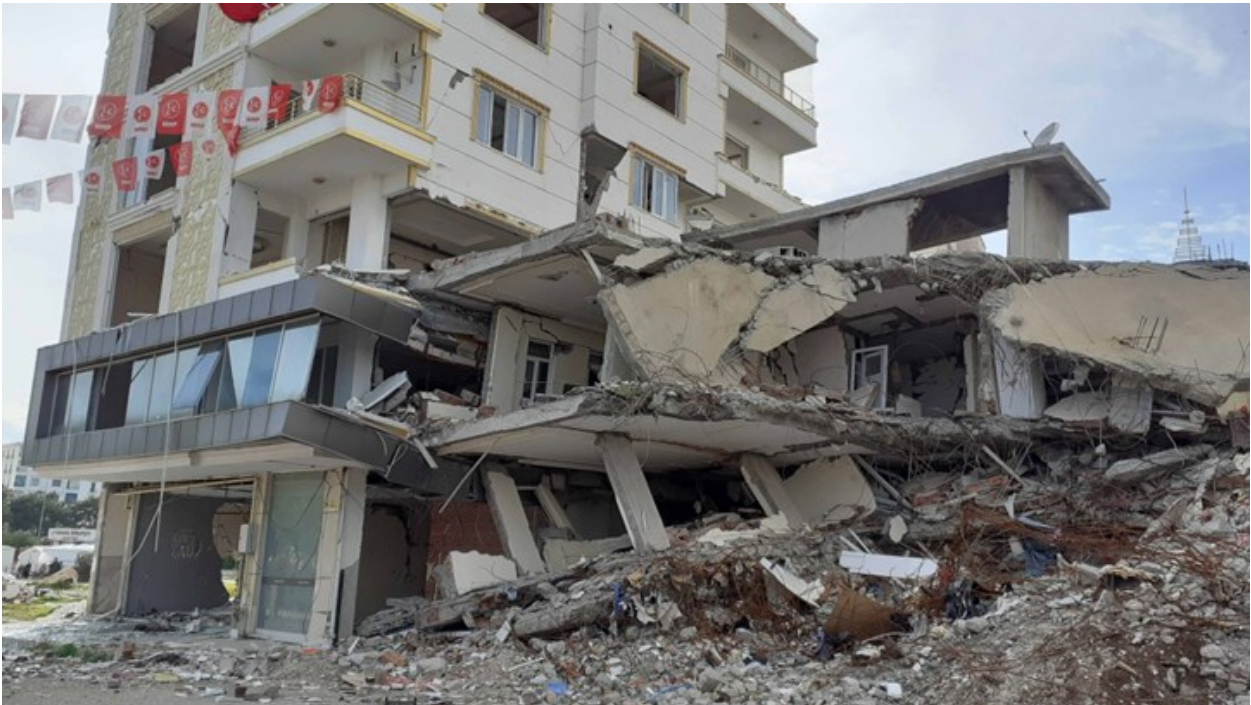
**Figure 5.1.4** Collapse of RC building with flat slabs along the weak direction of the vertical structural elements (Adiyaman). Photo: E. Vougioukas.

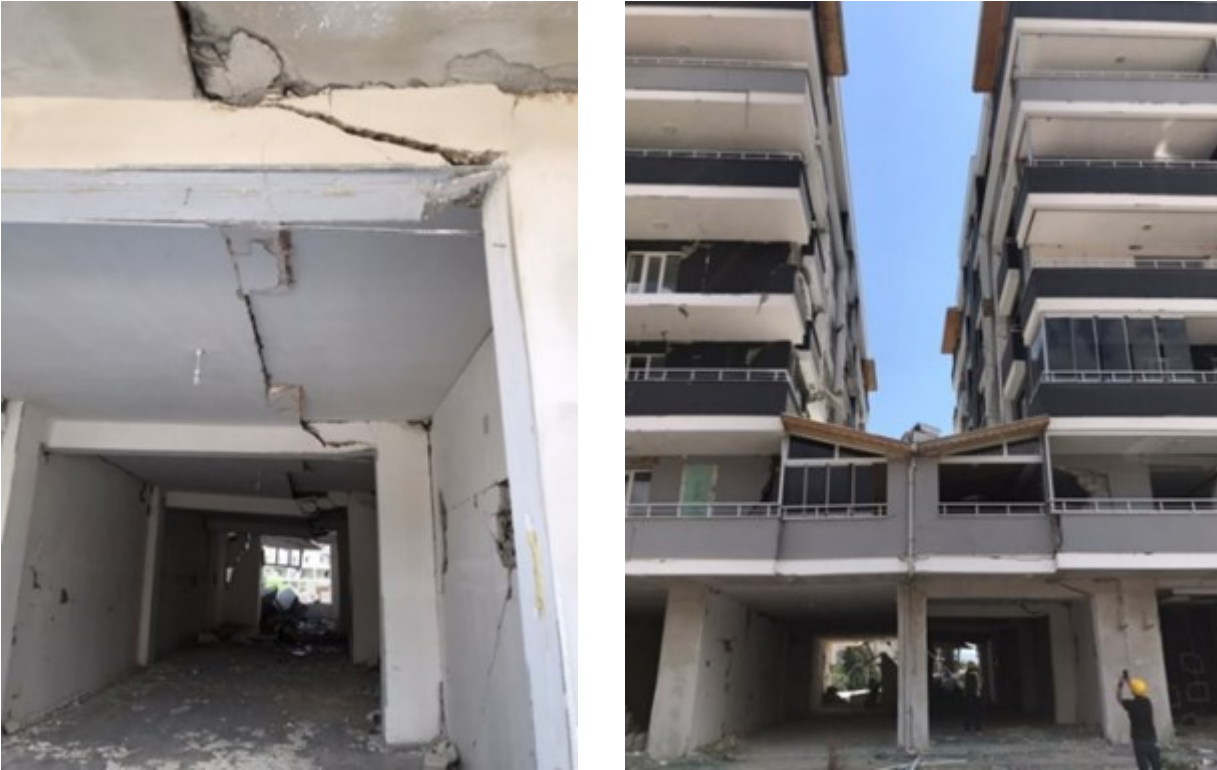
**Figure 5.1.19** Inclined cracking in beams caused by non-vertical seismic joint that crosses the beam (Nurdagi). Photo credit: P.Tsopelas

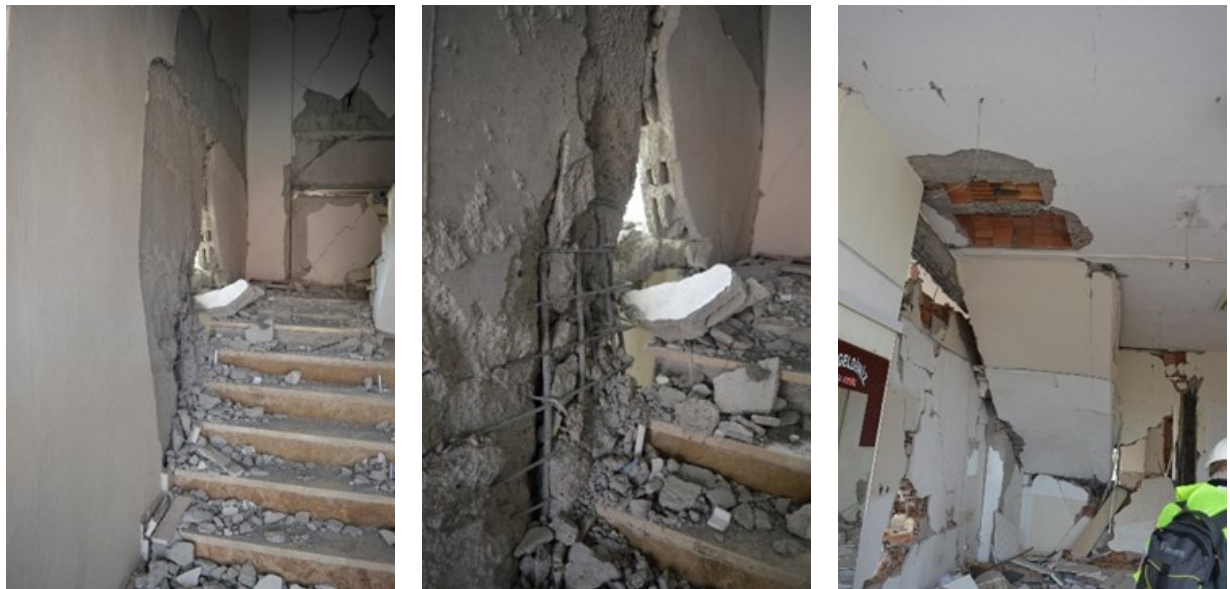
**Figure 5.1.23** Damage to stairways and associated local damage to the vertical framing elements and asmolten slab-stairwell connection . Photo credit: C. Zeris (Adiyaman)

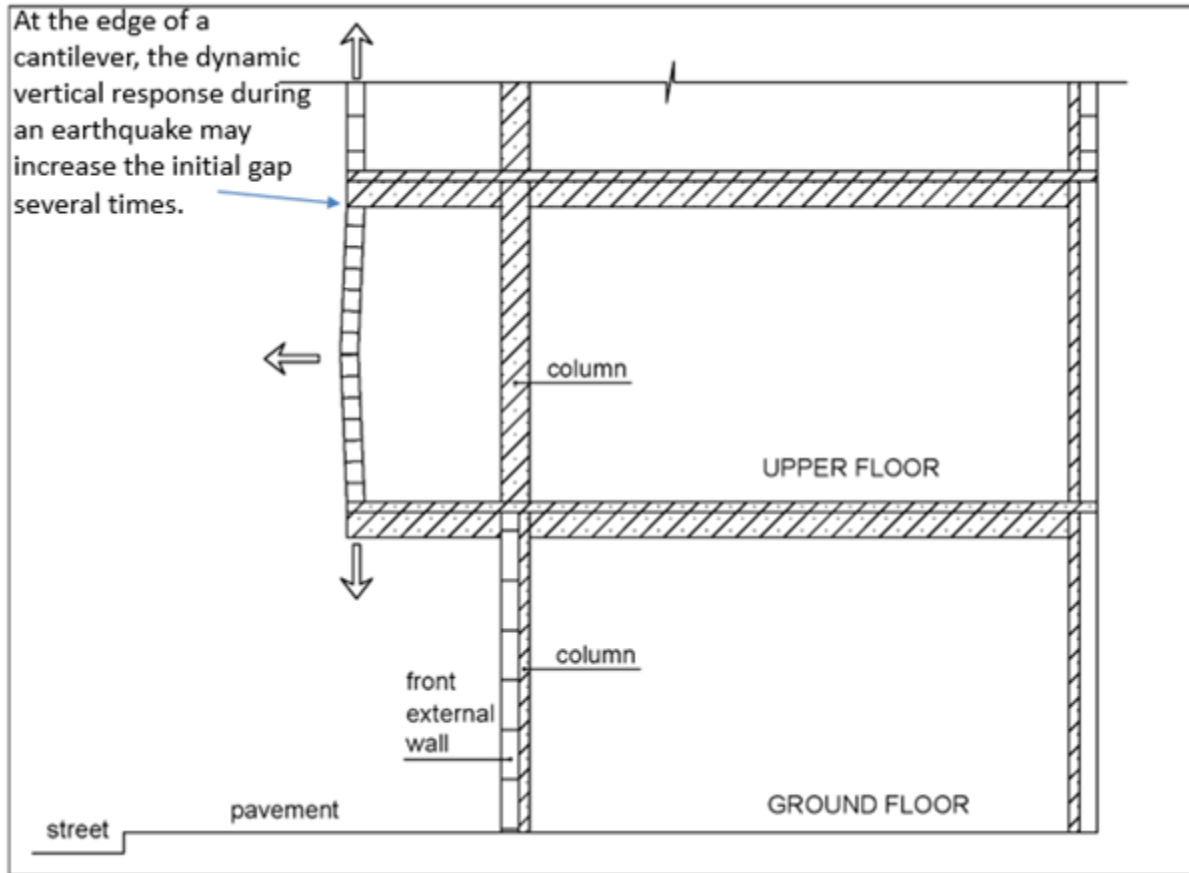
**Figure 5.1.27** Outer wall on a cantilever, subjected to combination of horizontal and vertical acceleration

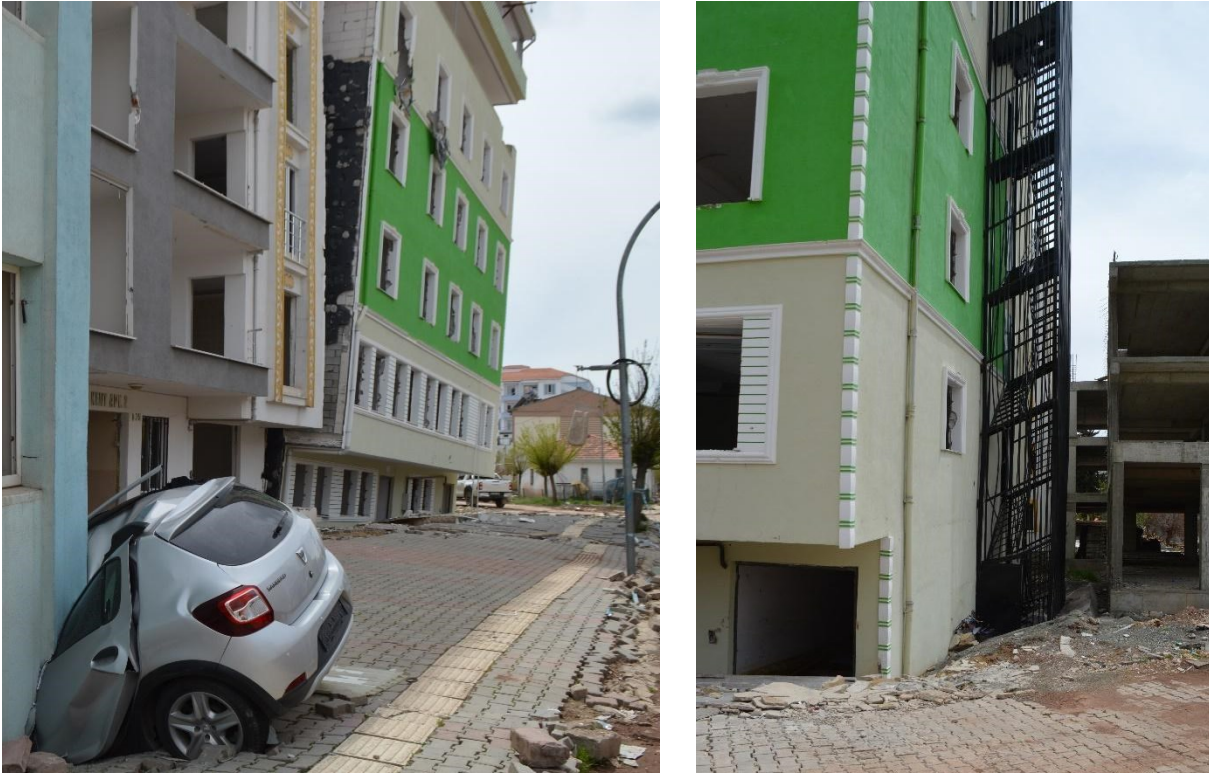
**Figure 5.2.5** Fire escape staircase failure in Gölbaşı due to soil liquefaction and extreme settlement of the main building.

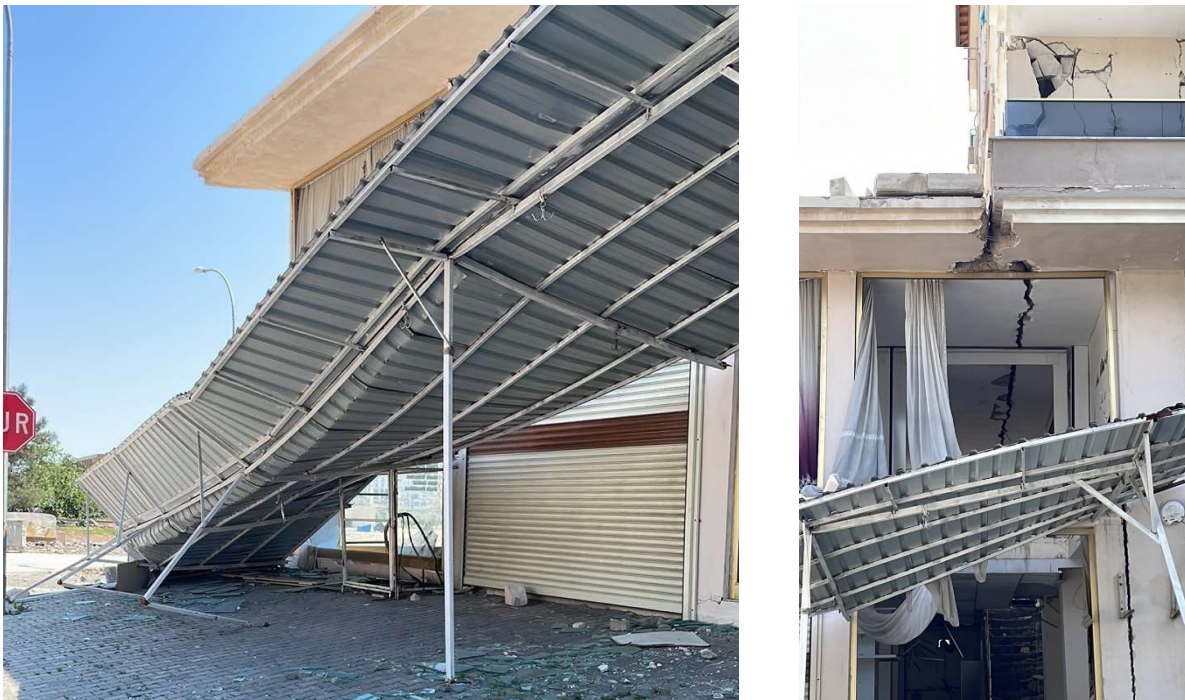
**Figure 5.2.6** Failure of a slender roof structure adjacent to a heavily damaged concrete building (Nurdağı).
