NATIONAL  
TECHNICAL  
UNIVERSITY  
OF ATHENS

# The February 6<sup>th</sup> Kahramanmaraş earthquake sequence in Türkiye

*Technical Report*

Aristidis Papachristidis, Anastasios Sextos

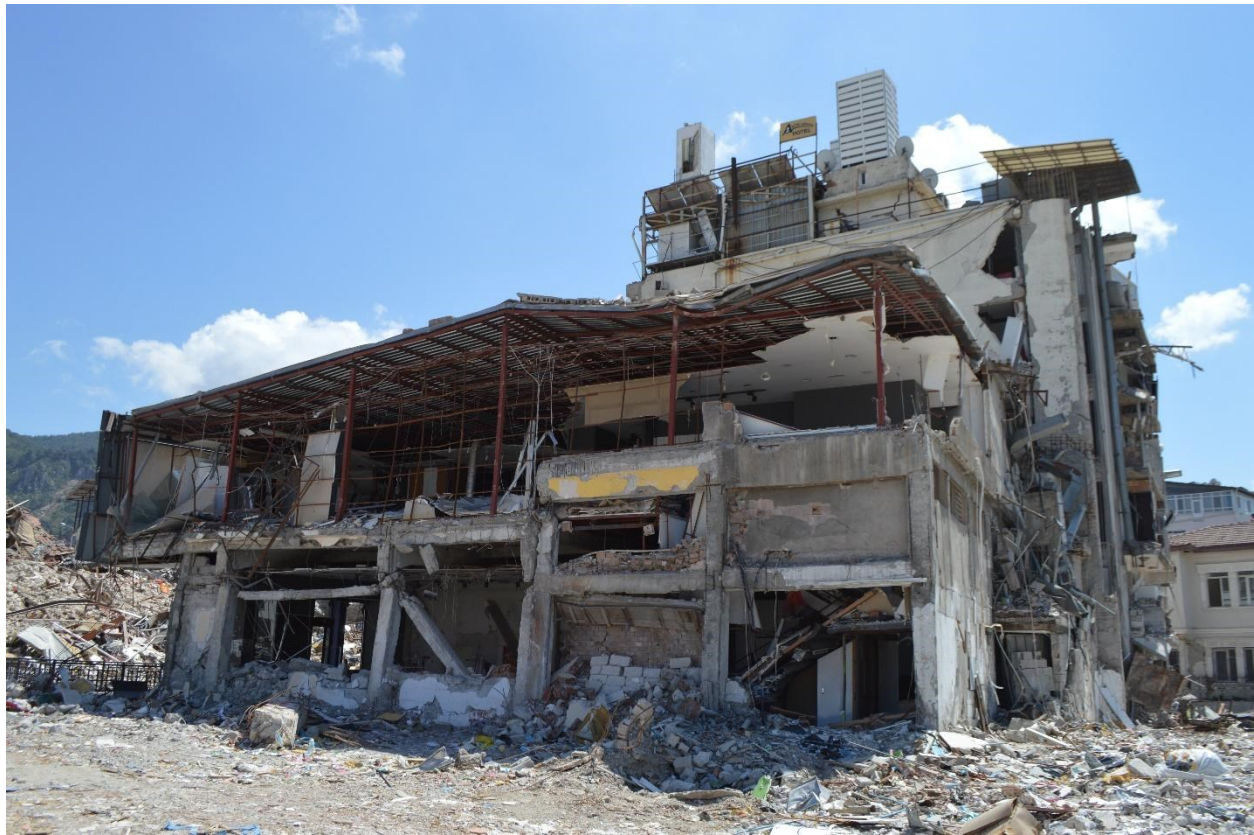
**Figure 5.2.7** Top floor steel roof of a heavily damaged concrete building mainly due to pounding of the adjacent collapsed building (Antakya).

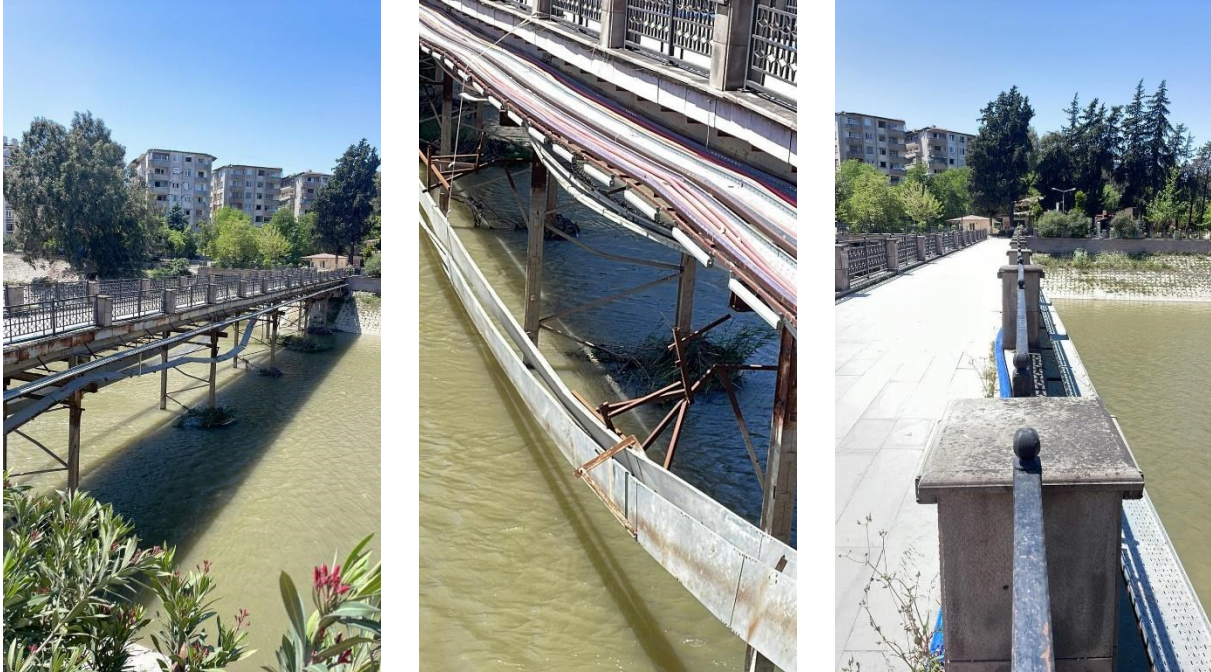
**Figure 5.2.11** Pedestrian bridge with non-structural damage (Antakya).

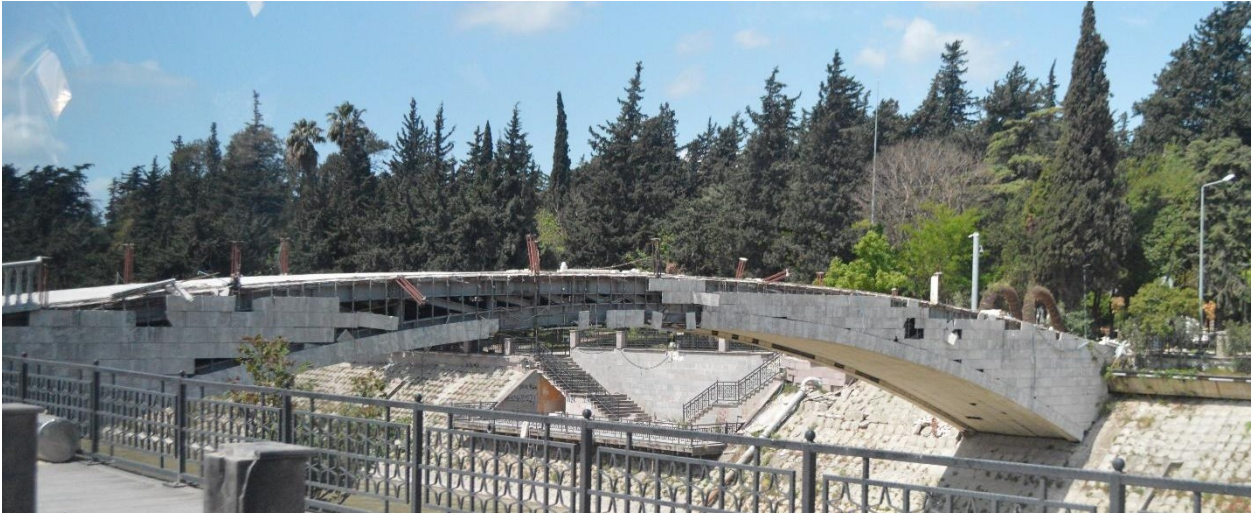
**Figure 5.2.13** Steel truss pedestrian bridge with non-structural damage (Antakya).

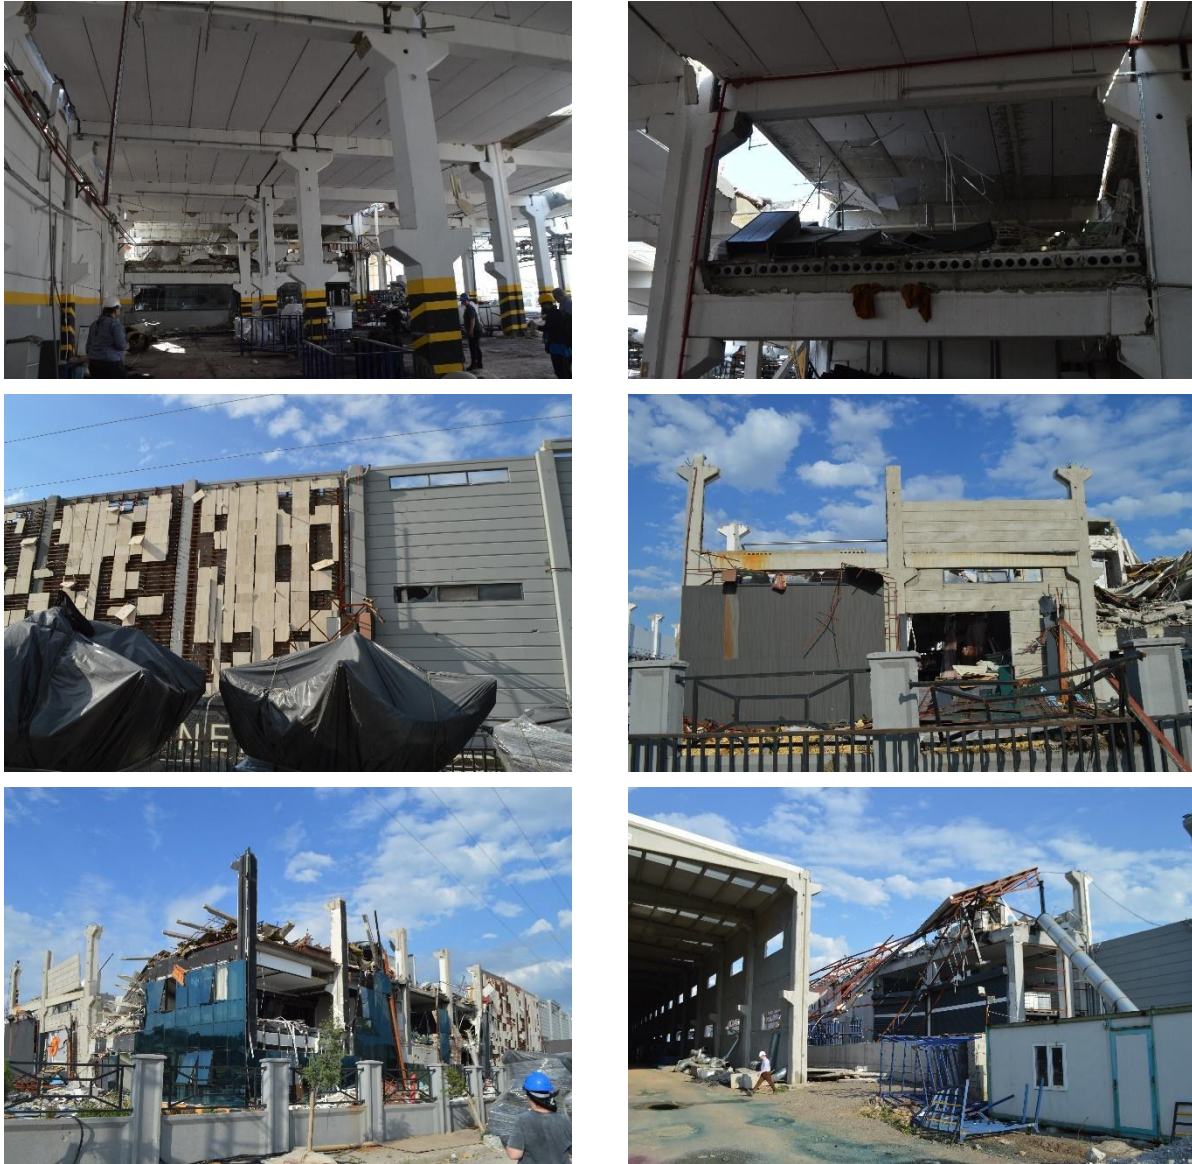
**Figure 5.3.3** Various types of failures of reinforced concrete industrial buildings and their structural steel appendages (Kahramanmaraş).

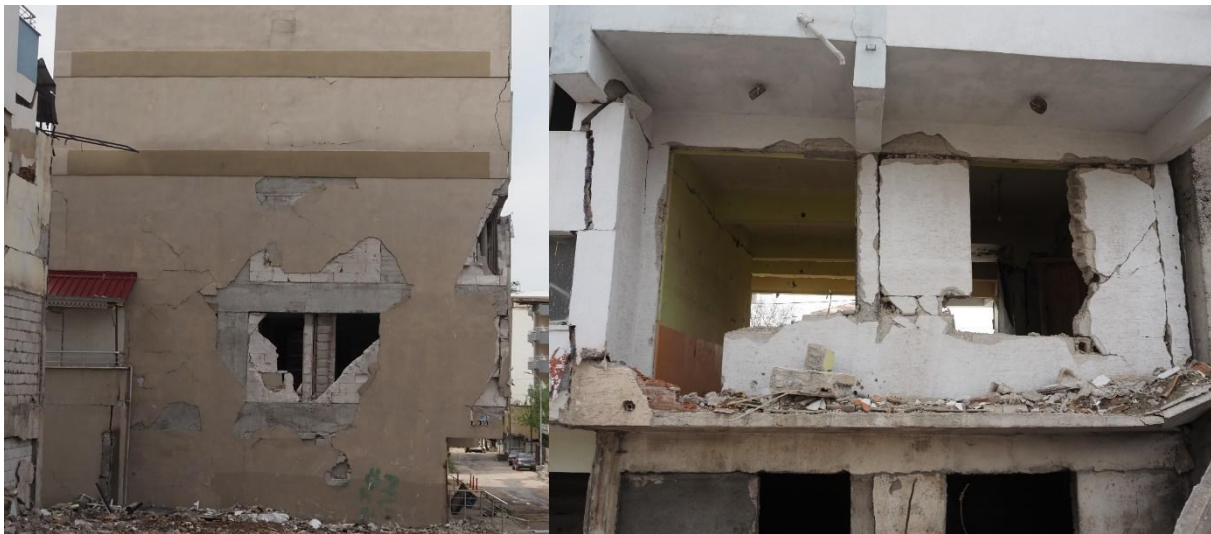
**Figure 5.4.8** Separation of the infill wall from the frame and (partial) overturning.

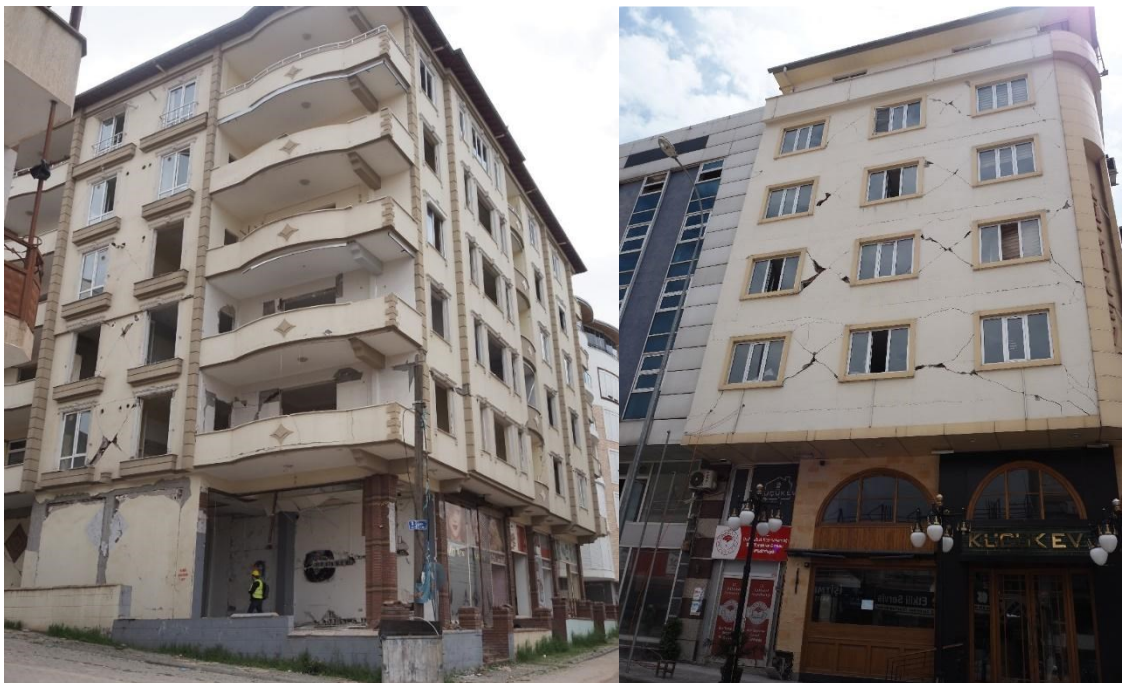
**Figure 5.4.9** Extensive bi-diagonal cracking.

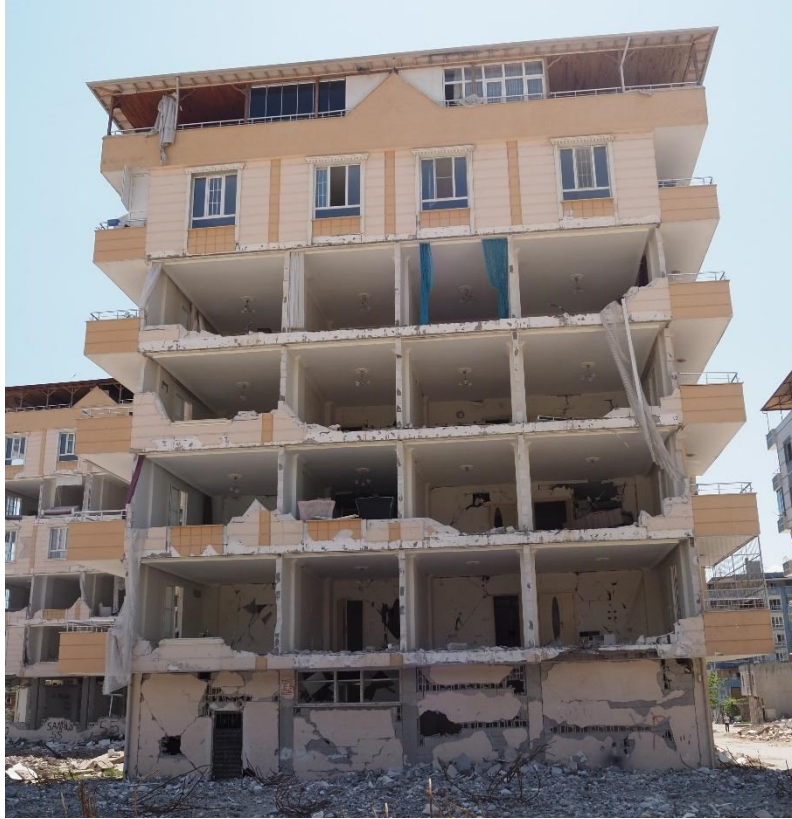
**Figure 5.4.10** Overturning of infill walls, because of out-of-plane loading.

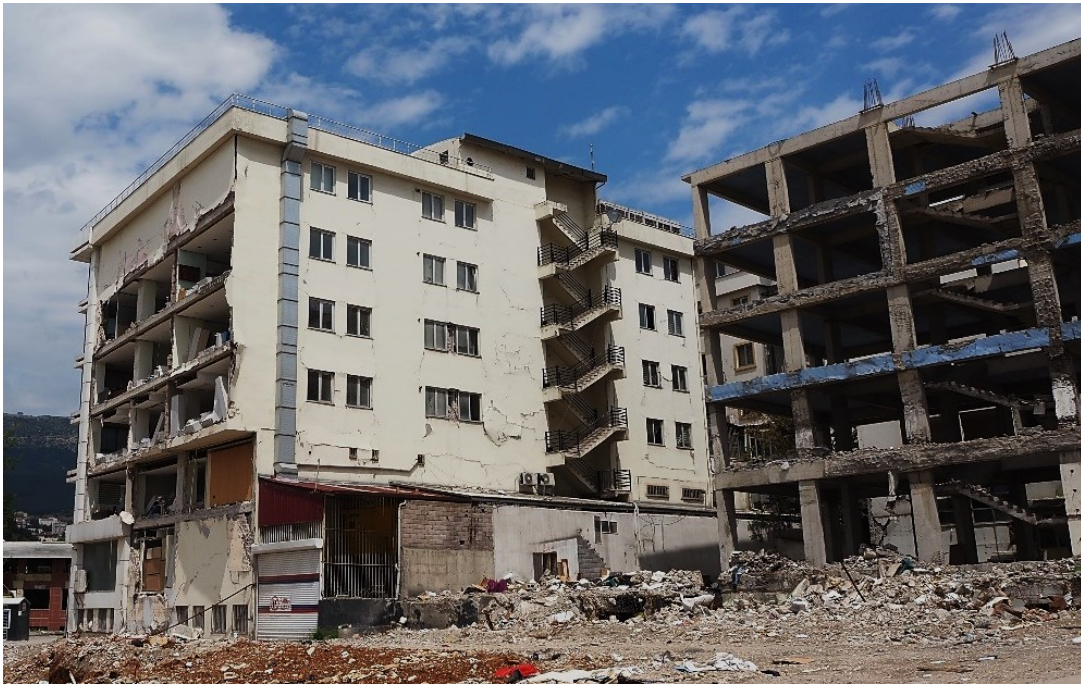
**Figure 5.4.11** Infill walls with diagonal cracking, along the direction of the earthquake and failing to out-of-plane loading, perpendicular to the main direction of the earthquake.

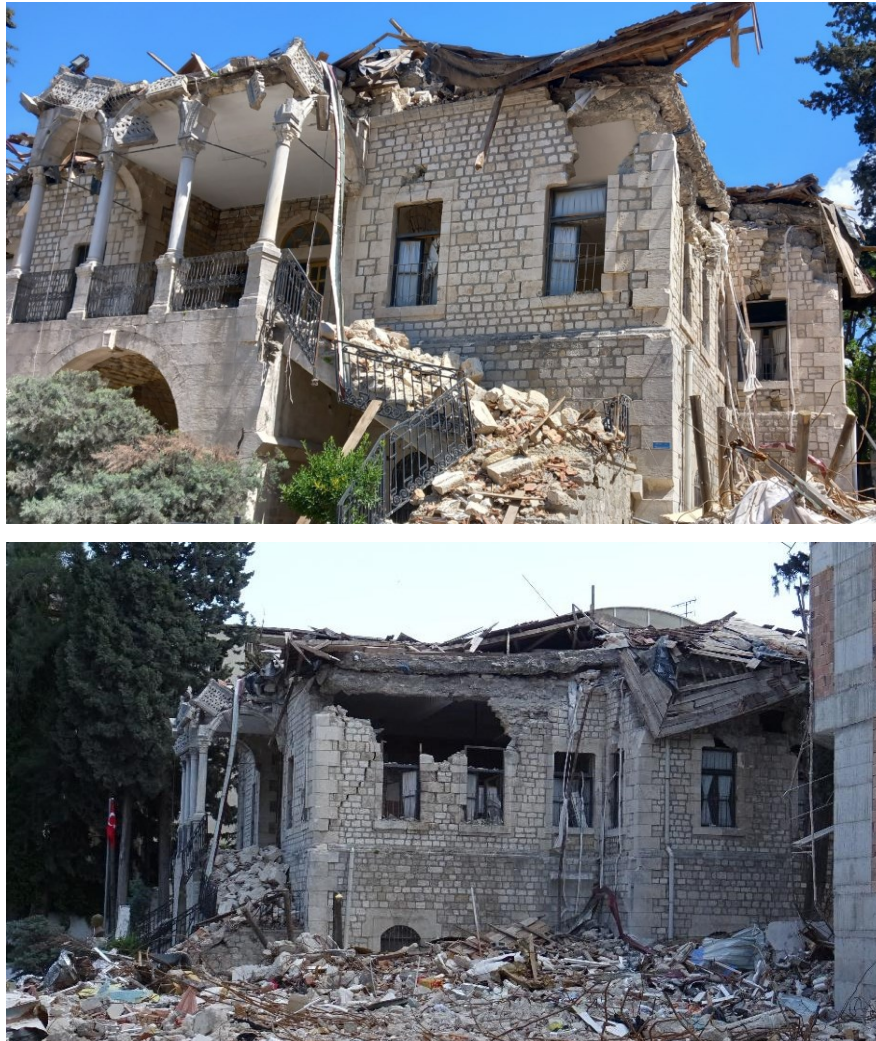
**Figure 5.6.20** Antakya, collapse of the upper storey, as a result of the action of the RC slab (upper photo: A.Sextos)

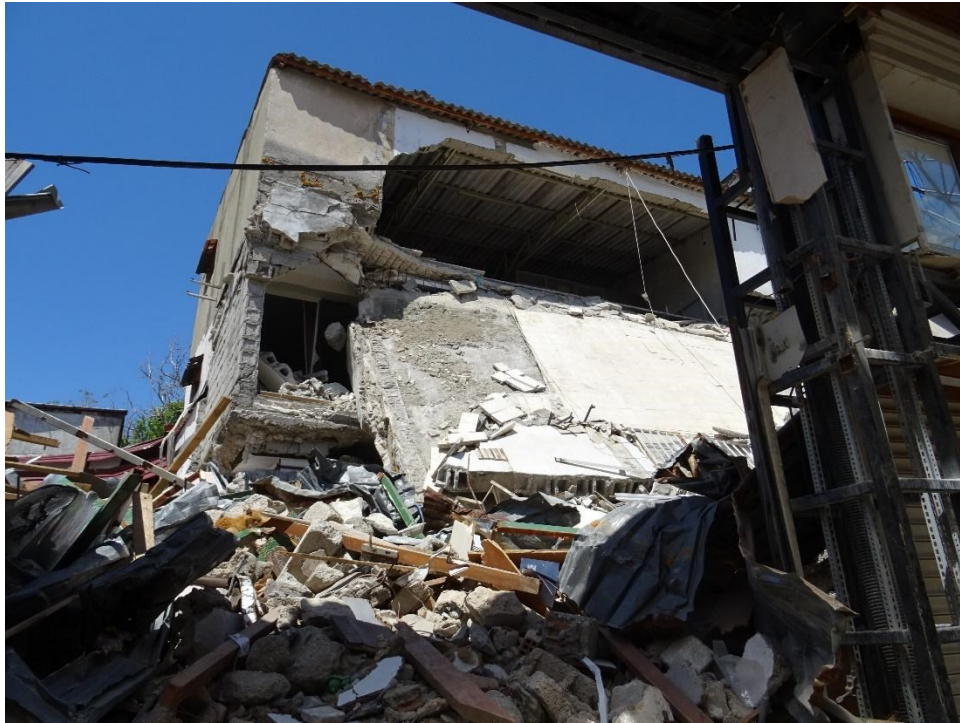
**Figure 5.6.26** Antakya, the effect of inadequate intervention using RC slab and jacket to masonry walls.

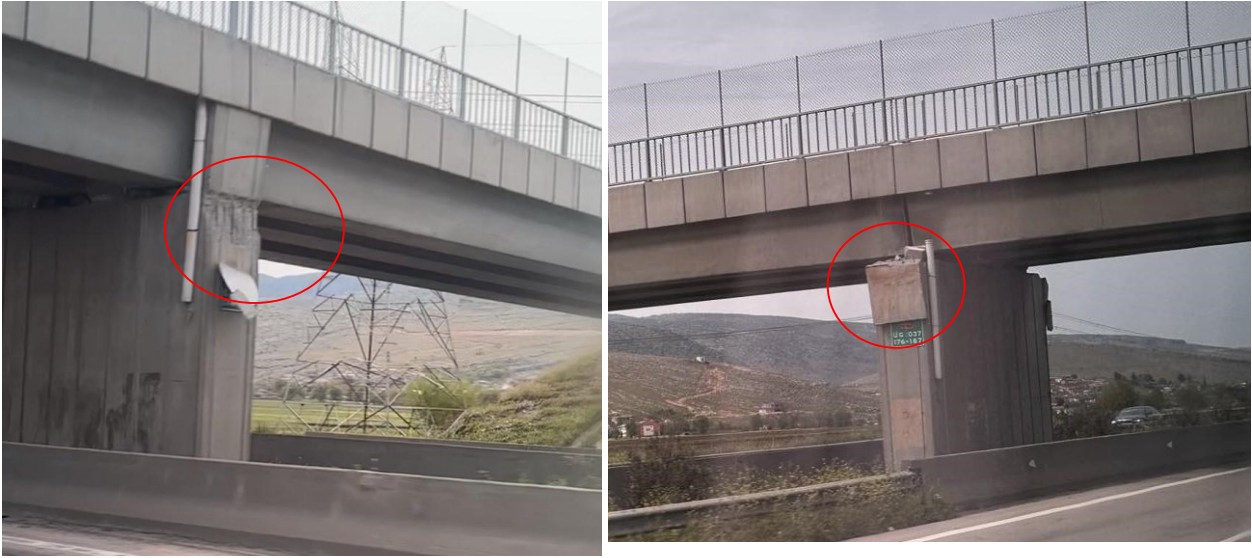
**Figure 6.6** Shear key (stopper) failure of a seismically isolated bridge of Kahramanmaras interurban network

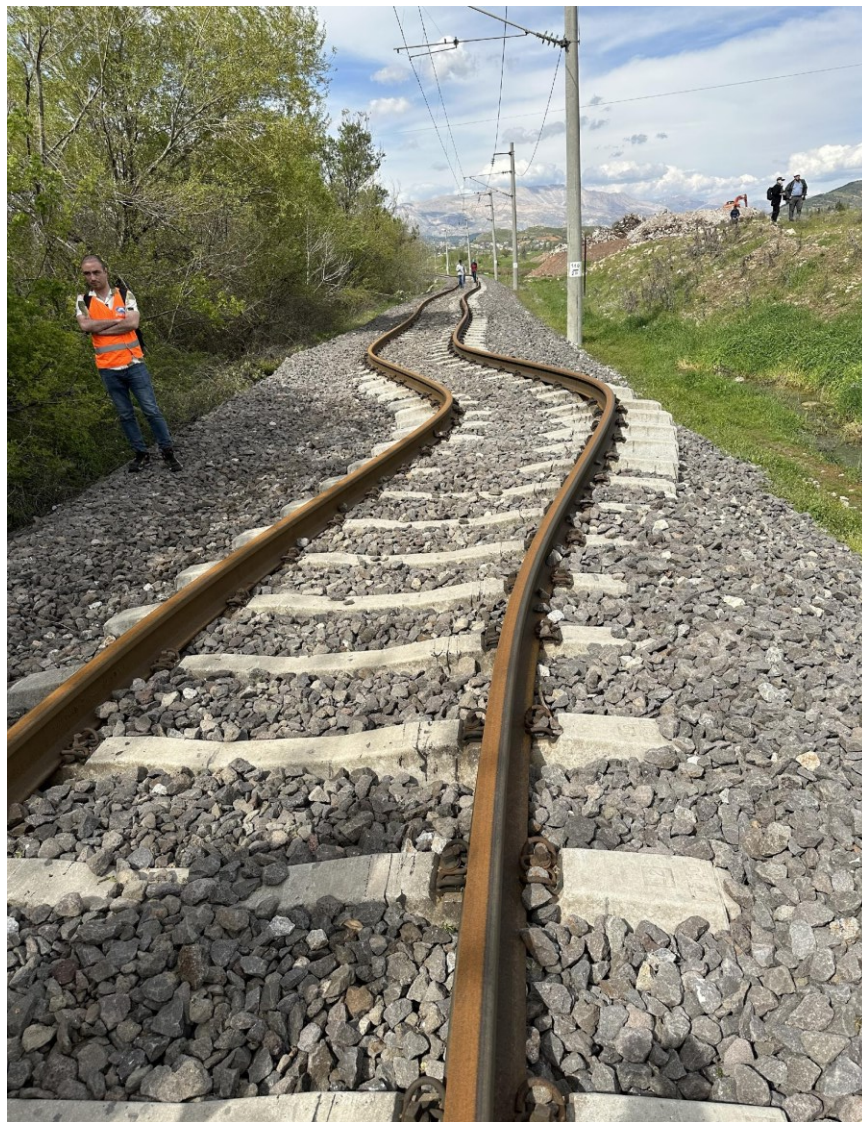
**Figure 6.11** Railway track damage
