# The Kaikoura, New Zealand Earthquake $M_w$ 7.8 , 14 November 2016

### "The Earthquake of Landslides"

### **Preliminary Report**

### George GAZETAS and Evangelia GARINI

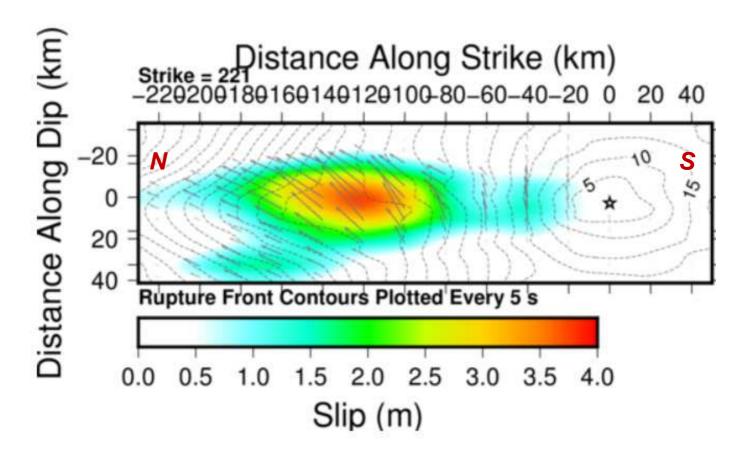
Cross-section of slip distribution. The strike direction is indicated above each fault plane and the hypocenter location is denoted by a star. Slip amplitude is shown in color and the motion direction of the hanging wall relative to the footwall (rake angle) is indicated with arrows. Contours show the rupture initiation time in seconds.

But notice an inconsistency with the observed 10 m ground-surface dislocation (see below) ![GG+EG]

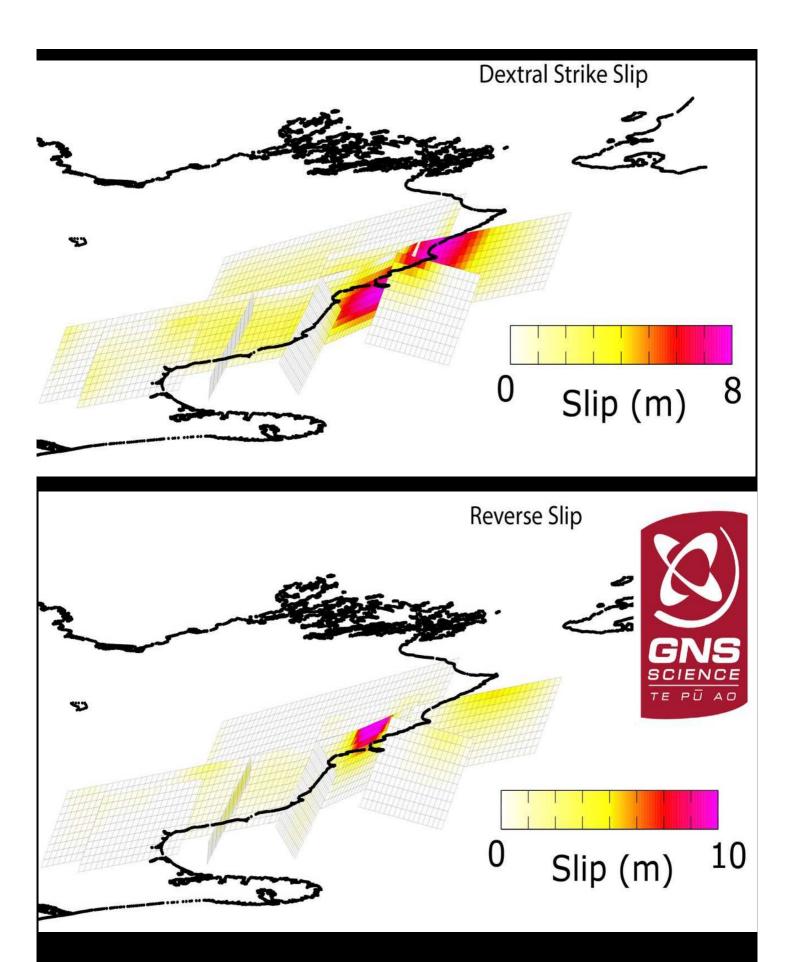
Fault rupture slip model based on the Sentinel-1 and GPS data

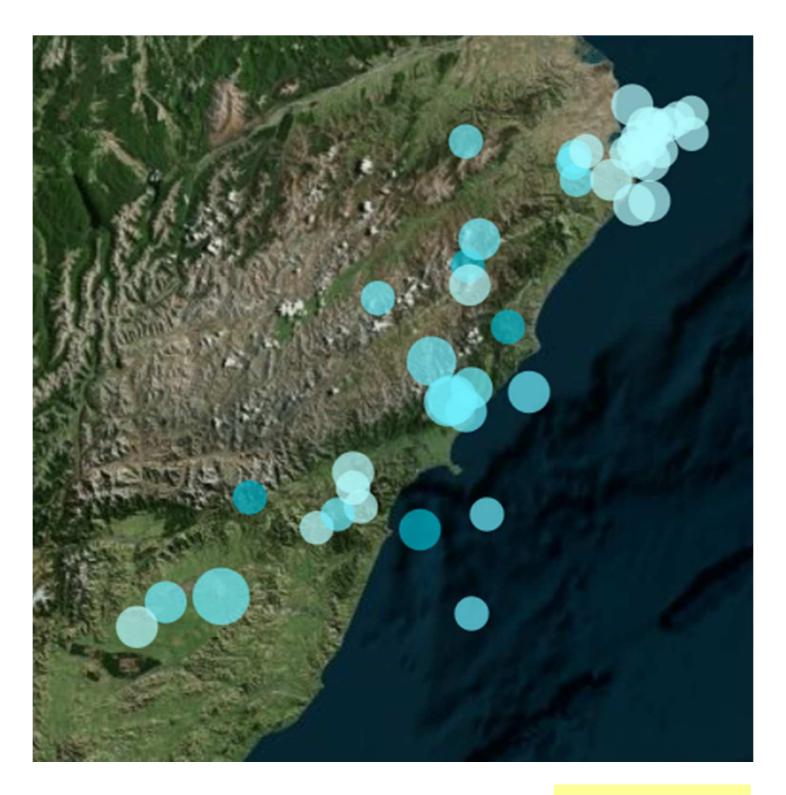
# Aftershocks recorded in the first 3 hours since the 7.8 mainshock.

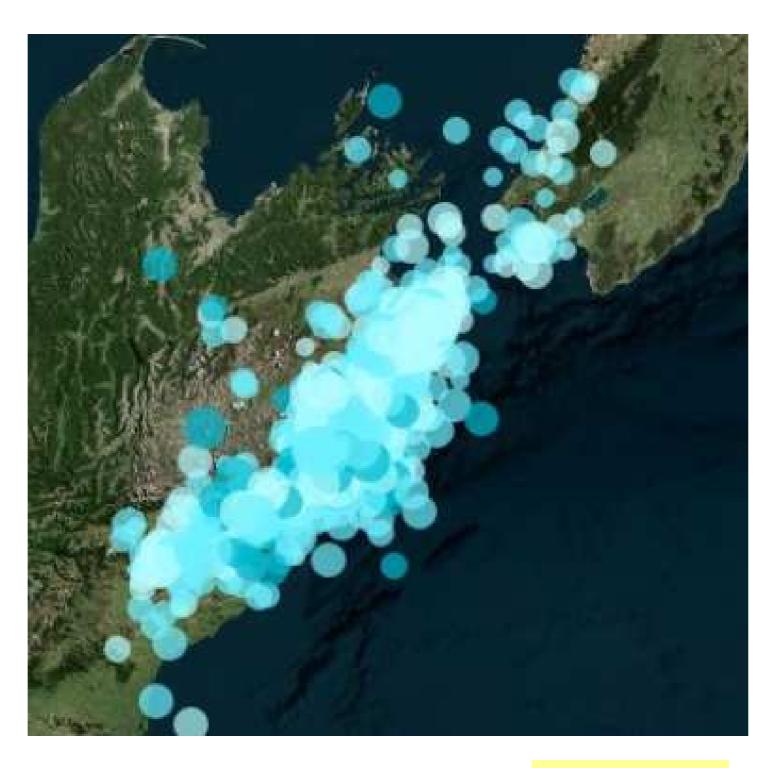
# Aftershocks recorded during the first 2 days since the 7.8 mainshock.

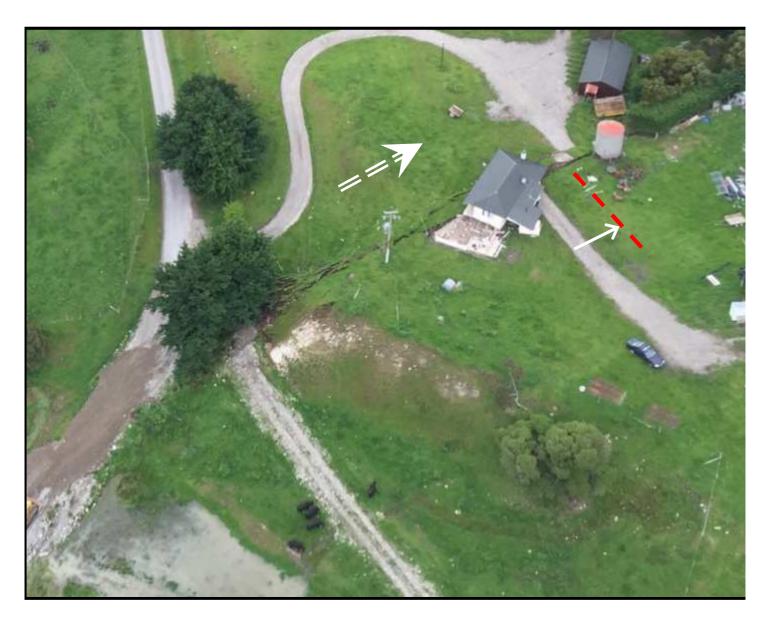
A house at Bluff Station btw Blenheim & Kaikoura. Right on top of the Kekerengu fault line.

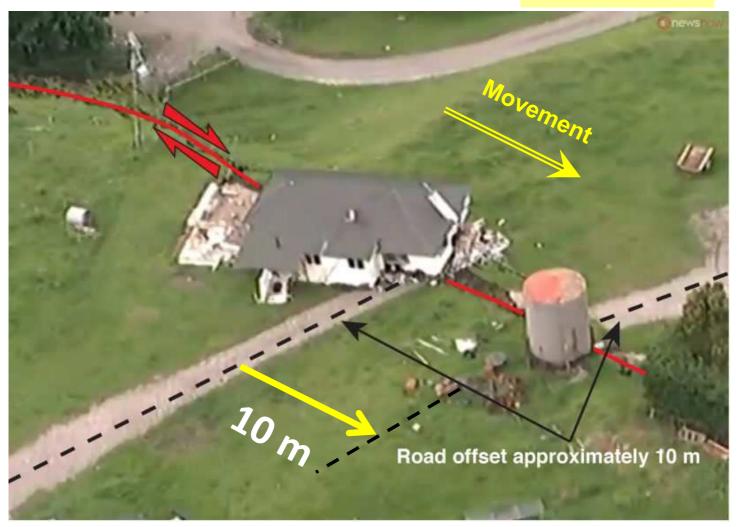
House moved and heavily damaged, but the cylindrical barn (or tank?) seems to have escaped damage (perhaps by fault "diversion"??)

#### **Kekerengu Fault rupture crossing a house**

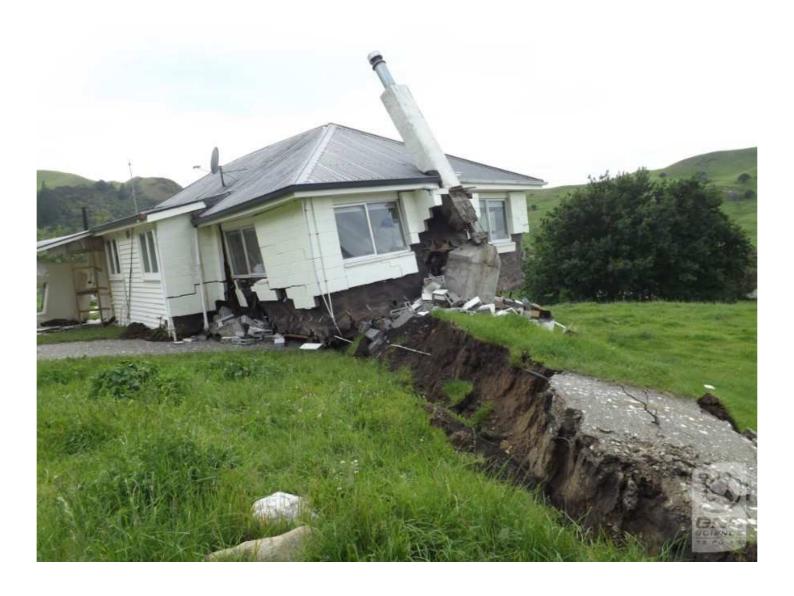
Thrust-Fault Rupture directly under the middle of a single-storey house (about 32km north-east of Kaikoura).

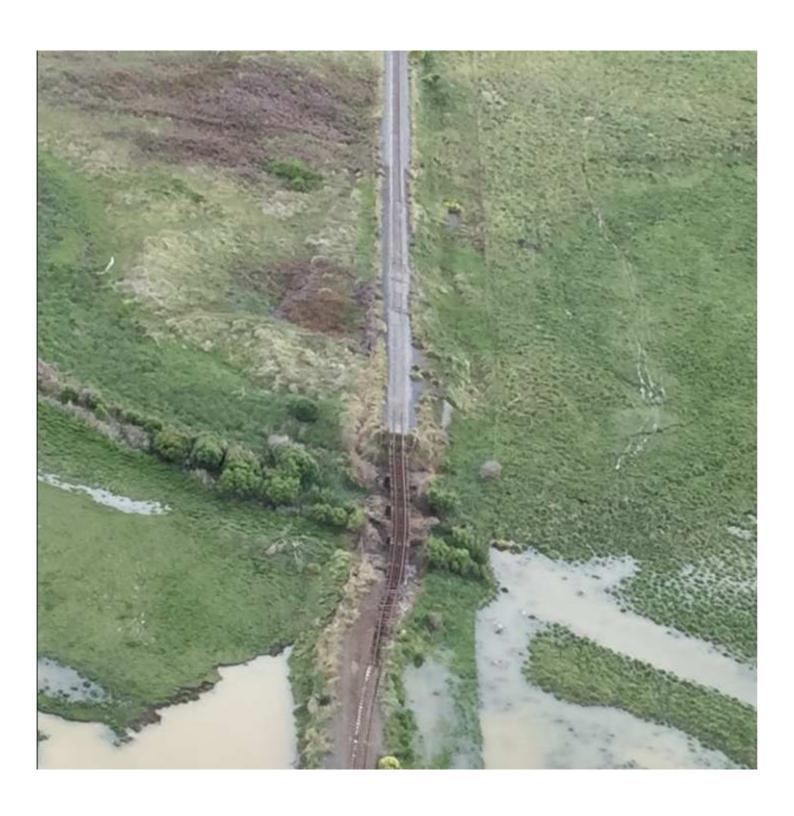
Kekerengu fault - very clear rupture here.

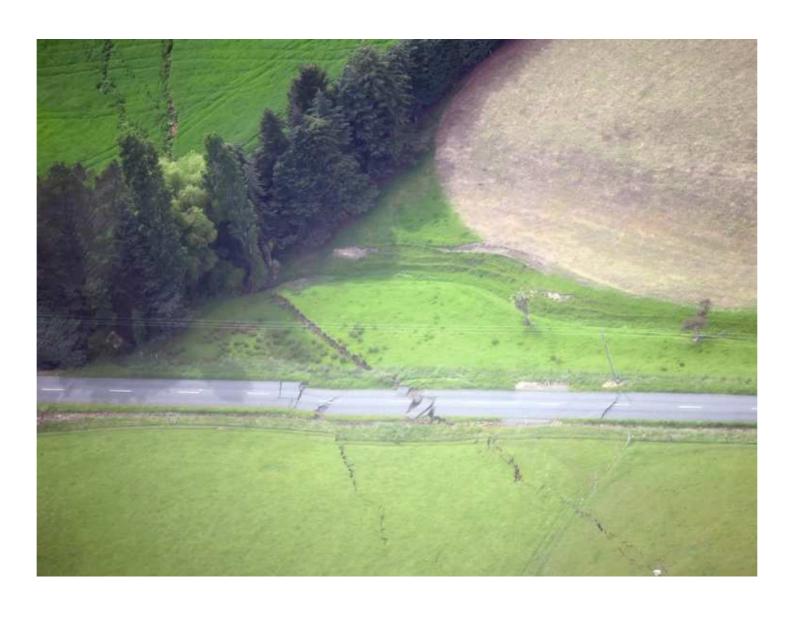
Right-Lateral Strike-Slip Fault rupture of the ground surface (\*near Kaikoura)

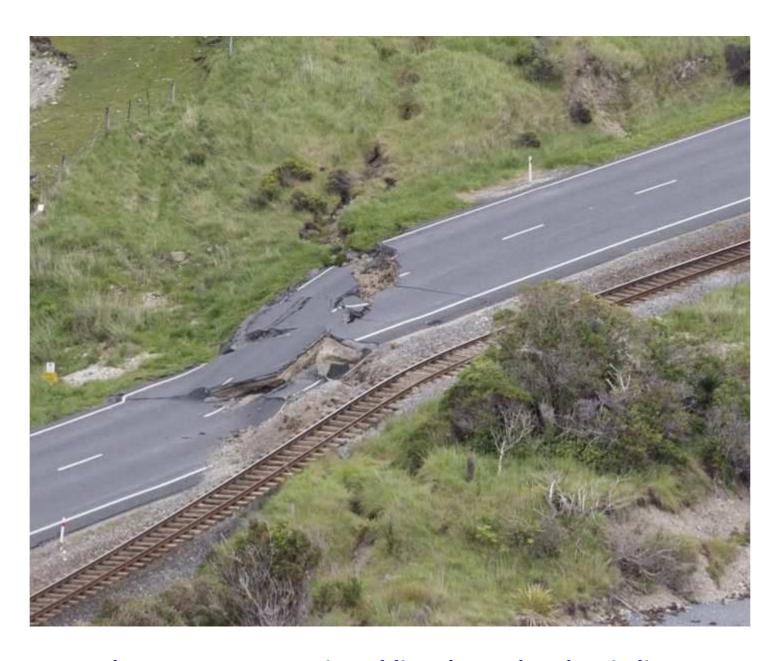
Thrust Rupture crossing obliquely road and train lines

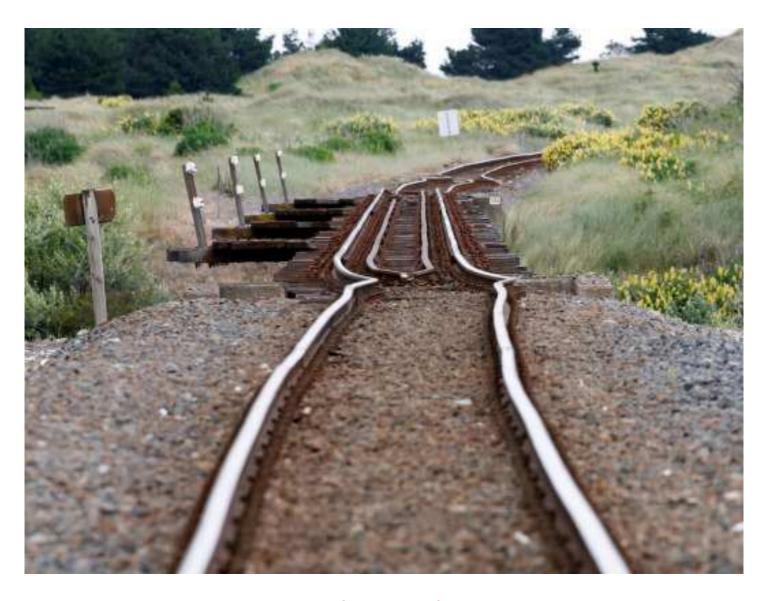
A railway line damaged (perhaps) by an emerging fault rupture. (Exact mechanism cannot be identified from this photo alone.)

(Near Tirohanga stream south of Blenheim.)

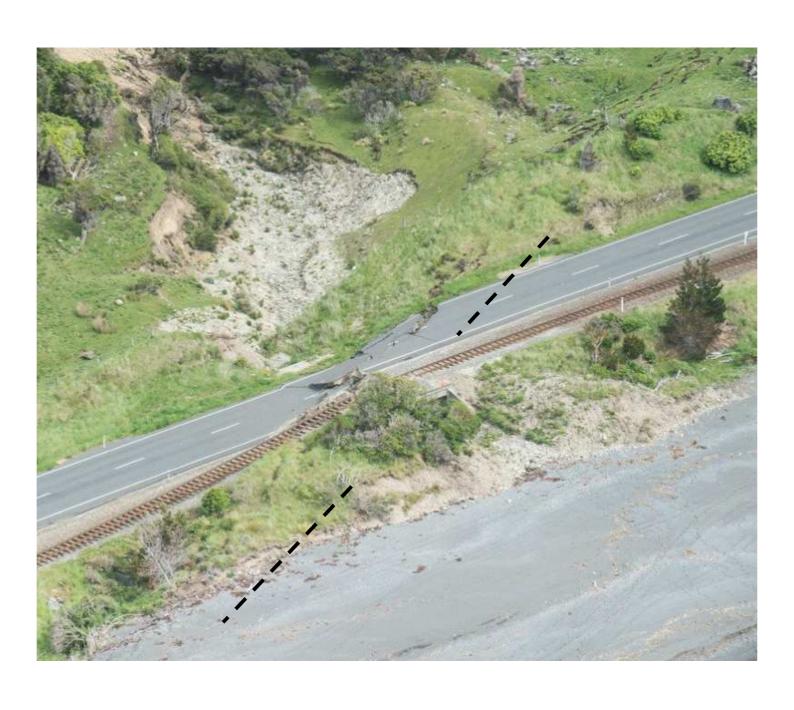
Strike-slip (?) Rupture hits obliquely the road

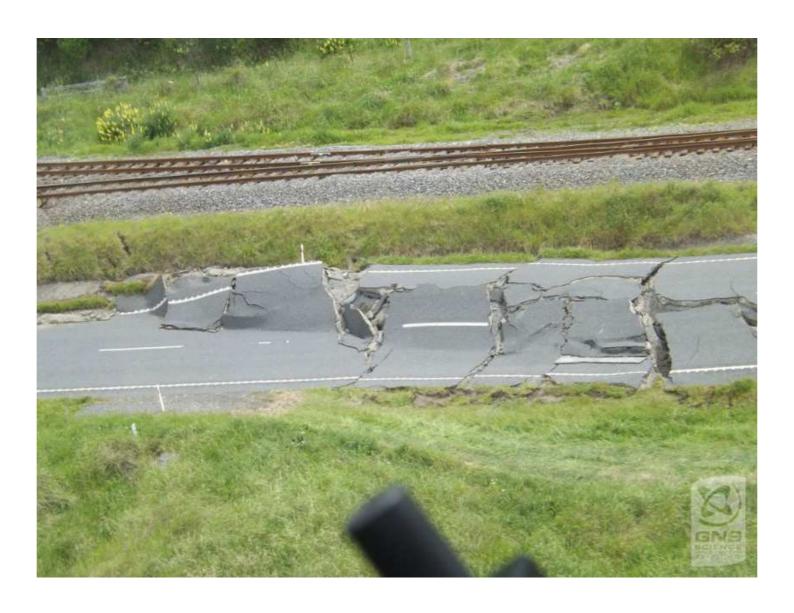
Rupture of the Hundalee Fault displacing SH1 and the railway line.

(Strike-Slip with a Thrust component ??)

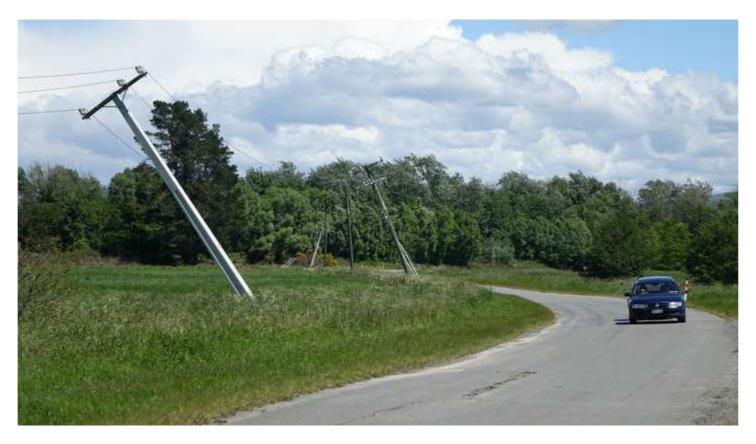
Lines damages on road close to Waiau

Interesting, but exact cause unknown

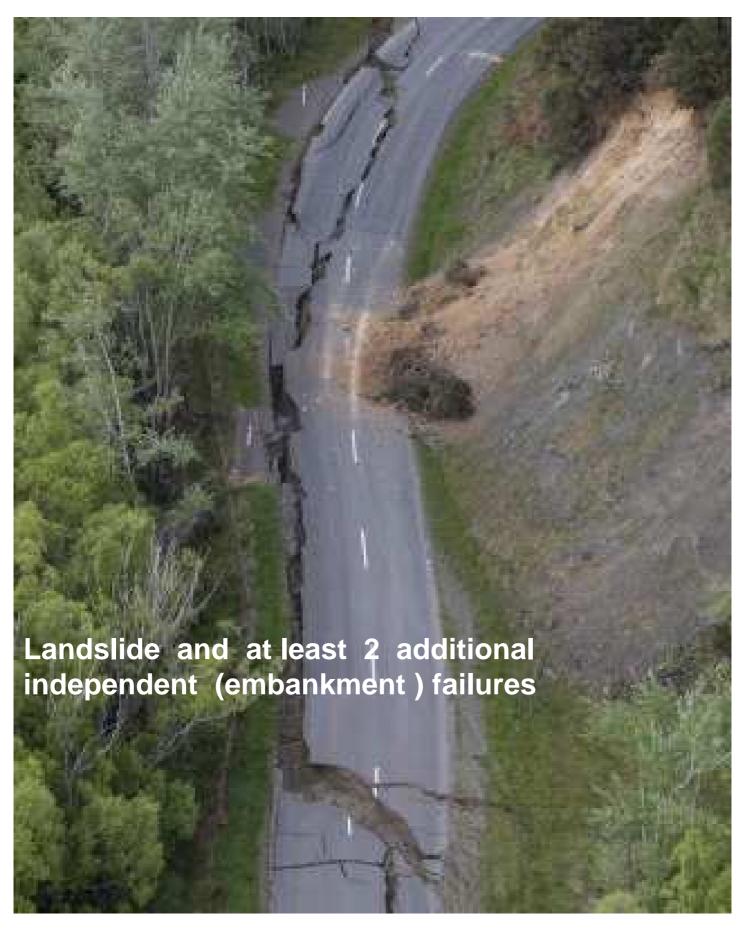
Major road damage near Mt Lyford. [AIN MCGREGOR/FAIRFAX]

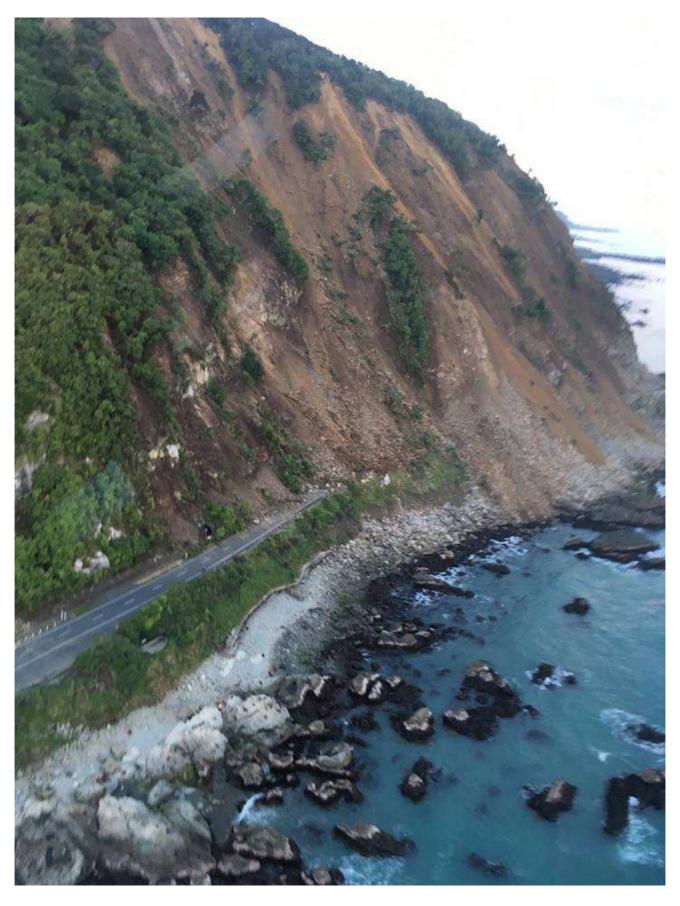
SH1: from precarious equilibrium to landslide

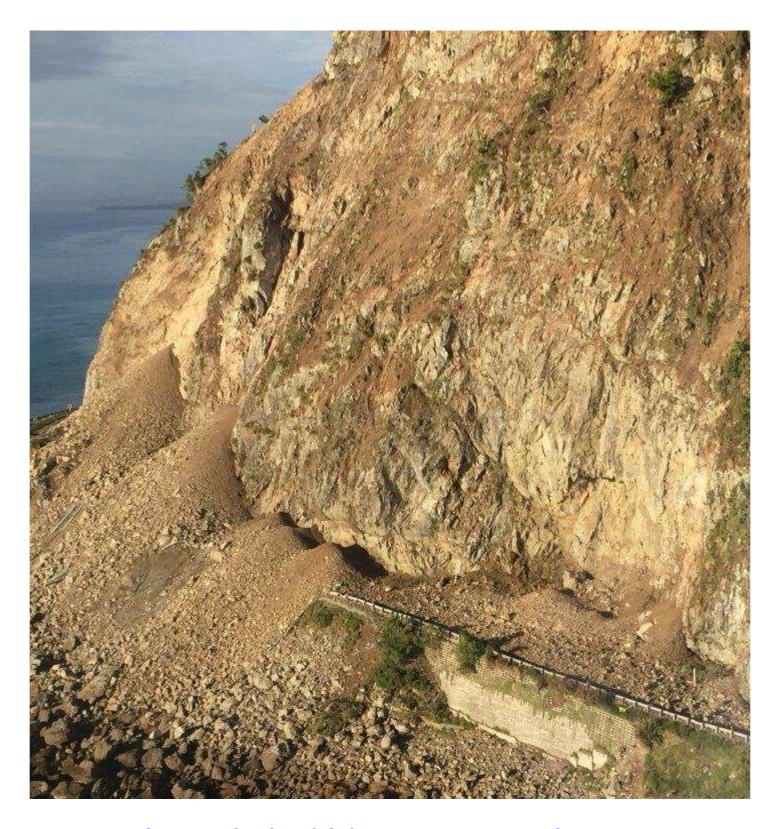
Another similar landslide on SH1, near Kaikoura

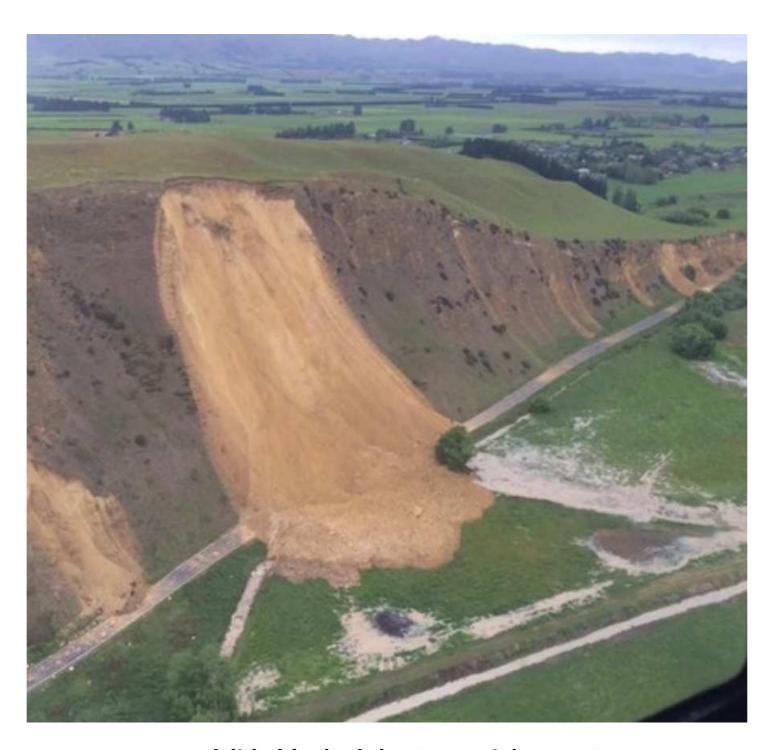
**Landslide blocked the State Highway 70**

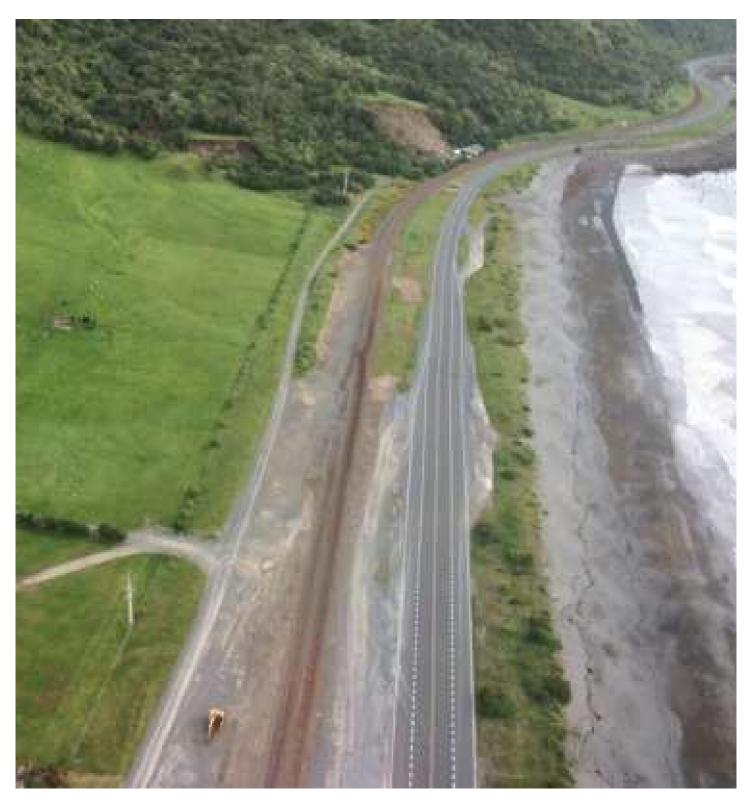
Slip near SH1 south of Kaikoura. [WESTPAC RESCUE HELICOPTER]

Several Failure Mechanisms can be seen (even if barely) in this photo ! [GG+EG]

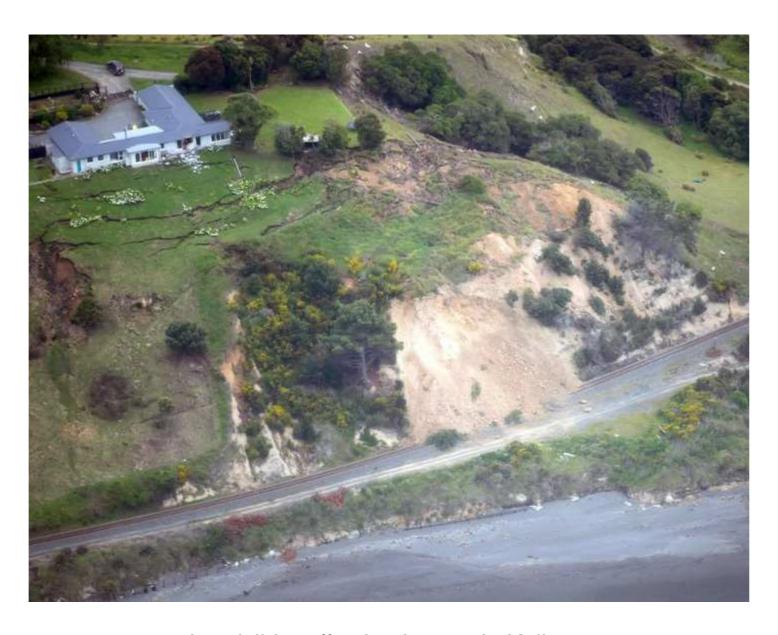
Landslide affecting house in Kaikoura.

House appears severely damaged, but it did not collapse [GG+EG]

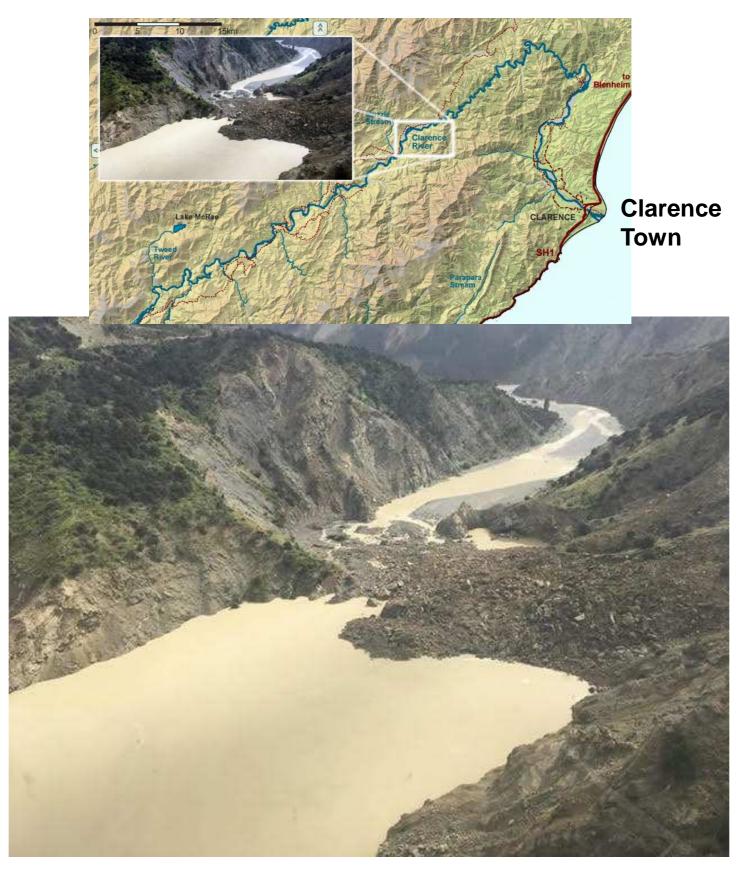
Clarence River, which flows from the Southern Alps, is blocked by landslide mass

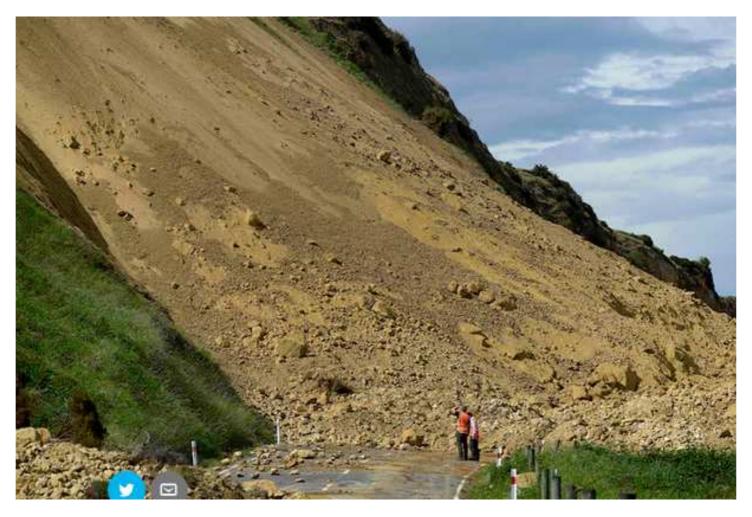
Damage to Rotherham Road near Waiau town, some 90 kms to the south of Kaikoura. [Photograph: Matias Delacroix]

Again, a very steep slope consisting of soft clay-like material next to the highway!

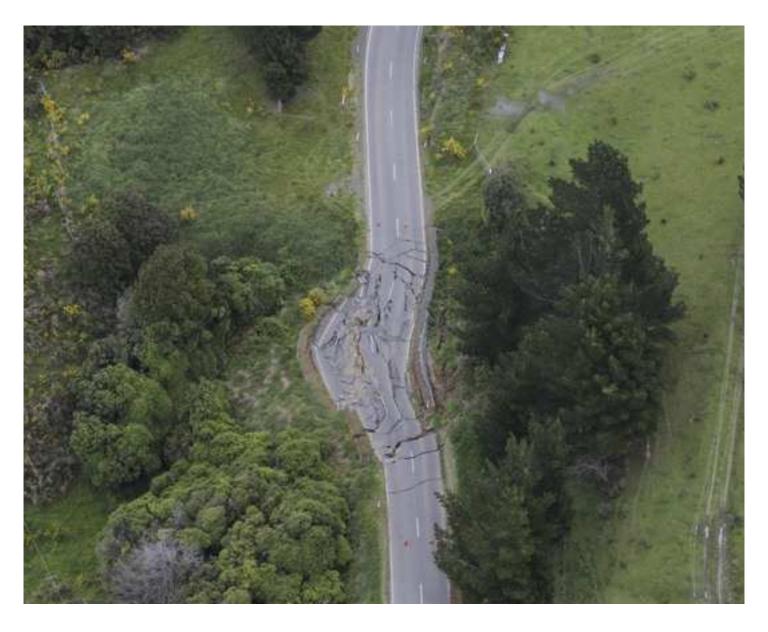
Damaged road from local slide (between Kaikoura and Mt Lyford)

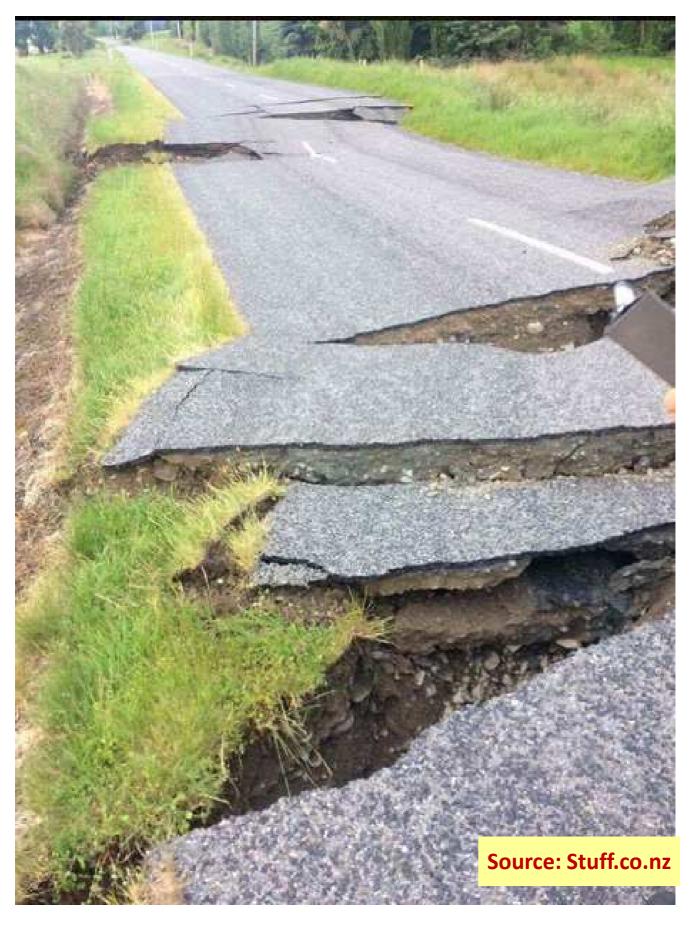
Several possible mechanisms... None obvious

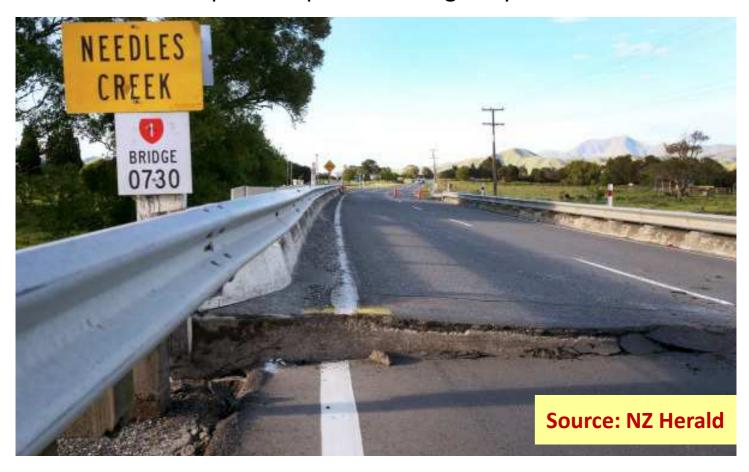
Damage to "Needles" Bridge Abutment (?) north of Ward.

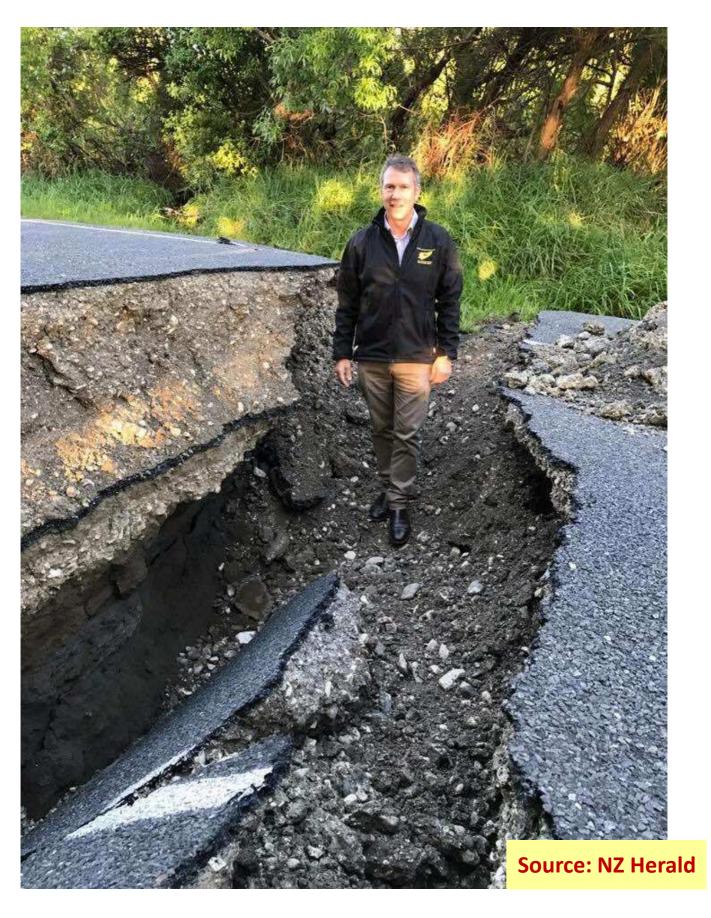
Kaikoura MP Stuart Smith stands in destroyed road *embankment*

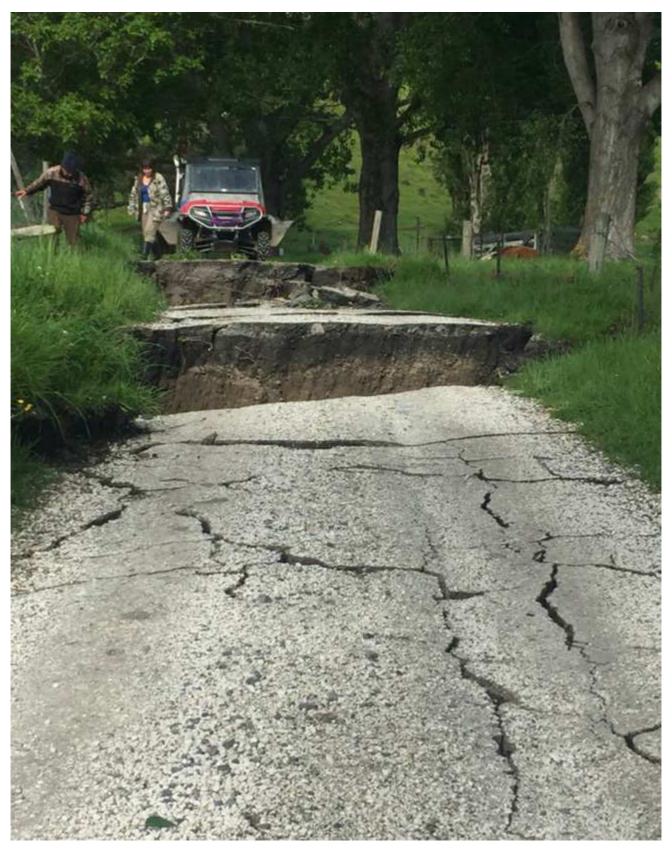
Damaged Road in the Clarence Valley, Hanmer Springs. [Photo: Tara Manson]

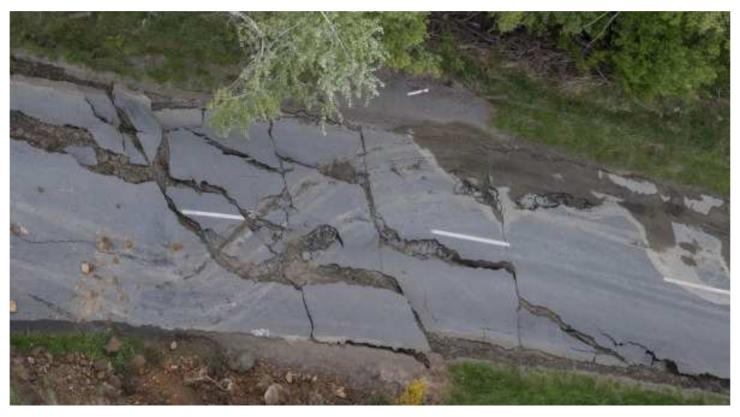
Major road damage near Mt Lyford. [AIN MCGREGOR/FAIRFAX]

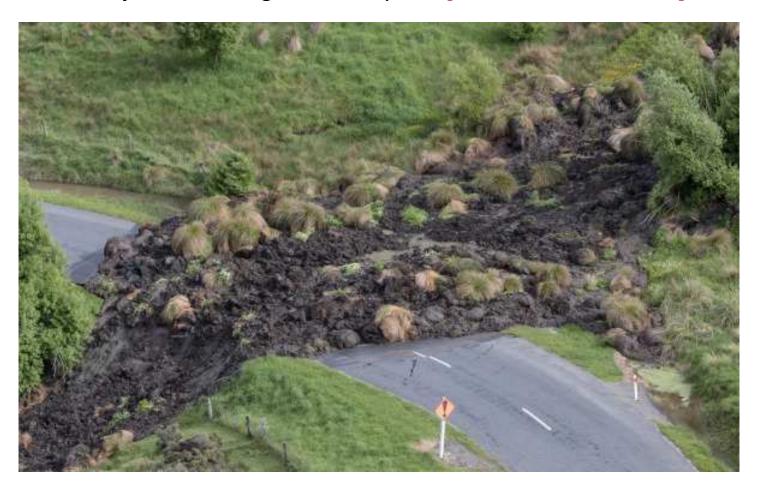
A slip near Mt Lyford. [AIN MCGREGOR/FAIRFAX]

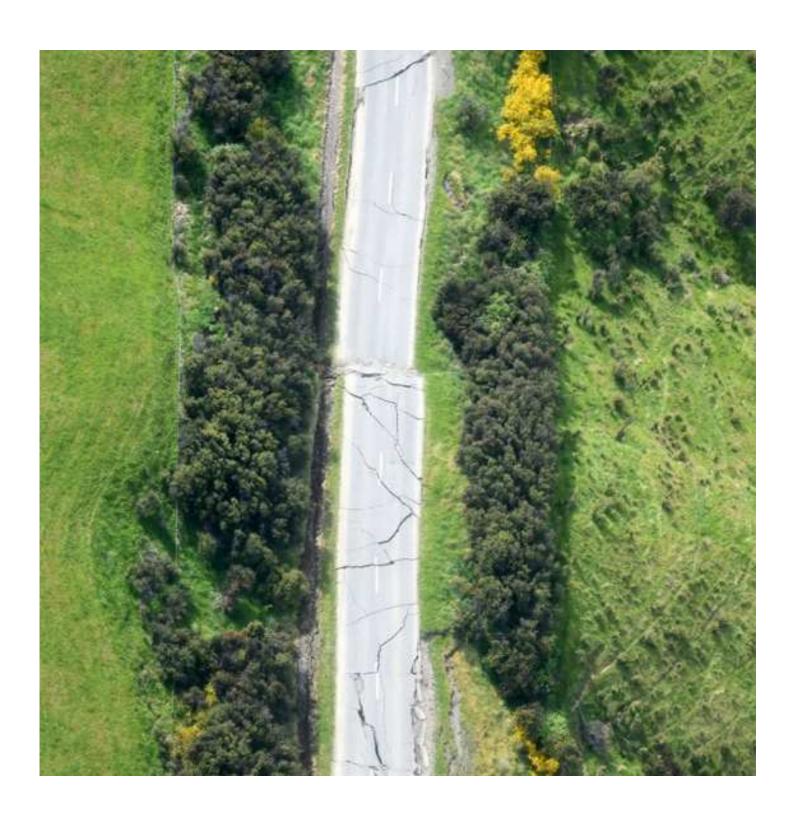
Road damage in the Kaikoura area .

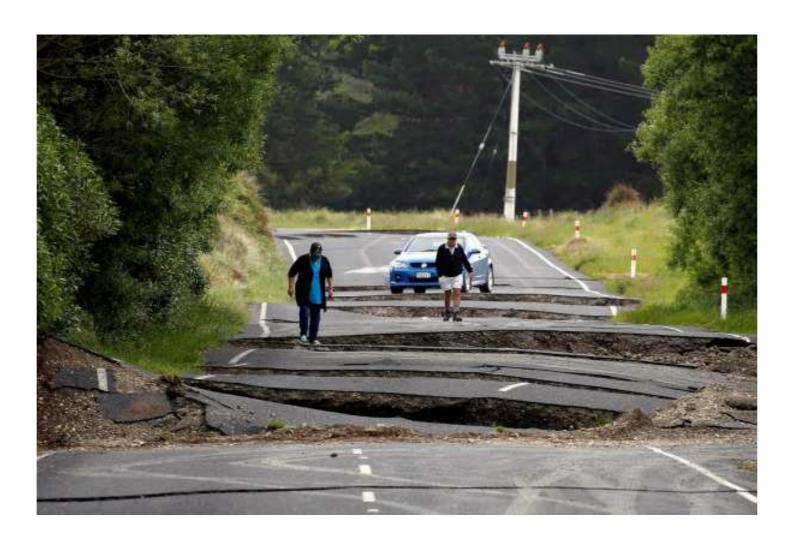
Local residents look at damage along State Highway 1 near the town of Ward.

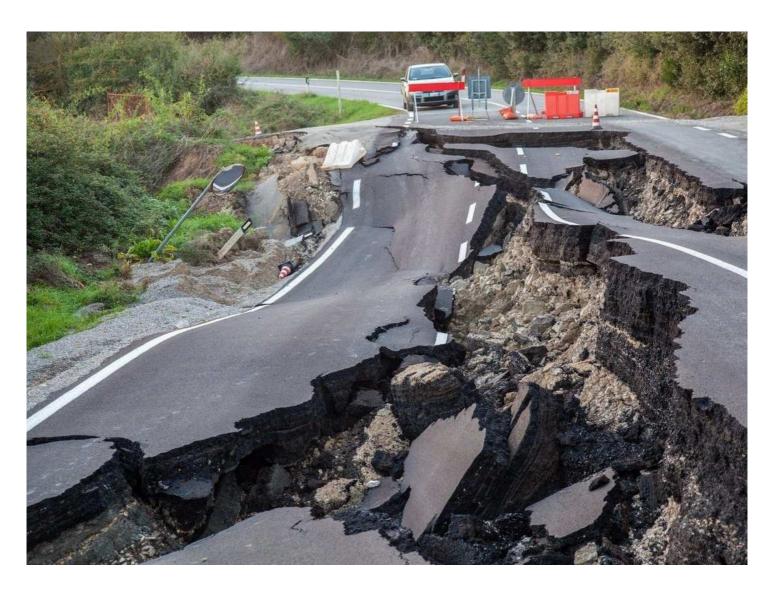
Damage along State Highway 1.

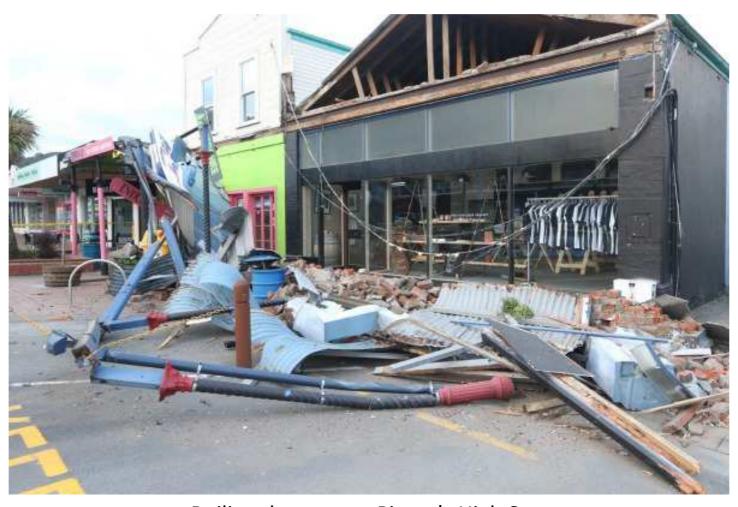
Builing damage on Picton's High St

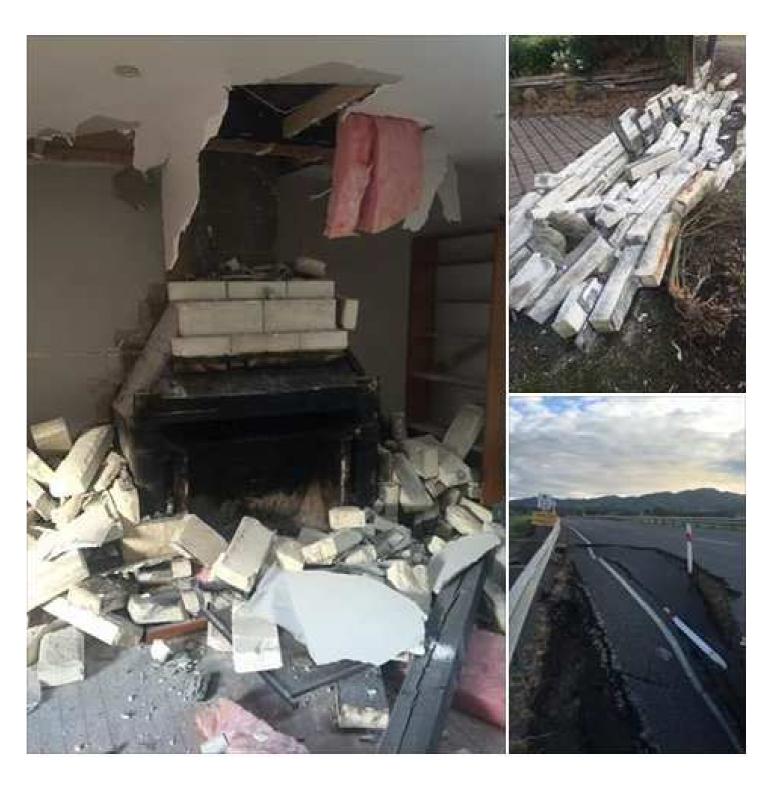
Damage in Parnassus, south of Kaikoura
