NATIONAL  
TECHNICAL  
UNIVERSITY  
OF ATHENS

# The February 6<sup>th</sup> Kahramanmaraş earthquake sequence in Türkiye

*Technical Report*

Aristidis Papachristidis, Anastasios Sextos

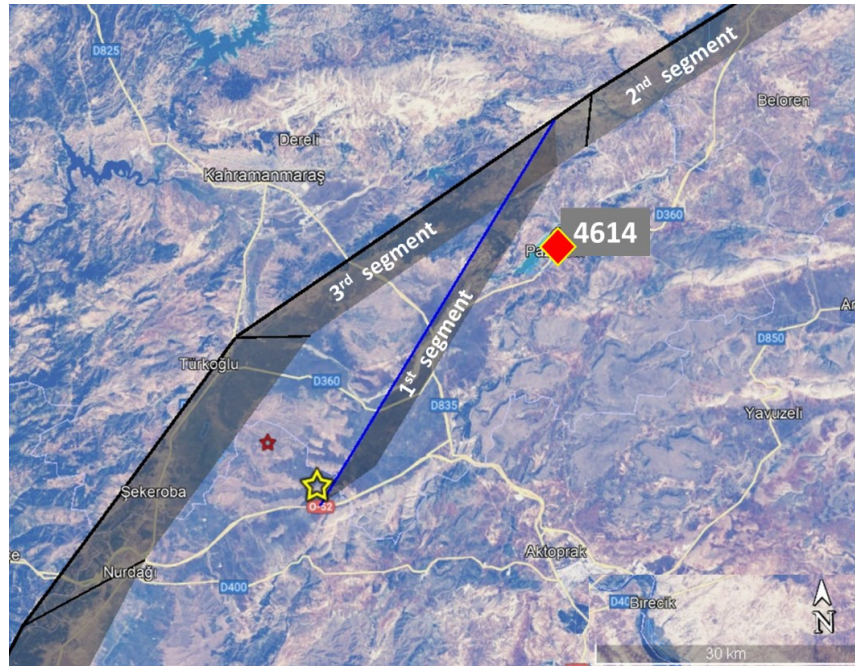
The highest peak acceleration was recorded in station 4614 in Pazarcik city, with 30 km epicentral distance but only 5 - 6 km fault distance from both the first and second rupture segments as Figure 2.5 shows. The recorded peak horizontal accelerations in station 4614 were: 2.15 g and 2.13 g in the HNE and HNN components respectively. The peak vertical component of 1.58 g was also very high.

Figure 2.5 Map of the rupturing fault segments during Mw7.8 Pazarcik earthquake along with the location of station 4614 in which the greatest PGAs were recorded.

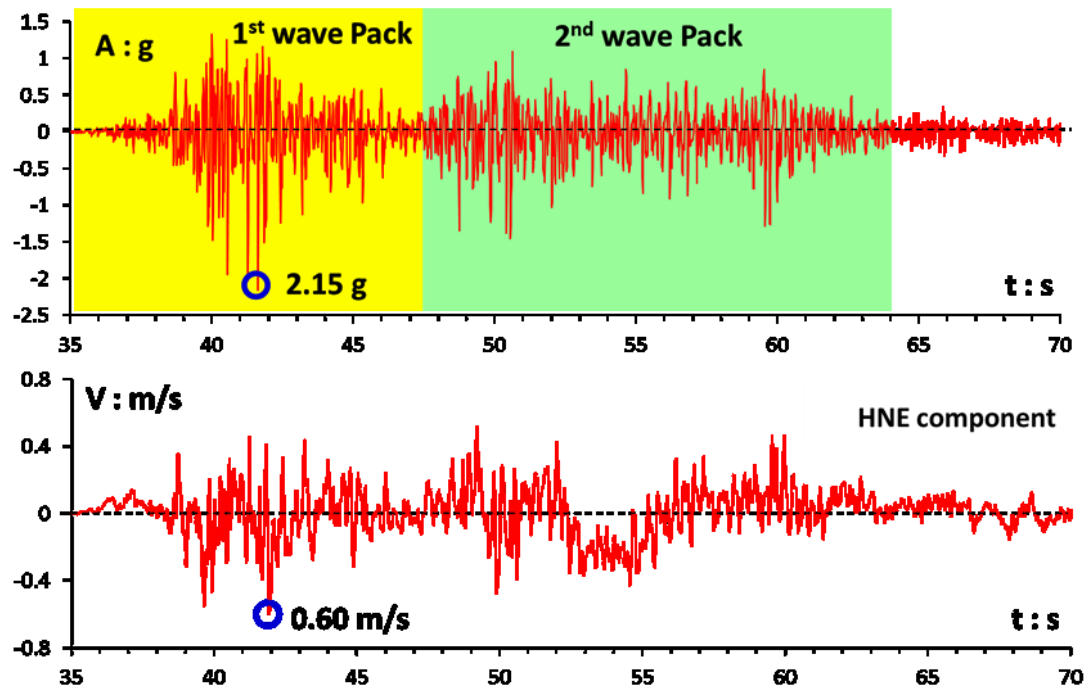
Acceleration and velocity time-histories of the two horizontal components of station 4614 are illustrated in Figures 2.6 and 2.7. The corresponding elastic response spectra are pictured in Figure 2.8. Observe the large spectral accelerations (greater than 1 g) for the period range [0.0 - 0.7 s]. Many near-fault records are captured with AFAD network: 33 stations recorded PGAs greater than 0.3 g (Table 2.1) from the Pazarcik earthquake.

Figure 2.6 Acceleration (top) and velocity (bottom) timehistories of the horizontal component HNE recorded in station 4614 during Pazarcik earthquake.

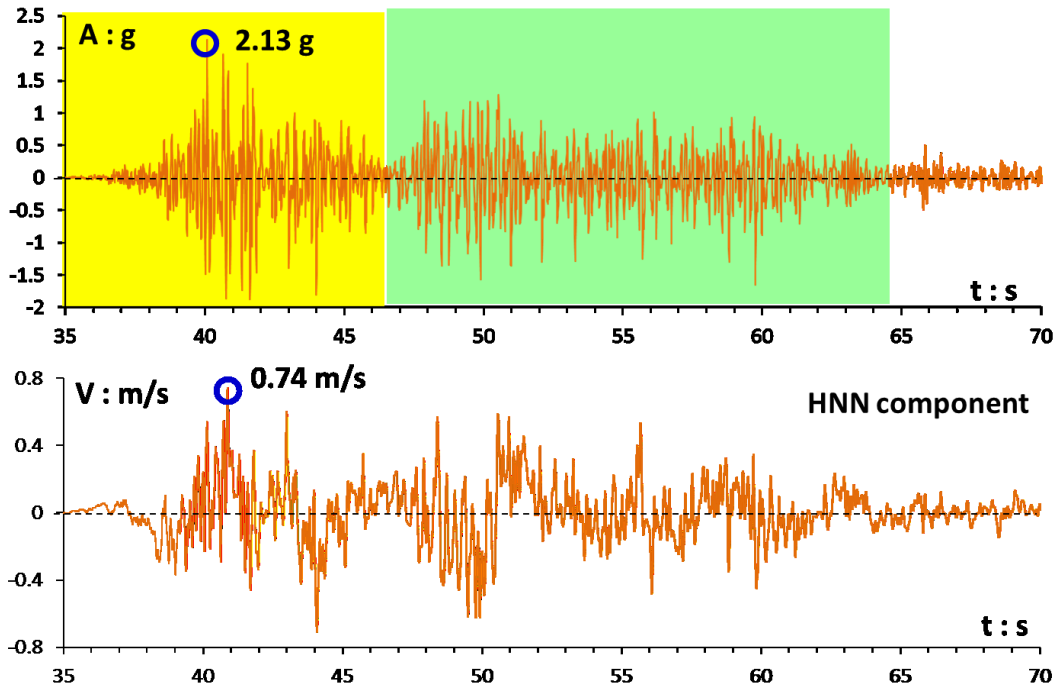
Figure 2.7 Acceleration (top) and velocity (bottom) timehistories of the horizontal component HNN recorded in station 4614 during Pazarcik earthquake.

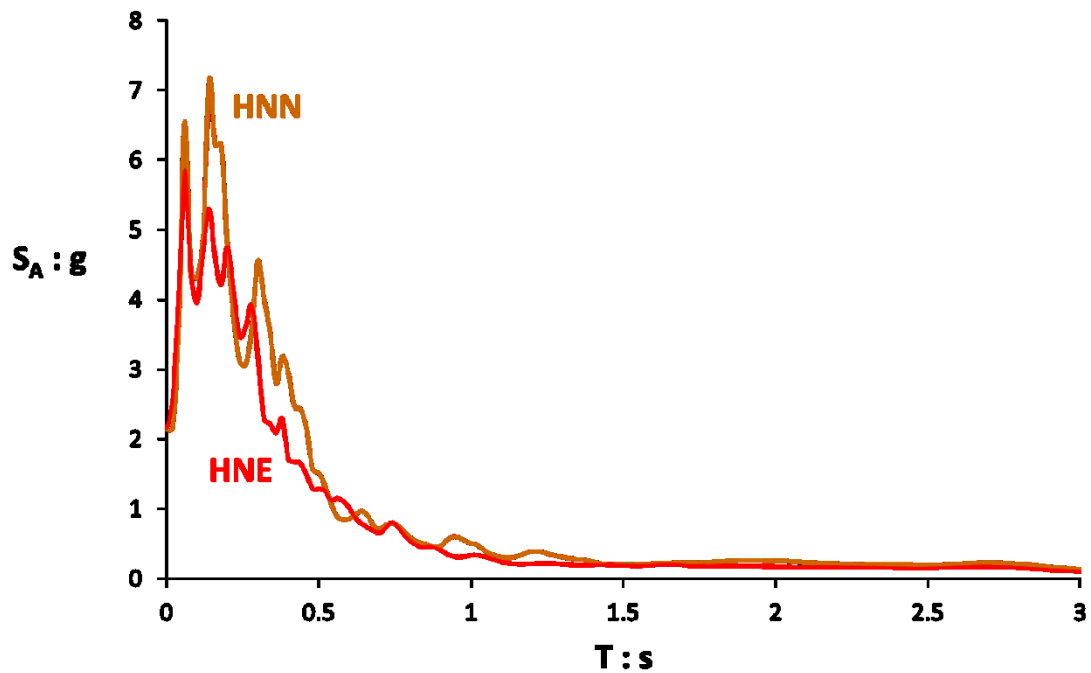
Figure 2.8 Acceleration spectra of the HNE and HNN components of station 4614 during Pazarcik earthquake.

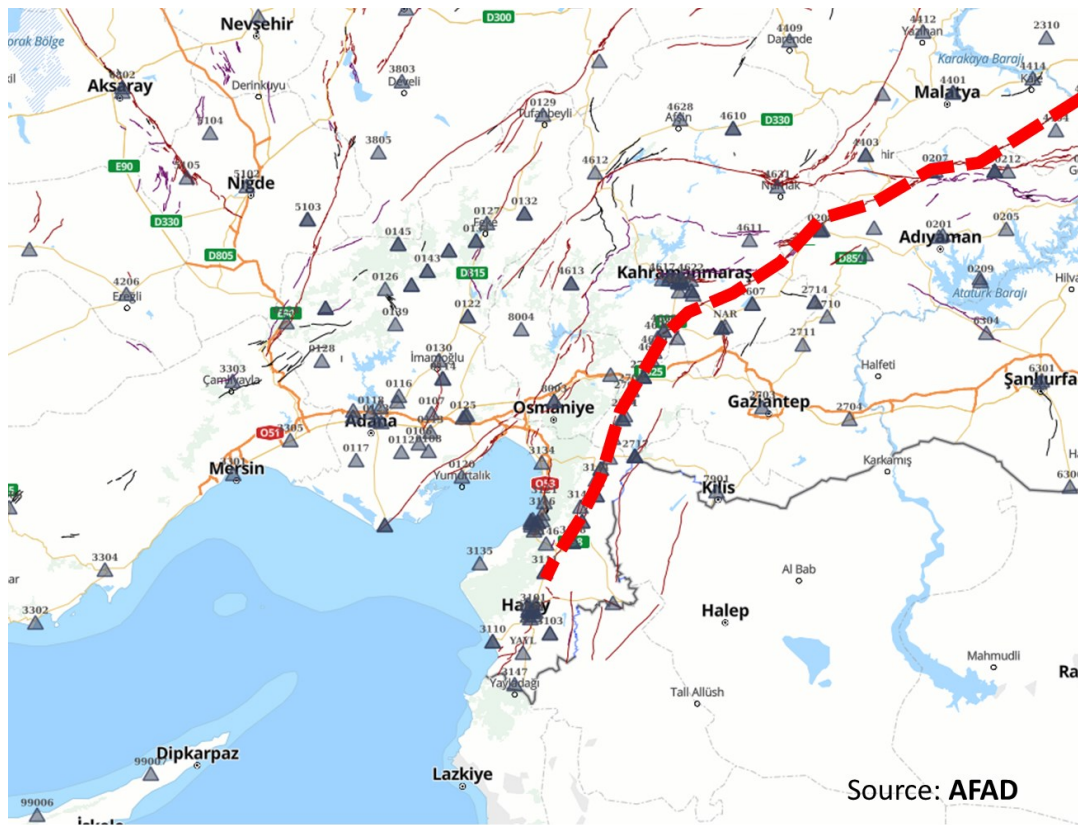
**Figure 2.9** Map of the recording stations and the East Anatolian Fault segment (dashed red line) that cracked in the  $M_w7.8$  Pazarcik earthquake.

More than 15 stations were located *on or near-field* the rupturing zone, as can be seen in Figure 2.9. Near-fault phenomena such as **forward-directivity** and **supershear** were captured in the acceleration and velocity timehistories of the recorded stations (Rosakis et al. 2023; Garini & Gazetas 2023). Forward-rupture directivity was manifested by the presence of large amplitude, long period pulses in acceleration and velocity timehistories recorded normal to fault plane. On the other hand, supershear appeared by well-defined velocity pulses in direction parallel to fault plane. In addition, when supershear occurred the parallel recordings were the dominating compared with the normal ones. Keep in mind that supershear can happen simultaneously with forward directivity, for instance in the Antakya 3126 station (Abdelmeguid et al. 2023; Wang et al. 2023).

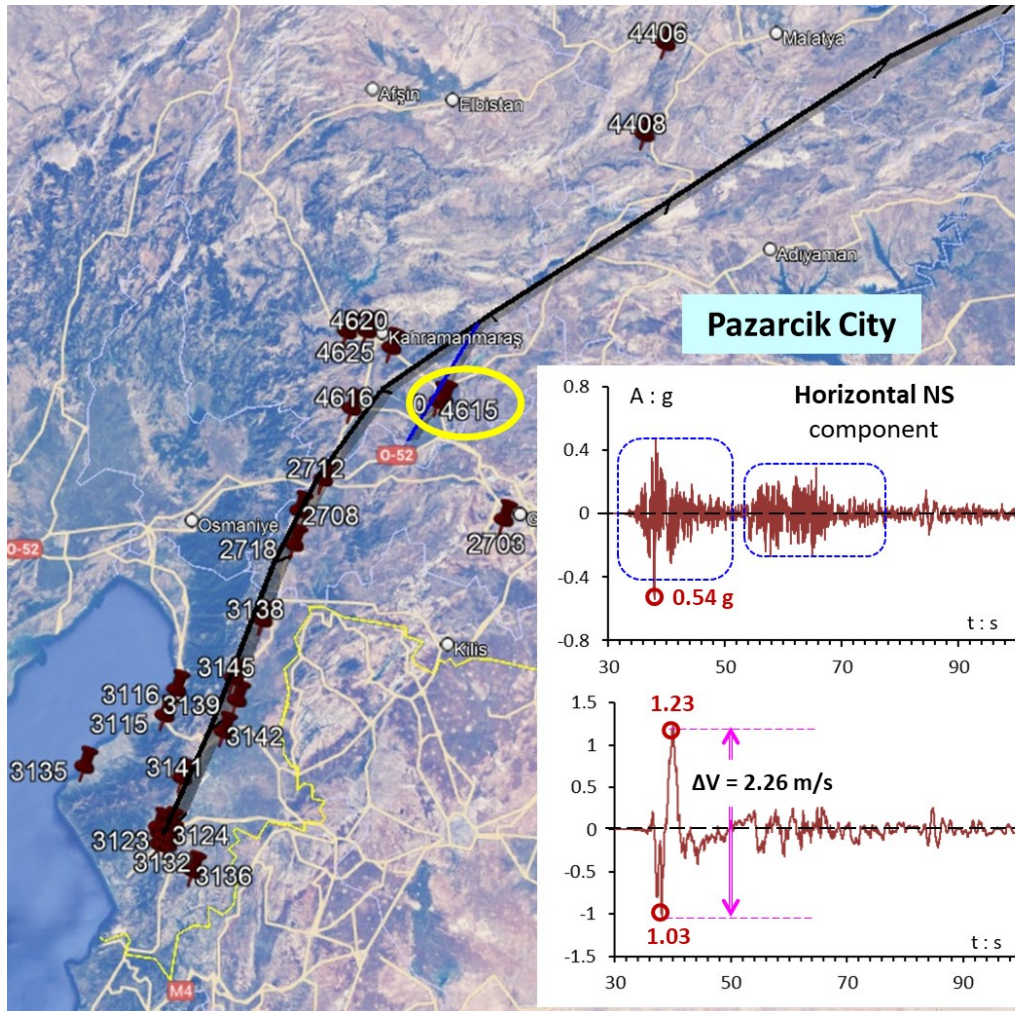
**Figure 2.10** Location of station 4615 close to the first rupturing segment of  $M_w$ 7.8 Pazarcik earthquake, along with the recording acceleration and velocity timehistories of the NS component of station 4615.

To demonstrate the evolution of acceleration records along the rupturing faults, Figures 2.10-2.13 present the recording accelerations and velocities in four characteristic locations: in station 4615 close to Pazarcik city, station 4616 in Turkoglu, and in stations 3123 and 3129 in Antakya. The distinct wave packets arising from the rupturing of the first and the second and third segments can be noticed in the acceleration timehistories of stations 4615 and 4616. On the contrary, Antakya recordings in stations 3123 and 3129 exhibit a sole sequence of acceleration pulses which are of large amplitude and period—a sign of the forward directivity effect.

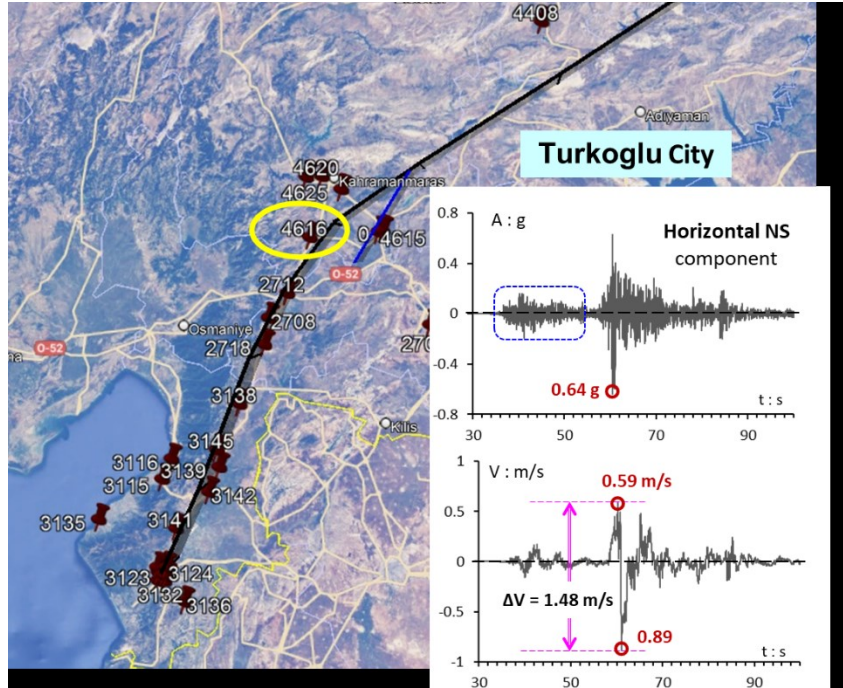
**Figure 2.11** Location of station 4616 close to the third rupturing segment of  $M_w$ 7.8 Pazarcik earthquake, along with the recording acceleration and velocity timehistories of the NS component of station 4616.

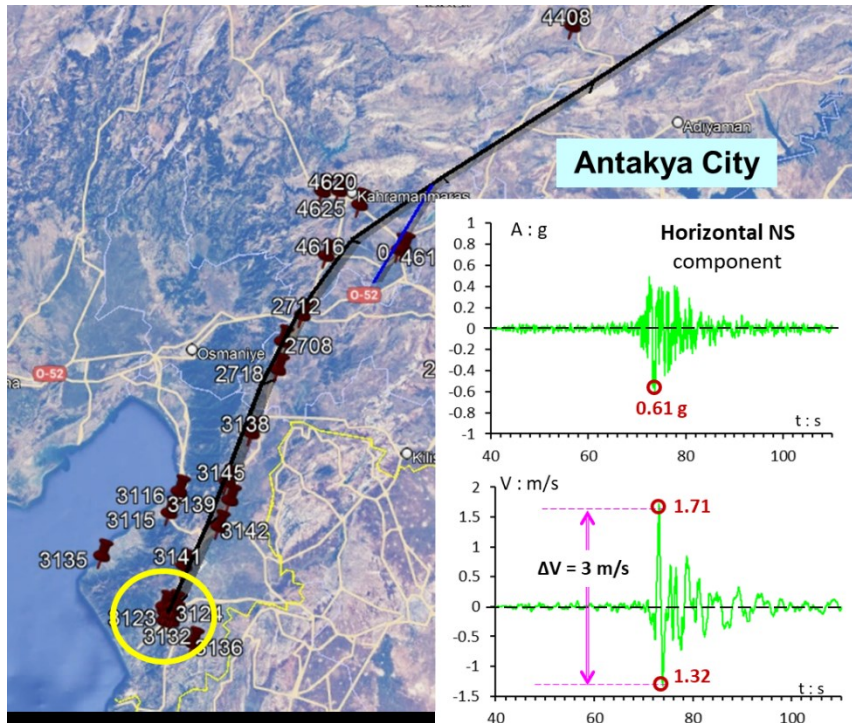
**Figure 2.12** Location of station 3123 in Antakya, along with the recording acceleration and velocity timehistories of the NS component during the  $M_w$ 7.8 Pazarcik earthquake.

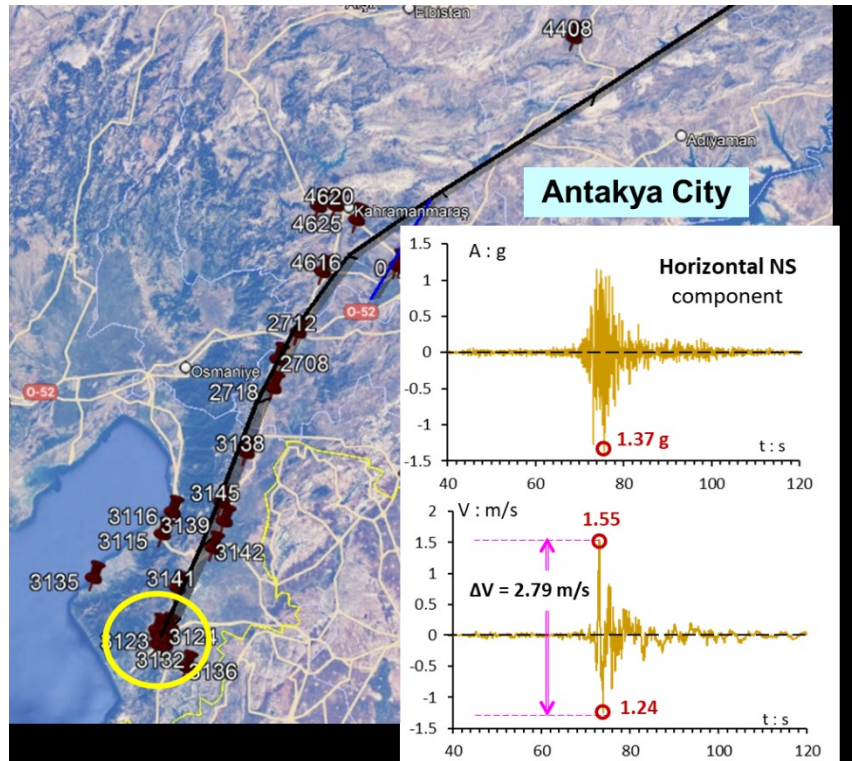
**Figure 2.13** Location of station 3129 in Antakya, along with the recording acceleration and velocity timehistories of the NS component during the  $M_w7.8$  Pazarcik earthquake.

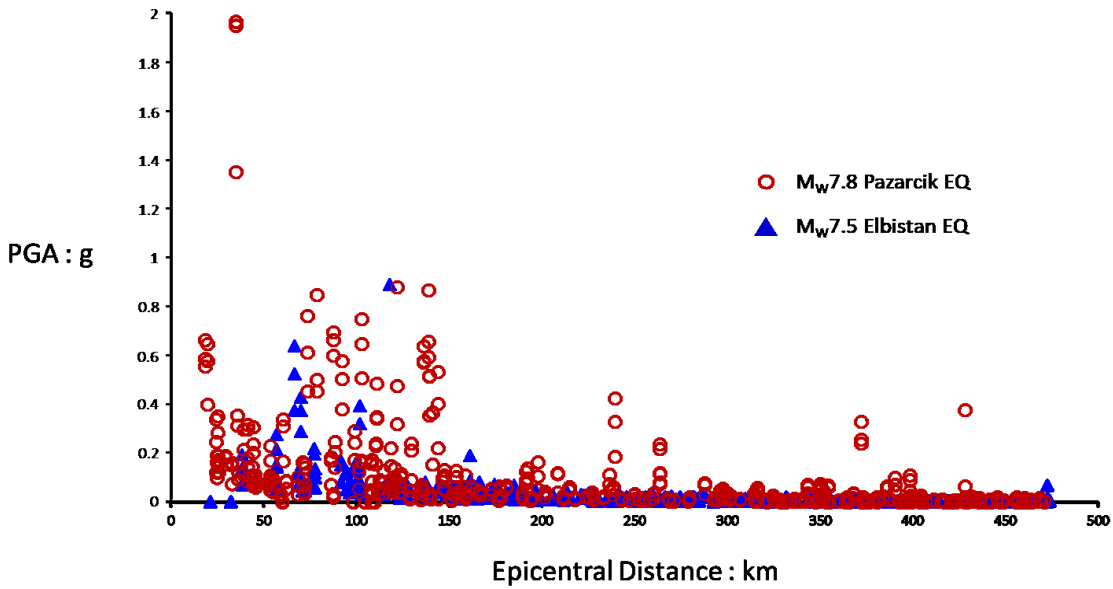
Figure 2.27 Comparison of the recorded PGAs between the  $M_w7.8$  Pazarcik (in red circles) and  $M_w7.5$  Elbistan (blue triangles) earthquakes.

All the recorded PGAs of the  $M_w7.5$  event are plotted in Figure 2.27 with respect to distance, along with the PGA's induced by the  $M_w7.8$  Pazarcik earthquake. Notice that the accelerations induced by the Pazarcik mainshock are by far greater than those by Elbistan. Table 2.2 also lists the peak acceleration values (in all three components) exceeding 0.20 g, of the AFAD stations in the Elbistan earthquake. Figures 2.28 and 2.29 illustrate in detail the recorded motions in Antakya stations 3123 and 3124, respectively. Obviously, the effect of this event was insignificant for the southwestern part of the East Anatolian Fault.

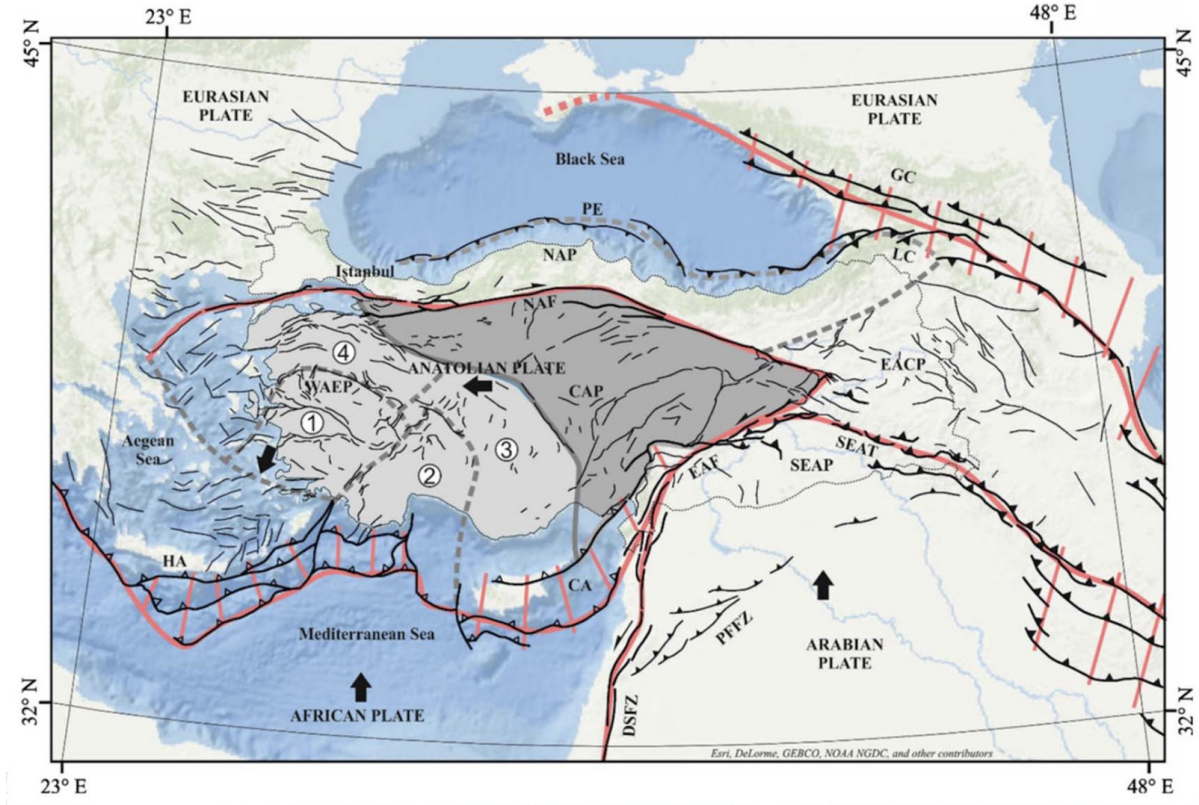
Figure 3.2 Geotectonic map of a wider area (Emre et al., 2018).

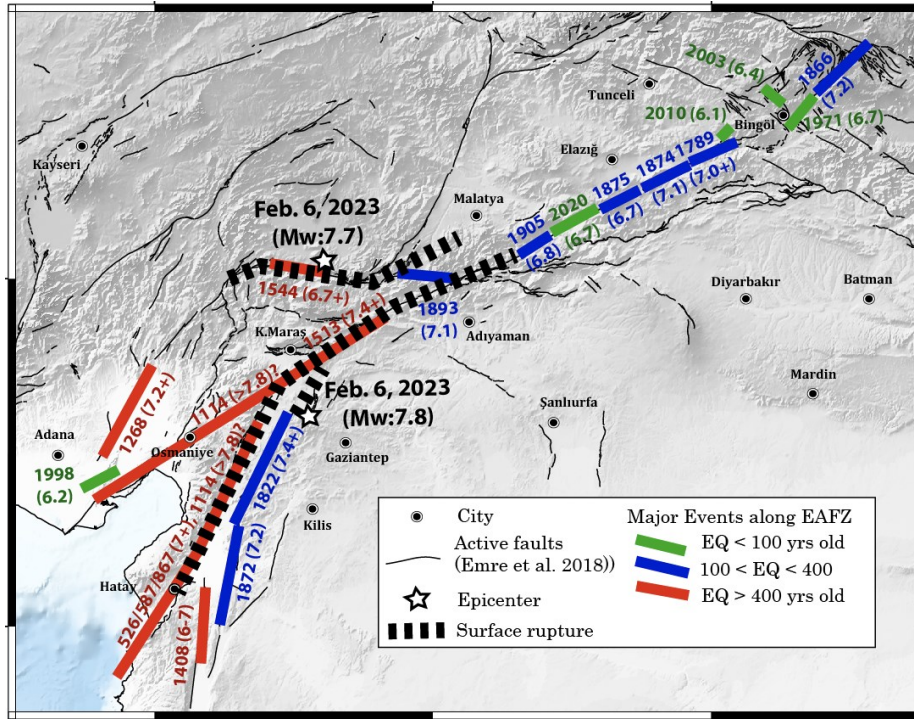
assessed by various institutes, with estimates ranging from 7.5 to 7.7. As for the Ekinözü earthquake, it affected the east-west trending Çardak and Sürgü faults, covering a total length of 120-130 km (Figure 3.4).

Figure 3.4 Total rupture length: Pazarcik Earthquake 400 km & Ekinözü Earthquake 160 km (Ozacar et al., 2023).

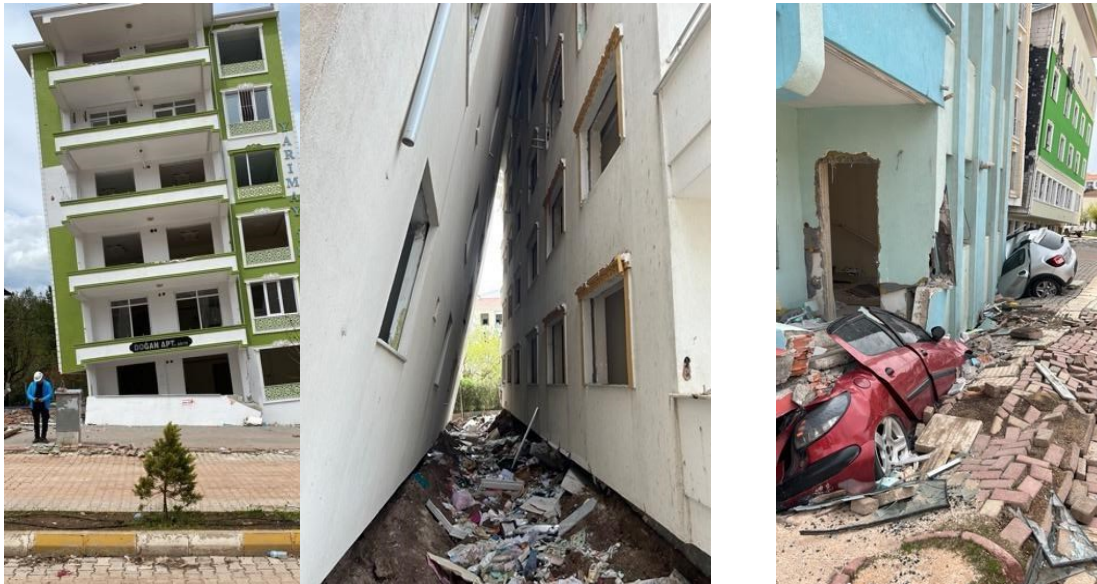
In Gulbasi, extended ground failures, as they are more detailed examined in the next paragraphs, were located around the recent lake and river deposits, in a basin formed by two faults. In “Maras”(Kahranmaras), the damages are extensive in very recent loose and soft sediments and reduced in the hilly areas of the consolidated alluvium soils or the bedrock (mainly limestone here). At the same time, a series of faults are located along the foot of the hills. Significant failures are also recorded in a wide zone along the fault in the Turkoglu area, where we also recorded up to 3,5m fault offset. Severe damages occurred in the town of Antakya, in the city center, where recent loose and soft Quaternary deposits are met, and there is a direct proximity to the fault. Here, we could not compare these damages to the hilly parts, where more compacted and sedimented materials of Neogene age are met. Similar observations were made in Adiyaman, where the city is built on recent soil alluvial formations and talus. Part of the fault extends to the outskirts of the city. In Iskenderun, there are numerous phenomena of liquefaction and large settlements that took place along the coastal deposits mainly composed of loose sandy deposits. The coastal zone at the time of our reconnaissance, was still flooded due to significant settlement. Finally, in Islayie, although there is proximity to the fault, the damages are more limited towards the extent of the city due to the outcrops of rocks (mainly basaltic).

**Figure 3.8** Zoning of extensive damage to buildings along and around recent lake and river deposits in a basin formed by two faults in the Gulbasi area.

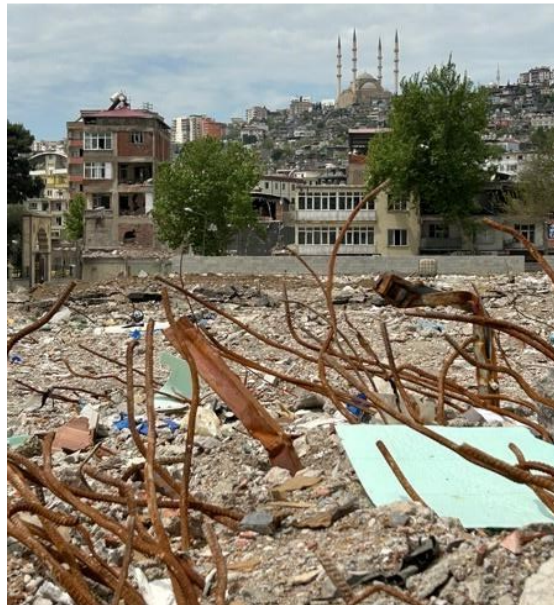
**Figure 3.10** The damages are extensive in very recent loose and soft sediments and reduced in the hilly areas of the consolidated alluvium-bedrock (mainly limestone here).

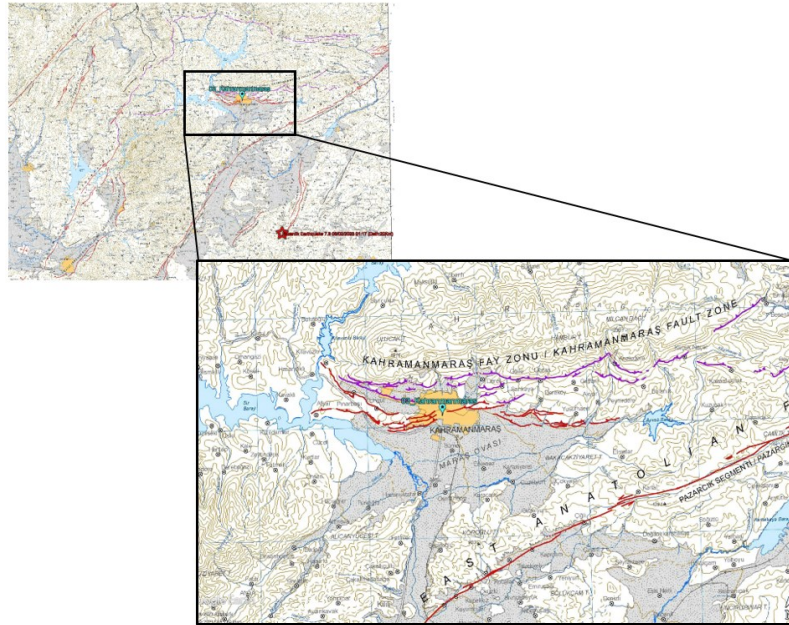
**Figure 3.11** Neotectonic conditions in Kahramanmaraş. The presence of the East Anatolian Fault is evident very close to the city, while a series of faults run parallel to the base of the cliff (Active fault map series of Turkey, Gaziantep (NJ 37-9), Quadrangle, serial No: 38, scale 1:250.000, General Directorate of Mineral Research and Exploration).

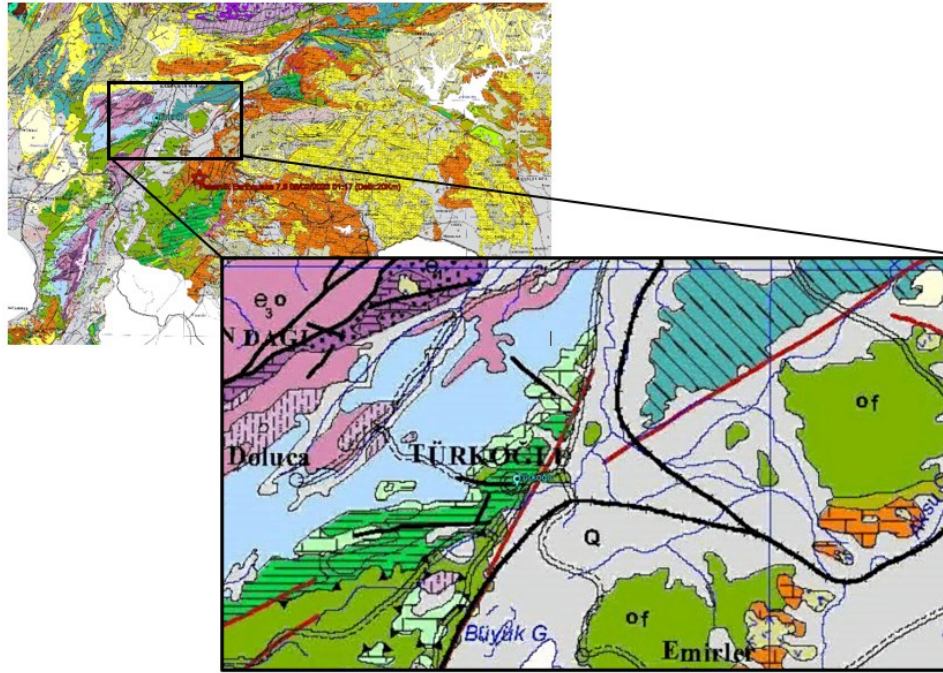
**Figure 3.12** Geological conditions in Turkoglu. The fault extends over the area which presents extensive damage (Geological maps of Turkey No16, Hatay sheet, scale 1:500.000, Editor: M. Senel & Technical assistant: N. Aydal).

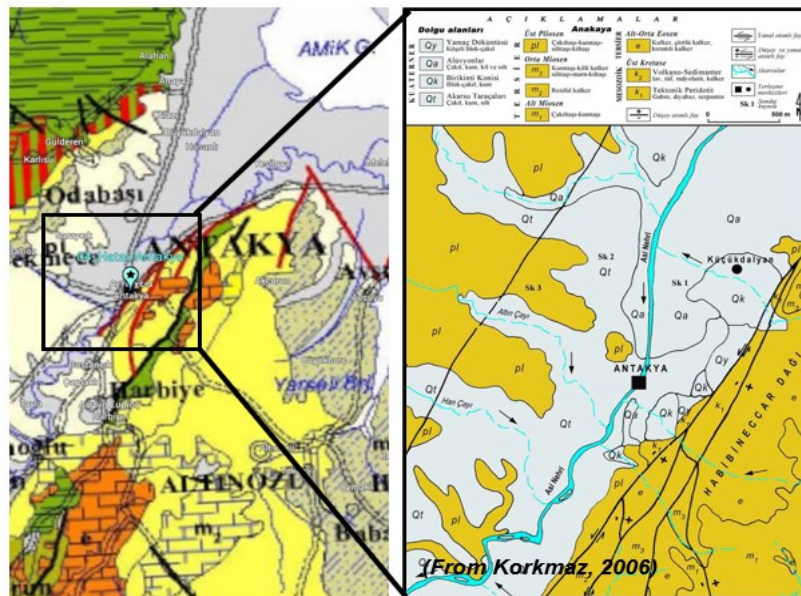
**Figure 3.14** The damages are extensive in the city center where recent Quaternary deposits are extended (Geological maps of Turkey No16, Hatay sheet, scale 1:500.000, Editor: M. Senel & Technical assistant: N. Aydal).

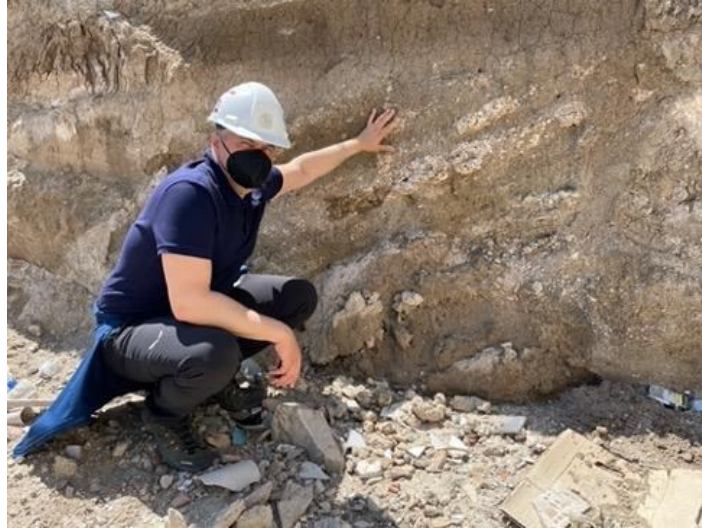
**Figure 3.15** Quaternary deposits are extended. Direct proximity to the fault.

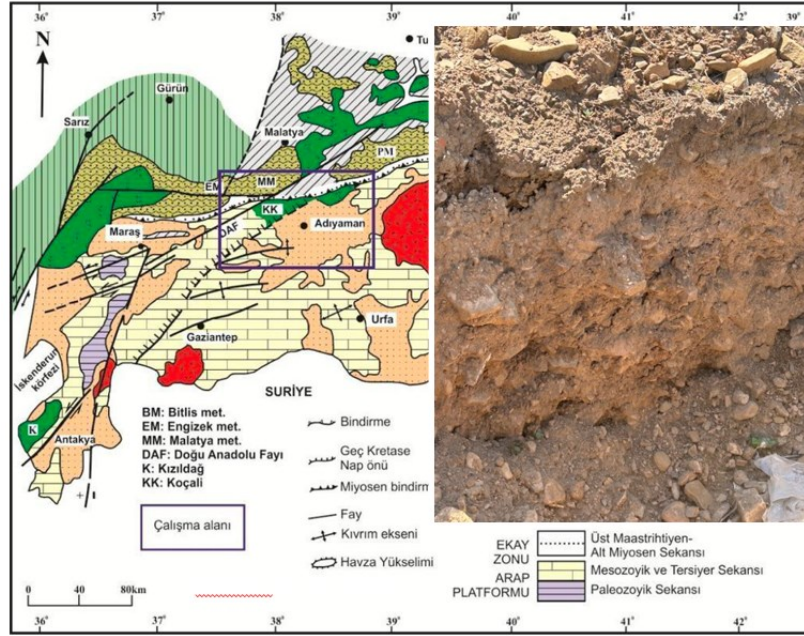
**Figure 3.17** The Adiyaman is built on recent soil alluvial formations and talus. Part of the fault extends to the outskirts of the city (Geological maps of Turkey No16, Hatay sheet, scale 1:500.000, Editor: M. Senel & Technical Assistant: N. Aydal).

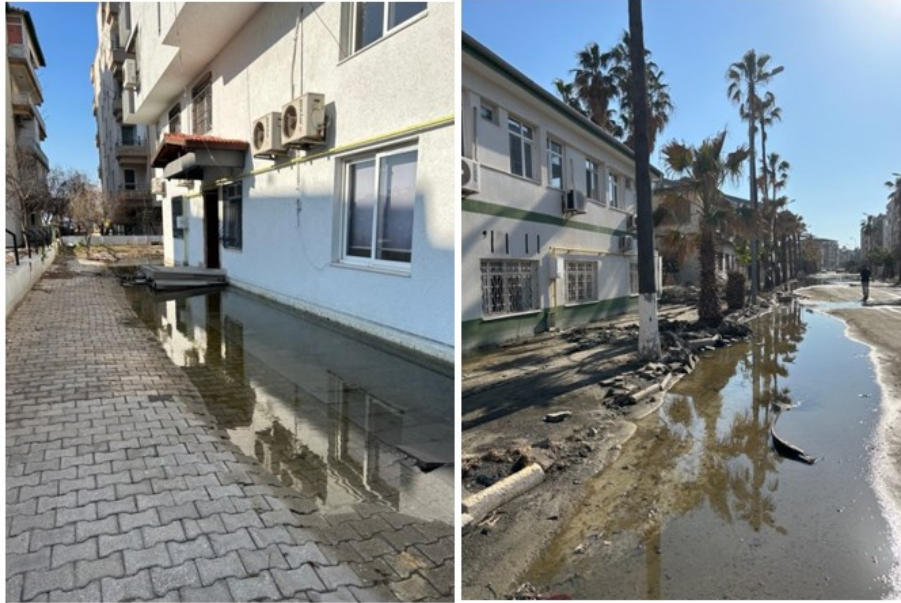
**Figure 3.19** Coastal deposits from mainly composed of loose sandy deposits. The coastal zone is still flooded due to significant settlement and liquefaction phenomena.

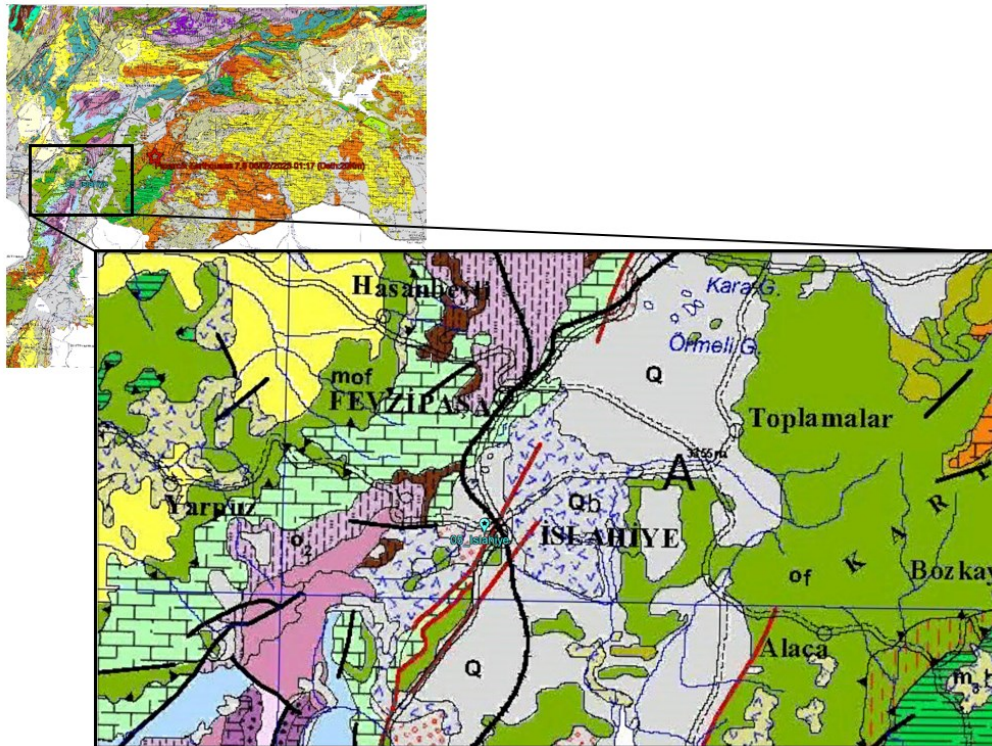
**Figure 3.20** Geological conditions in Islayie. Although there is proximity to the fault, the damages here are more limited in extent of the city that are significantly built on rock foundations (mainly basalts) Geological maps of Turkey No16, Hatay sheet, scale 1:500.000, Editor: M. Senel & Technical Assistant: N. Aydal).

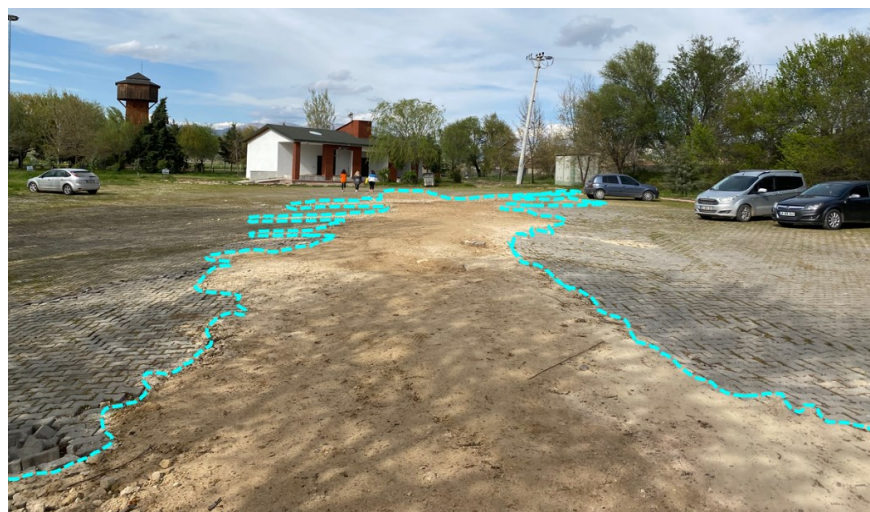
**Figure 3.23** Soil ejecta at the surface, as evidence of seismic liquefaction, occurred in Gölbaşı (37.798553N, 37.662833E).

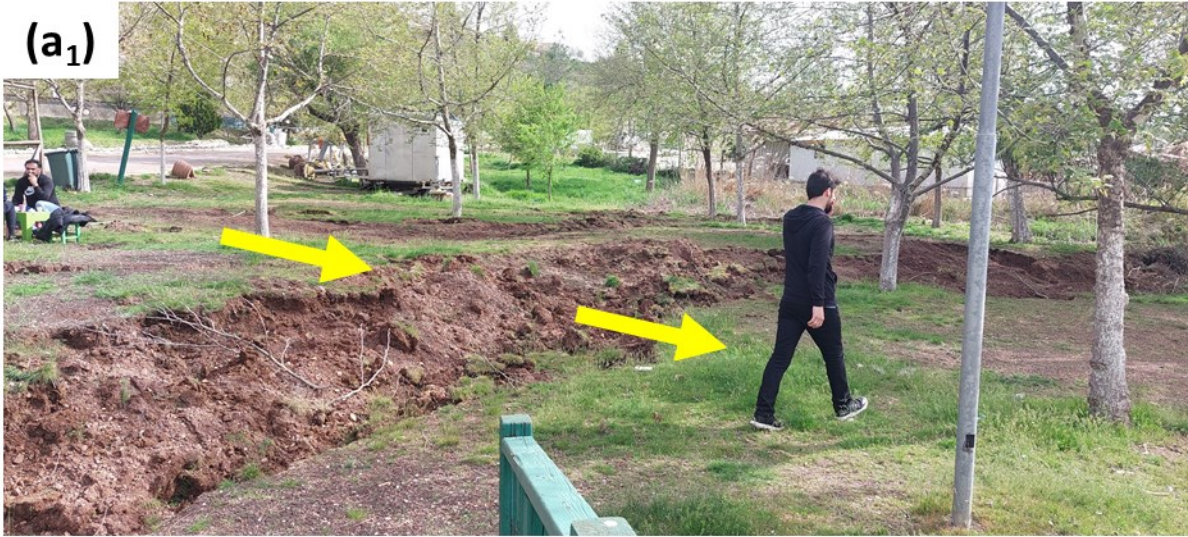
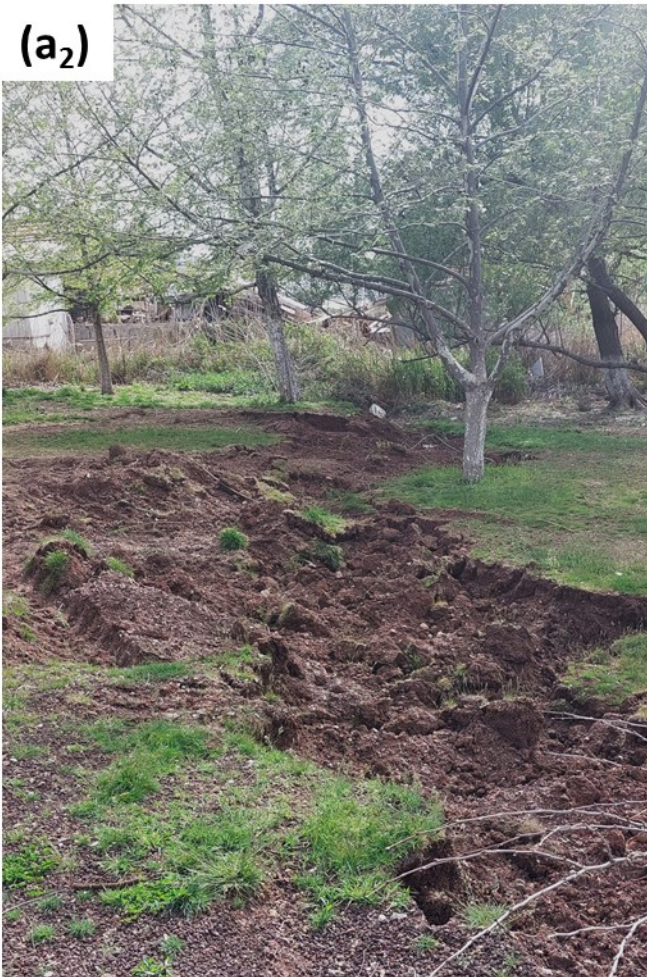
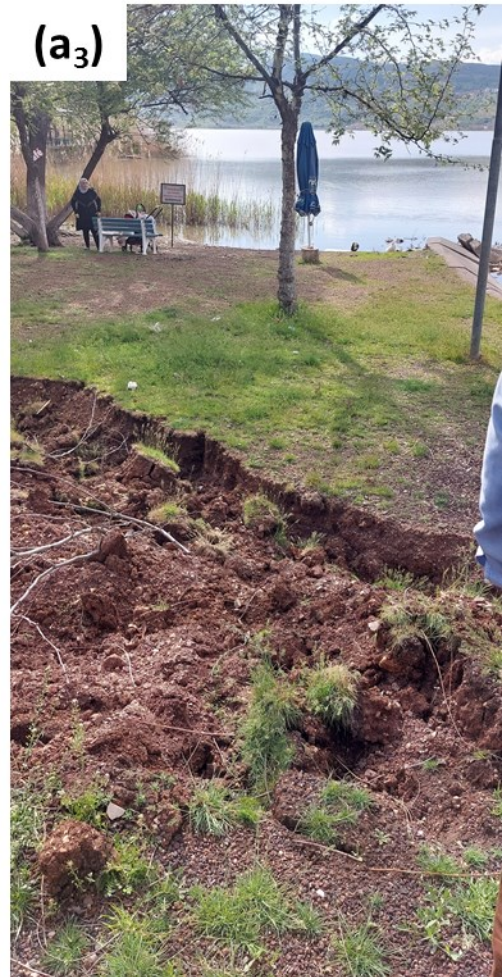
Figure 3.22 to Figure 3.27 depict soil liquefaction in Antakya and Gölbaşı and lateral spreading at Gölbaşı whereabouts. When liquefaction occurs close to waterfronts, usually lateral spreading is caused: the liquefied soil, unable to resist any shear excitation, is deformed laterally, creeping along any stiffer layer sitting above it. This process opens cracks running parallel to the waterway (Youd 1993).

**Figure 3.26** (a<sub>1</sub>)-(a<sub>3</sub>): Cracks induced by the soil's lateral movement towards the Lake Gölbaşı waterfront (37.798226N, 37.662083E)

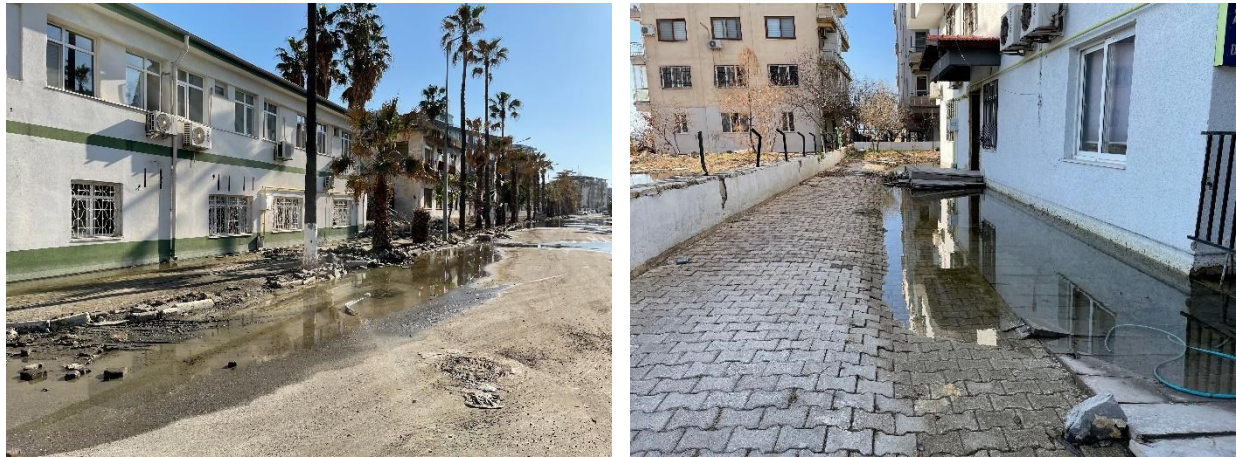
Extensive liquefaction and soil subsidence were witnessed in the port area at Iskenderun, close to the waterfront. During our visit, water was still present on the roads and pavements behind the quay wall, but there is no clear explanation why (Figure 3.28).

**Figure 3.28** Building and pavement subsidence close to the Iskenderun port (a) (36.590425N, 36.179943E) and (b) (36.590425N, 36.179943E)

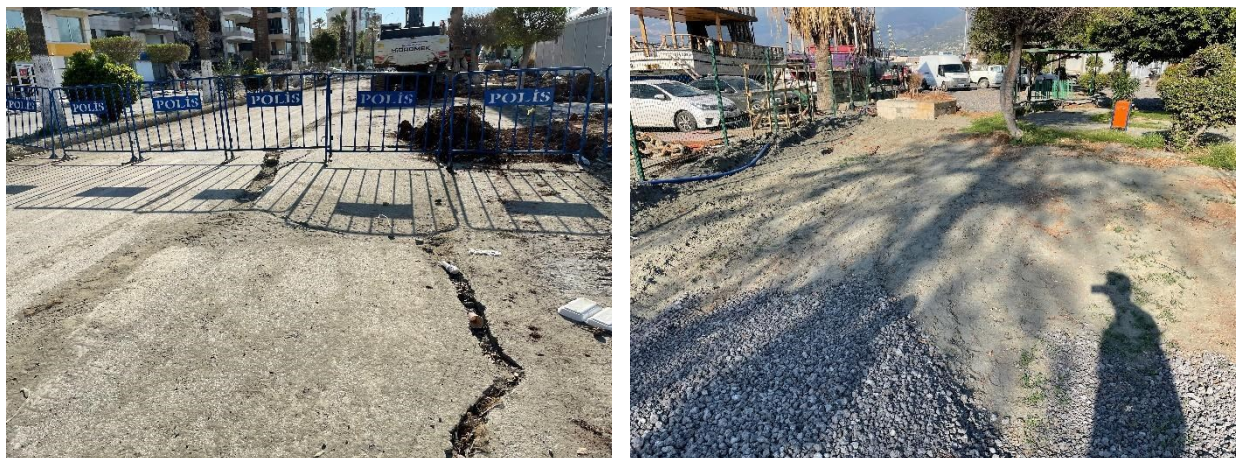
Cracking of the road pavement and clayey soil ejecta were also witnessed at a distance of less than 80m from the waterfront (Figure 3.29), because of soil liquefaction and lateral spreading toward the coast (to the north)

**Figure 3.29** (a) Cracks on the road pavement (36.591096N, 36.176768E) and (b) soil ejecta (36.591051N, 36.176851E) because of lateral spreading and soil liquefaction

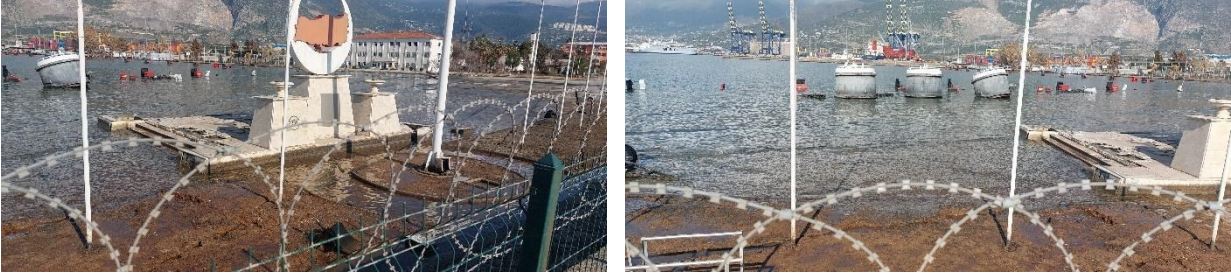
The quay wall at the port of Iskenderun was submerged because of lateral spreading and liquefaction (Figure 3.30).

**Figure 3.30** Permanent subsidence and tilt of the quay wall at the port of Iskenderun (36.593440N, 36.180389E)

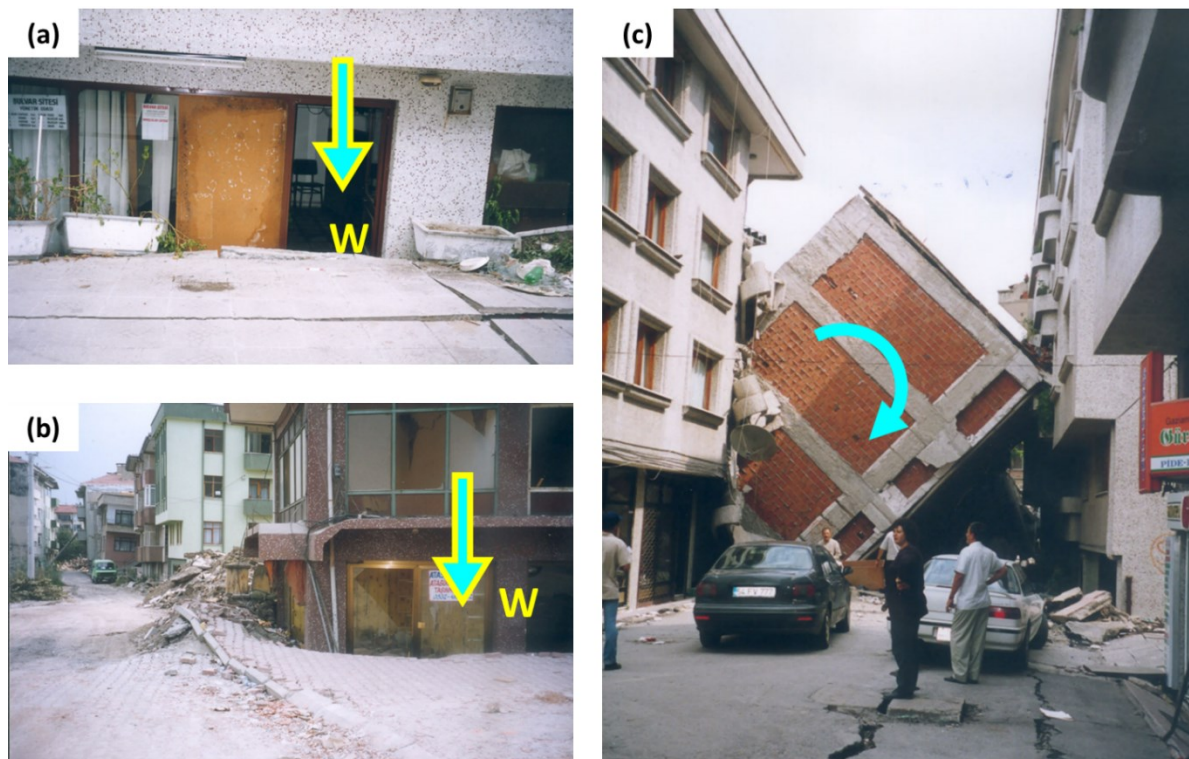
**Figure 3.31** Cases from 1999 Adapazari earthquake: (a), (b) seismic subsidence of buildings induced under their static load (their own weight), due to soil liquefaction of an underneath soil layer; (c) toppled of a structure undergone rocking oscillation.

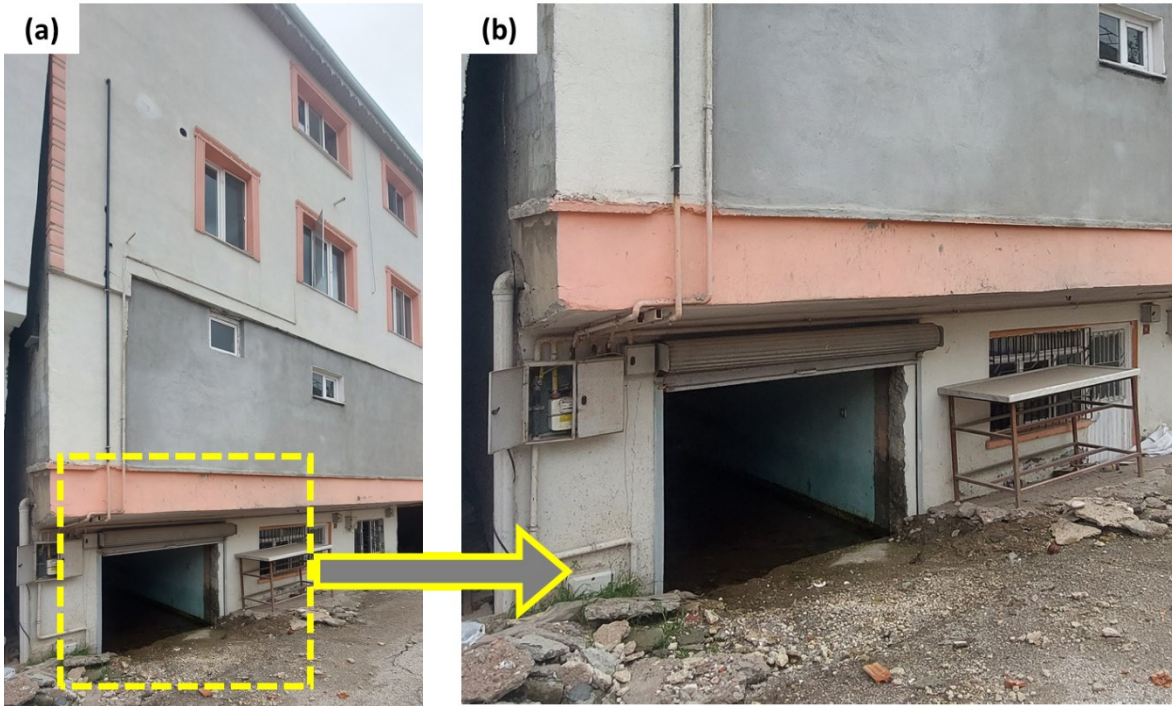
Figure 3.33 (a)-(b): Permanent settlement of a 4-story building in Gölbaşı (37.790248N, 37.650917E)

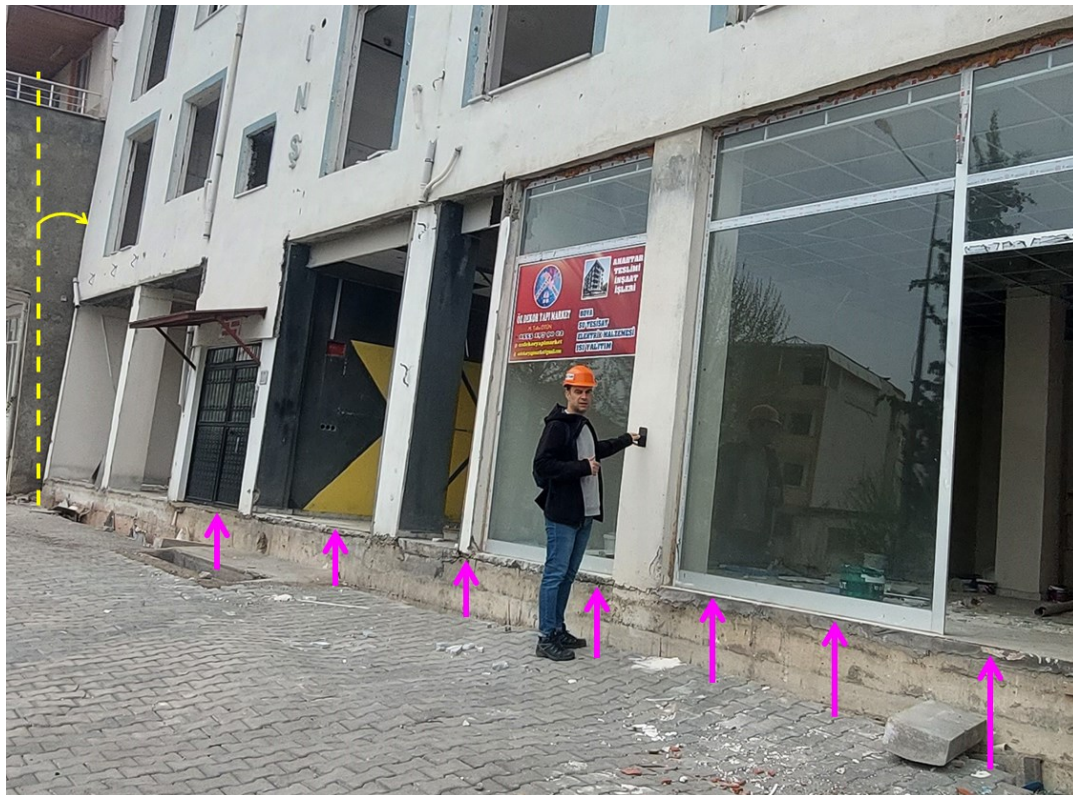
Figure 3.34 RC building with permanent tilting. Uplifting displacements in the façade (37.790129N, 37.651630E)
