NATIONAL  
TECHNICAL  
UNIVERSITY  
OF ATHENS

# The February 6<sup>th</sup> Kahramanmaraş earthquake sequence in Türkiye

*Technical Report*

Aristidis Papachristidis, Anastasios Sextos

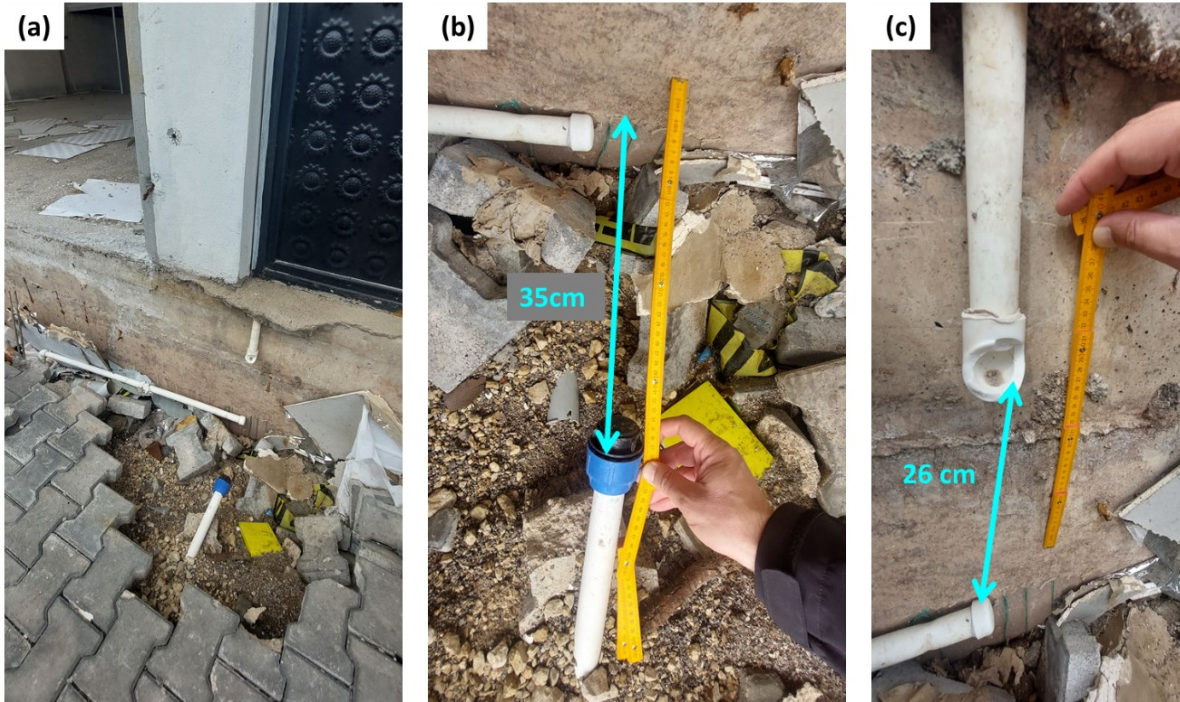
**Figure 3.35** (a): Dislodged joint due to permanent uplifting; (b) and (c): measured horizontal and vertical displacement of the joint (37.790129N, 37.651630E)

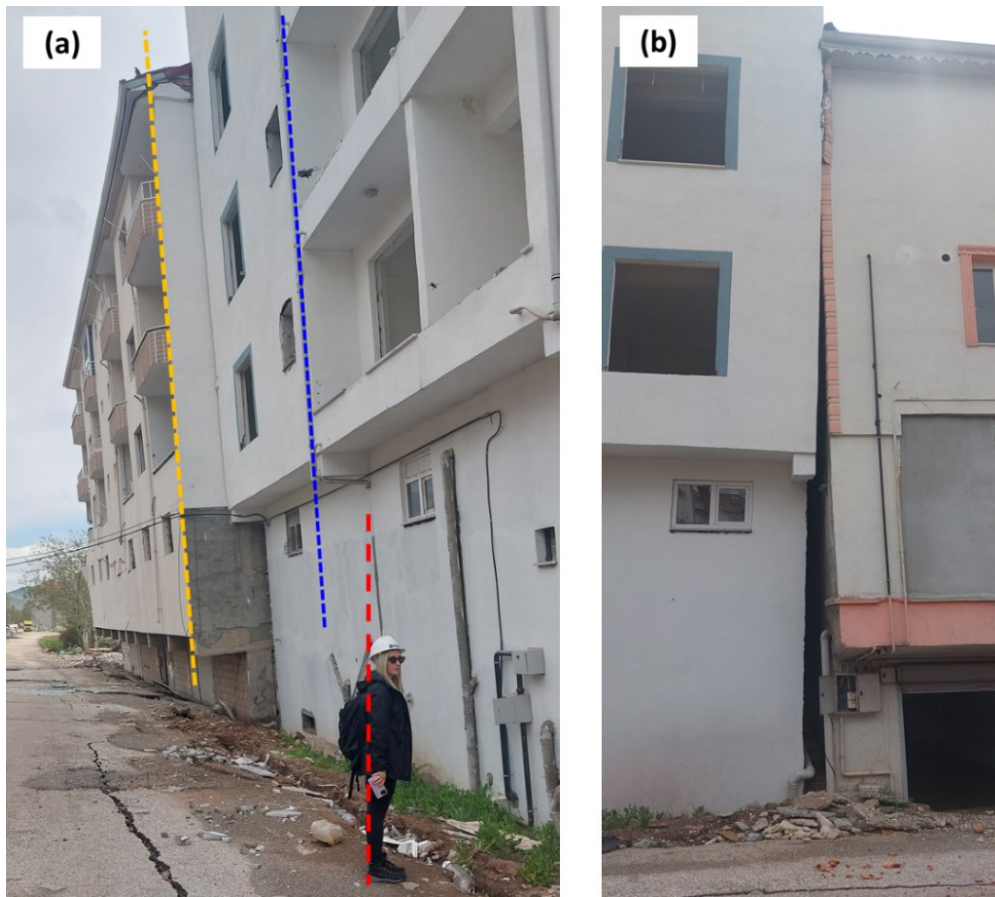
**Figure 3.36** Tilted residential buildings in Gölbaşı (37.790134N, 37.650747E)

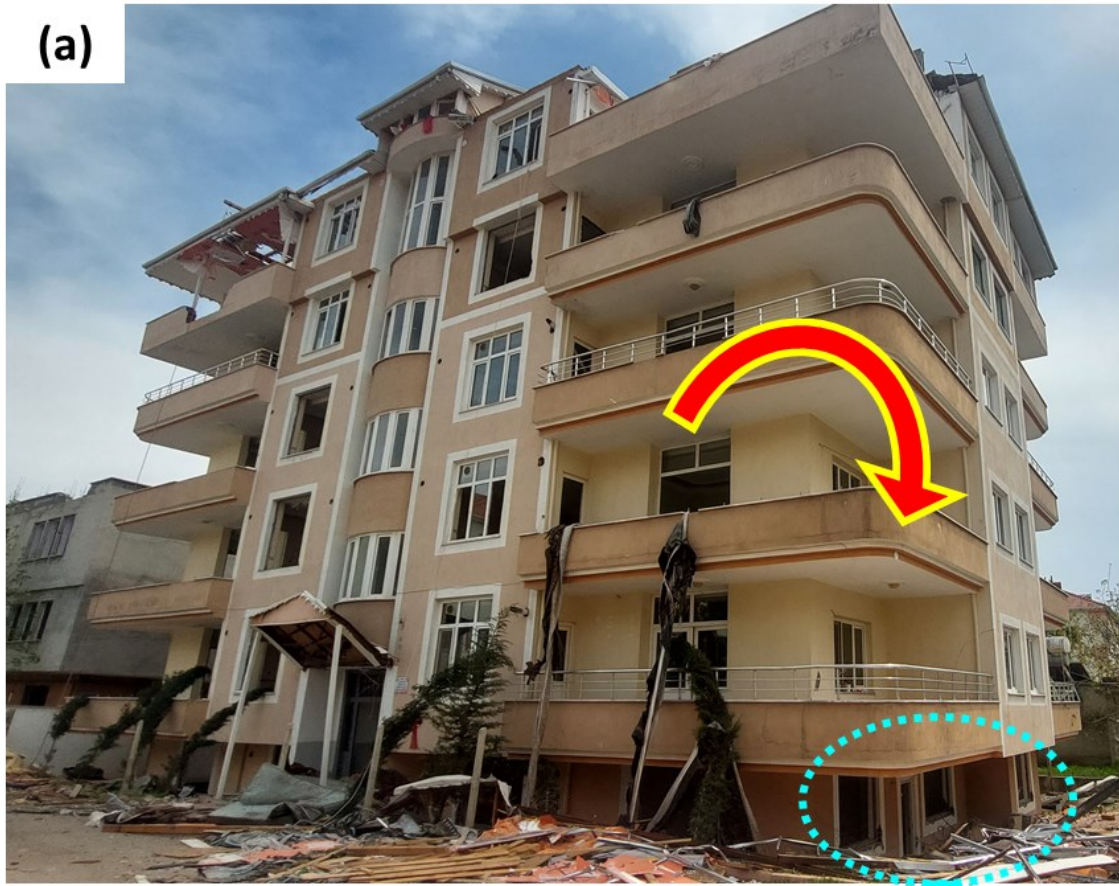
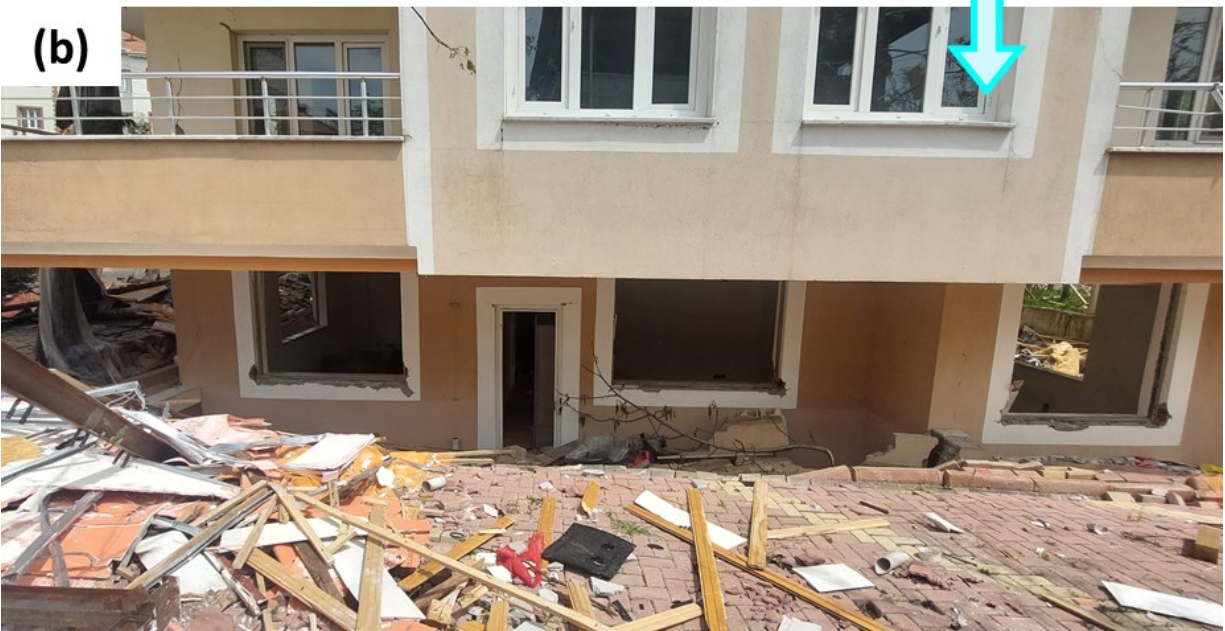
Figure 3.37 (a) Complete and (b) detailed view of a rotated 6-story RC building (37.787913N, 37.646741E)

The cases above of tilted buildings could be modeled as slender blocks on deformable soil excited by earthquake ground motion. A possible mechanism of such behavior is sketched in Figure 3.38 d (see Gazetas 2015, 2019). Cases of severe tilting and overturning are shown in Figure 3.38 to Figure 3.43.

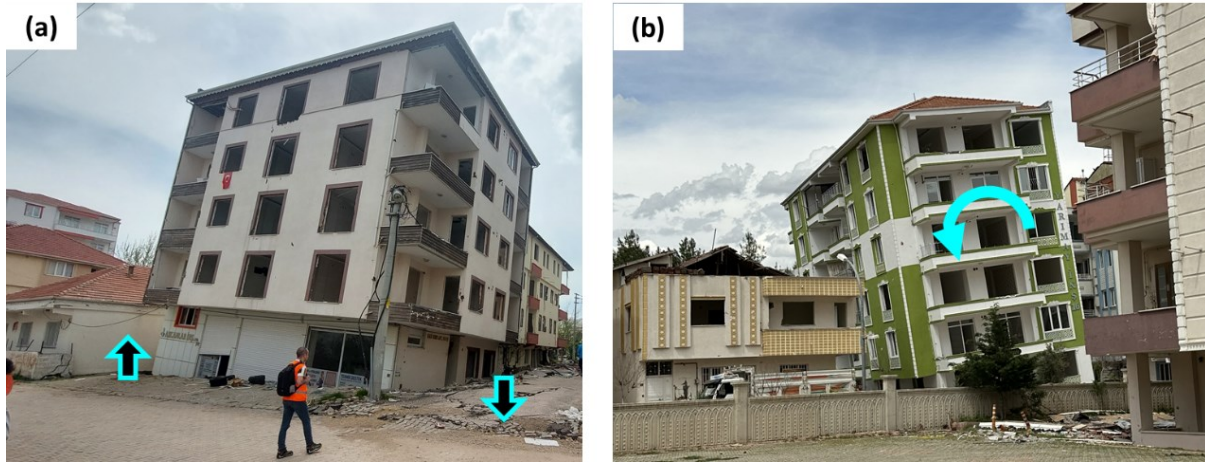
Figure 3.41 Characteristic cases of buildings with permanent rotation in Gölbaşı.

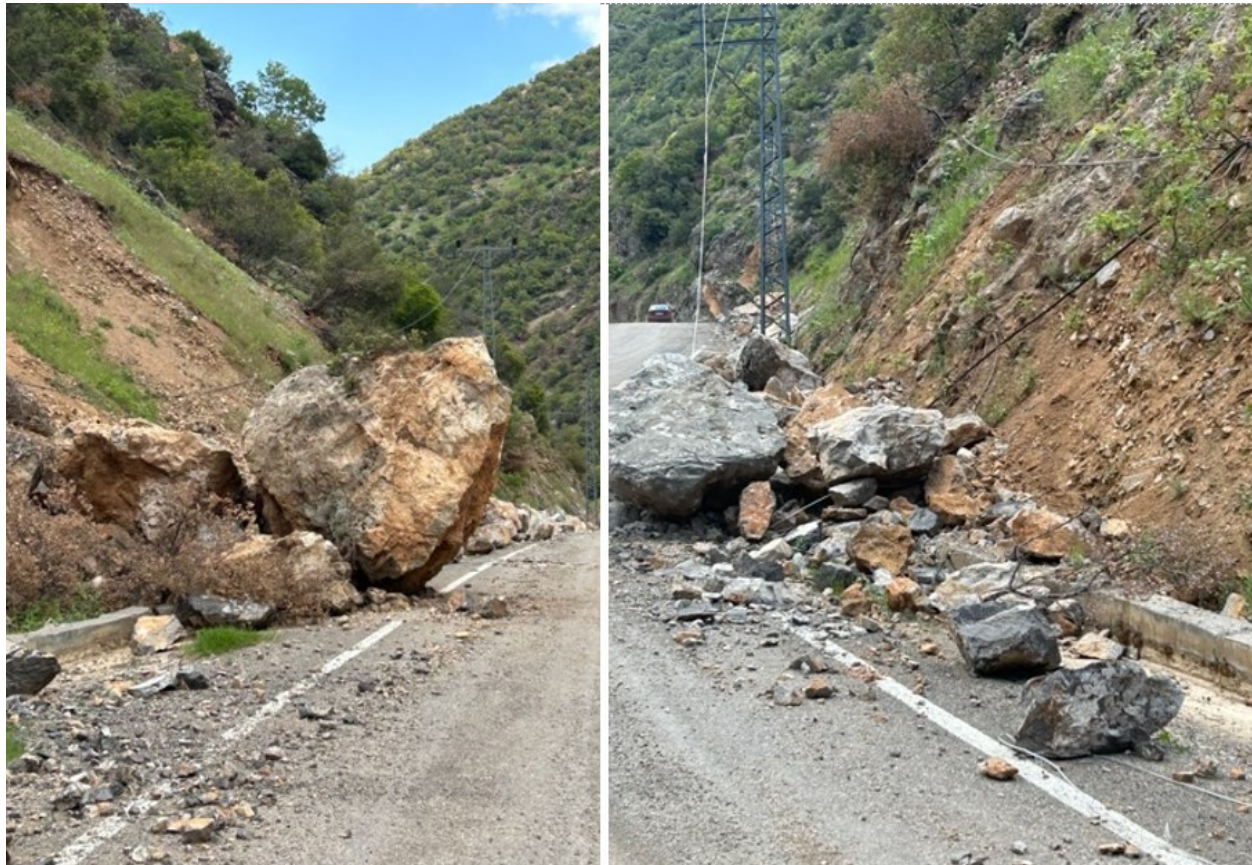
The predominant coseismic slope instabilities in the area affected by the earthquake are rock falls. Individual blocks reached sizes of 6-7m<sup>3</sup> in certain regions, of limestone nature mainly. Such rock-block falls were identified during our reconnaissance close to Islayie town in limestone steep terrain (Figure 3.47).

**Figure 3.47** Rockfall incidents in the Islayie region in limestone steep terrain close to Islahiyi area. Blocks reached up to sizes of 6-7m<sup>3</sup>.

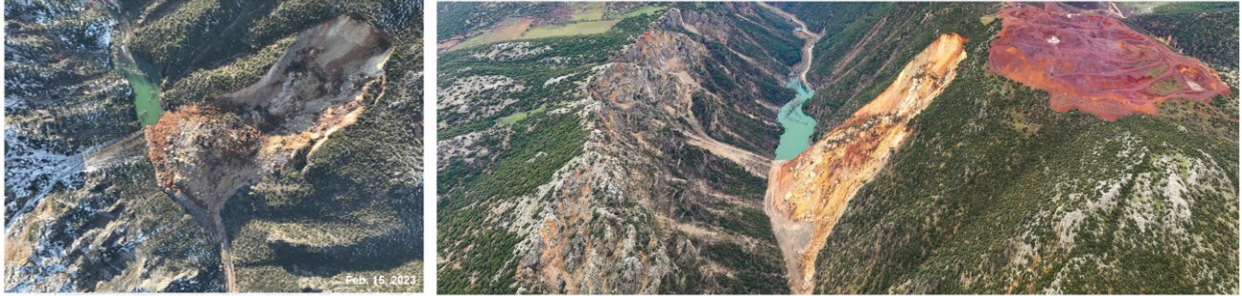
Bedrock rotational slides are common in the study area, especially in the north. They were mainly triggered within pre-existing landslides and on areas, where the rock mass is heavily fractured. A deep-seated landslide was identified in Islahiye region, where millions of m<sup>3</sup> have slid and blocked the river creating a dam behind the fallen mass (Figure 3.48). The rock mass is highly karstified and brecciated with a high presence of clayey infilling material around rock fragments and along fractured certain sub-vertical zones (Figure 3.49).

**Figure 3.48** A deep-seated landslide was identified in the Islahiye region, where millions of m<sup>3</sup> have slid and blocked the river creating a dam behind the fallen mass.

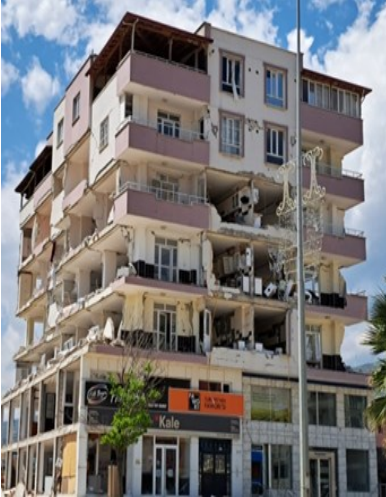
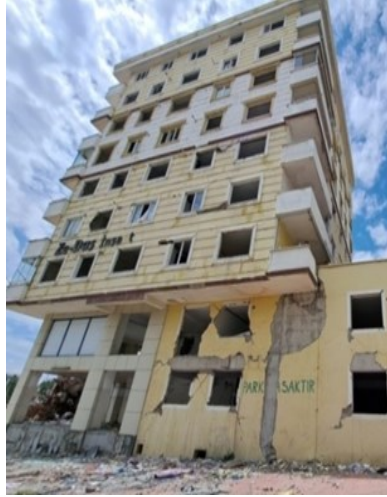
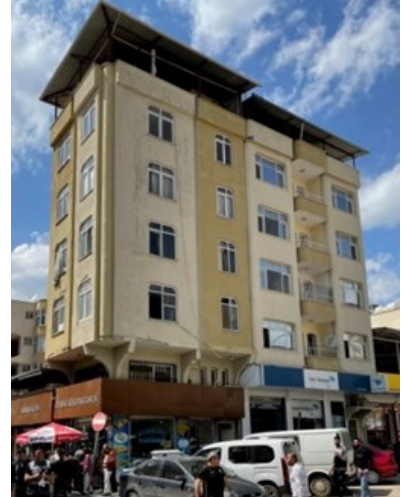
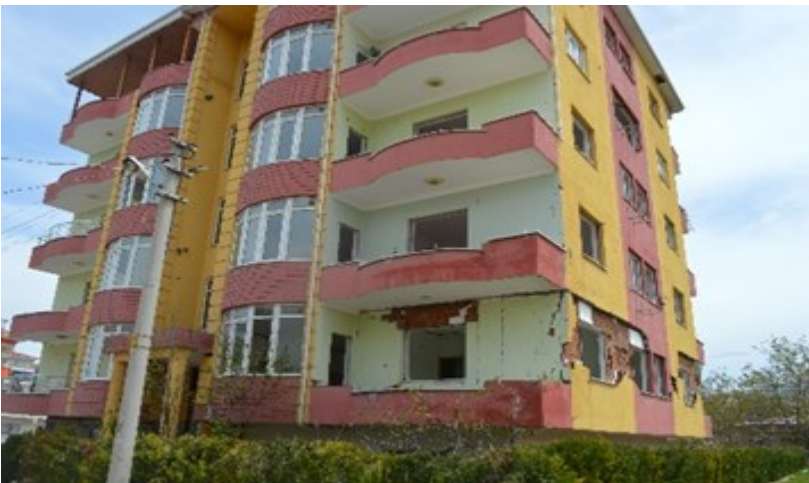
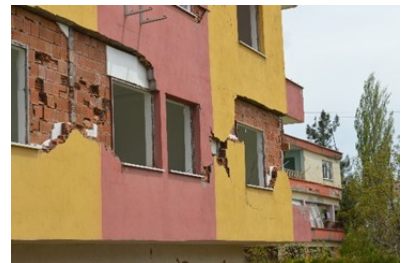
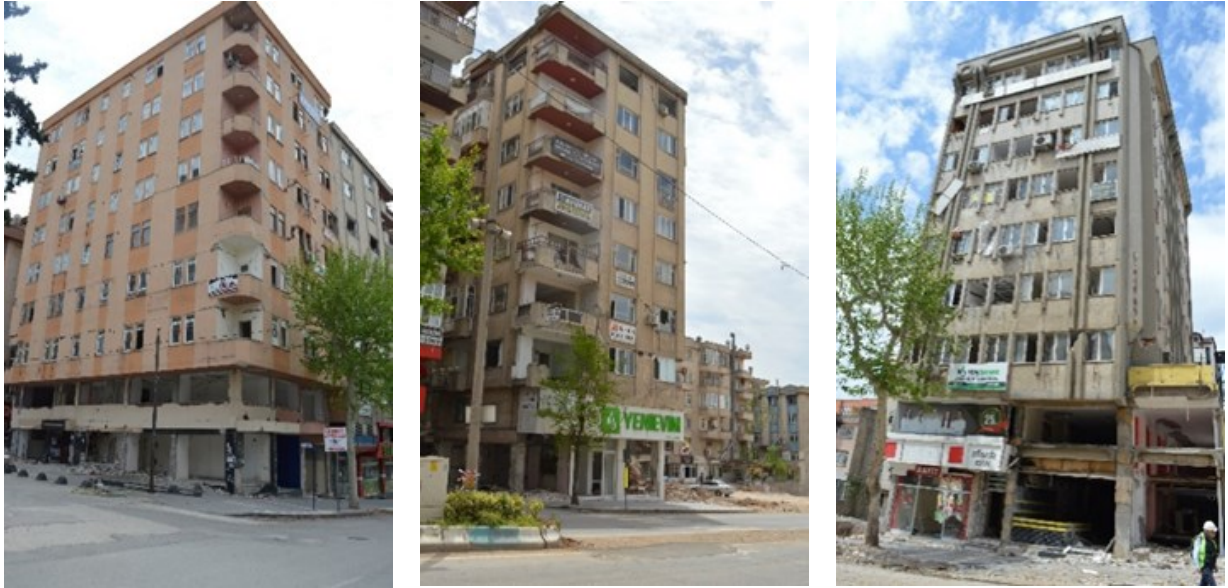
**Figure 5.1.1** Typical reinforced concrete buildings in the areas visited, indicating the façade damage in the continuous şahnış, with inadequate infill wall confinement (Adiyaman).

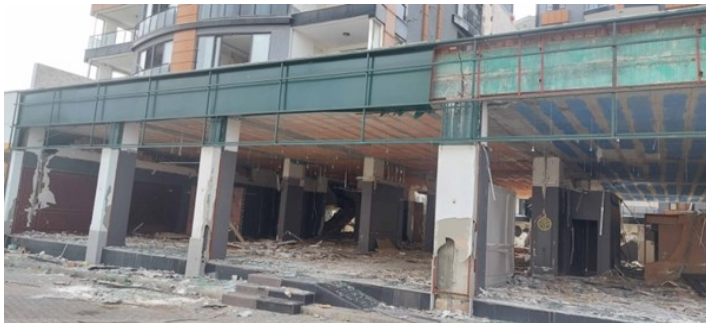
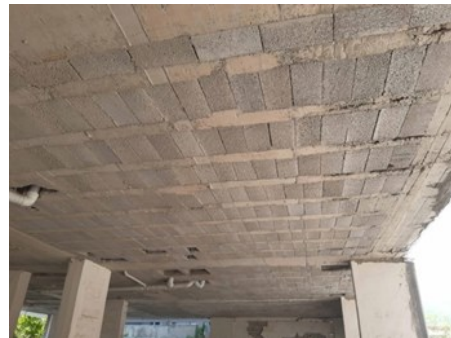
Frame and frame/wall systems were the prevalent structural type, with wall frame structures being more common in recent construction (see tunnel forms above). Only occasional RC shear walls were observed, especially in buildings constructed later than 2010. Furthermore, in many framed buildings, the use of filler-joint (asmolen) floor system was adopted, often without the

**Figure 5.1.2** Building with filler-joist (asmolen) floor system (Adiyaman) with filler blocks.

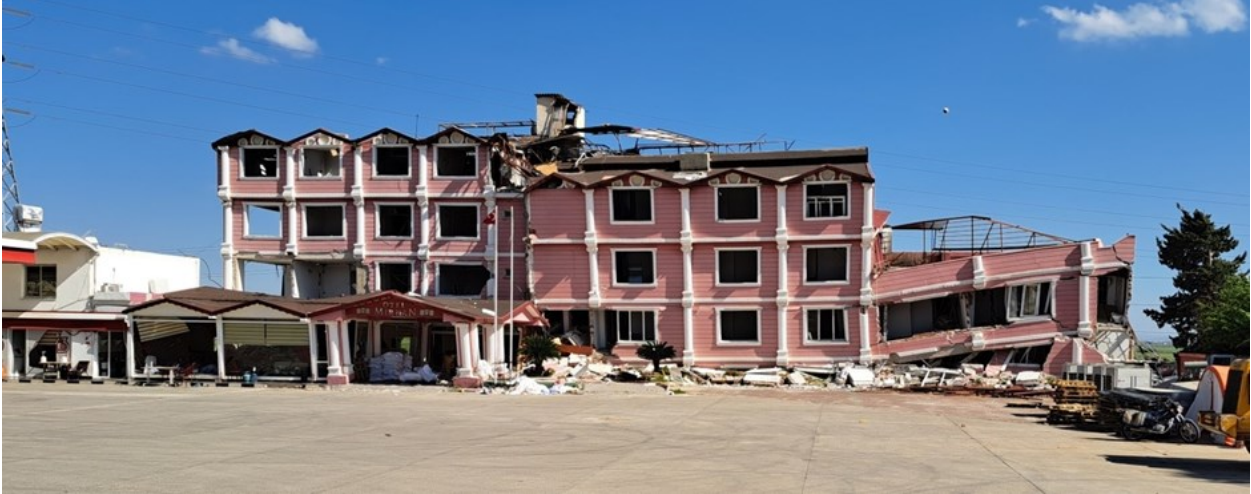
Buildings with inadequate lateral stiffness appear to have been more damaged as compared to similar stiffer buildings. Figure 5.1.3 depicts a commercial / hotel building in Belen-Hatay, near the fault line, in which the ground soft story collapsed.

**Figure 5.1.3** Collapse of soft ground story (Belen-Hatay). Photo: M.Moretti.

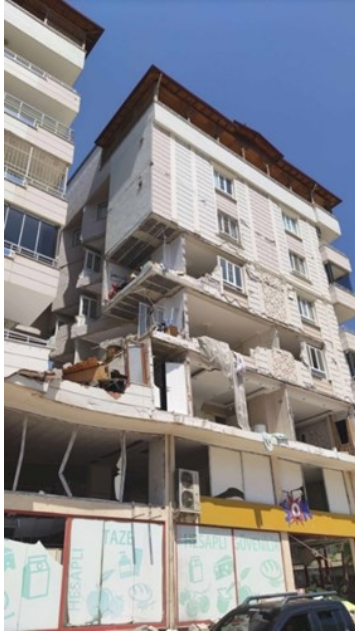
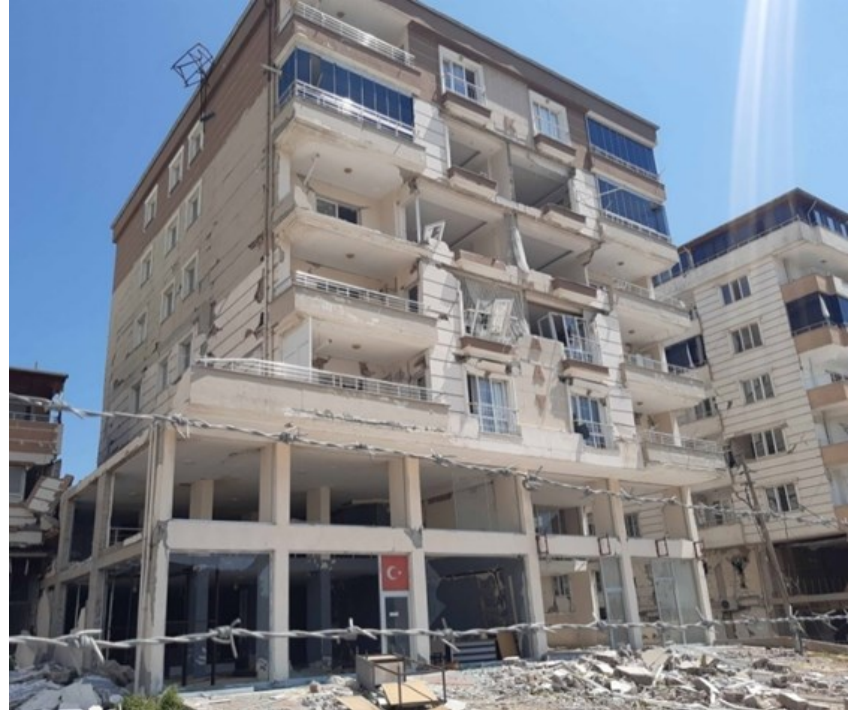
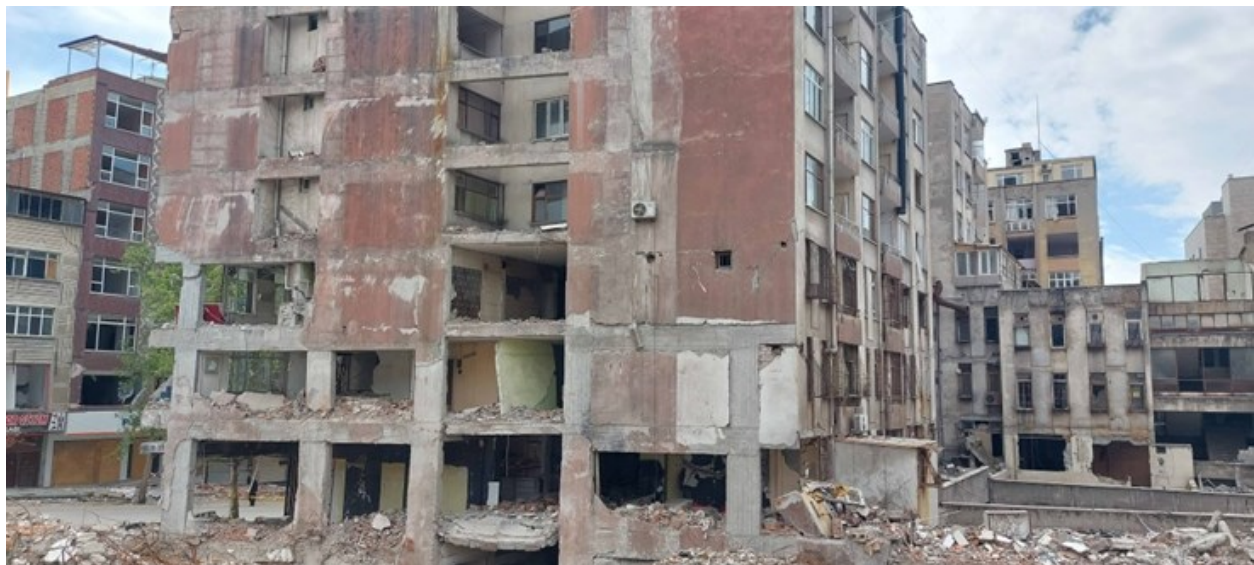
As a rule, less damage was observed in buildings with stiffer vertical structural elements. Buildings using a frame system with irregularity, especially in-height, proved to be more vulnerable, as shown in Figure 5.1.5. The building displayed in Figure 5.1.6 in Nurdagi, with large cross-section columns and several shear walls, despite the moderate irregularity in-height,

**Figure 5.1.5** Irregularities in-height in frame systems proved to increase structural vulnerability.

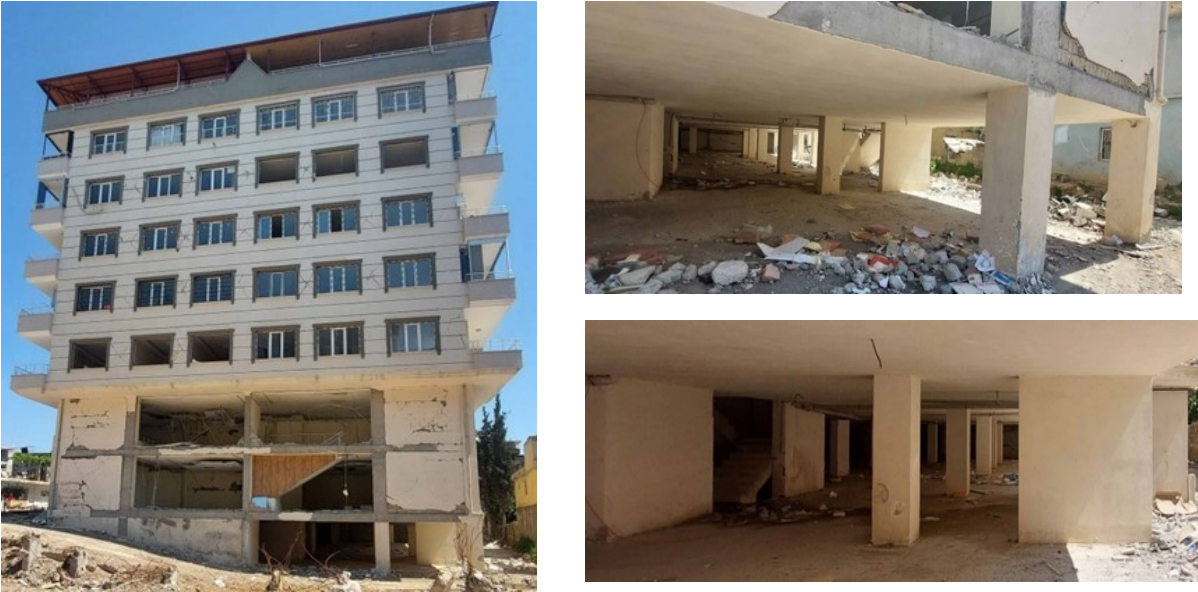
suffered damage only in the infills of the lower stories. Incomplete wedge of the outer walls has resulted to the loss of their out-of-plane stability, leading to the reduction of the whole structures' earthquake resistant capacity.

**Figure 5.1.6** Buildings with increased structural stiffness showed good to excellent overall seismic performance.

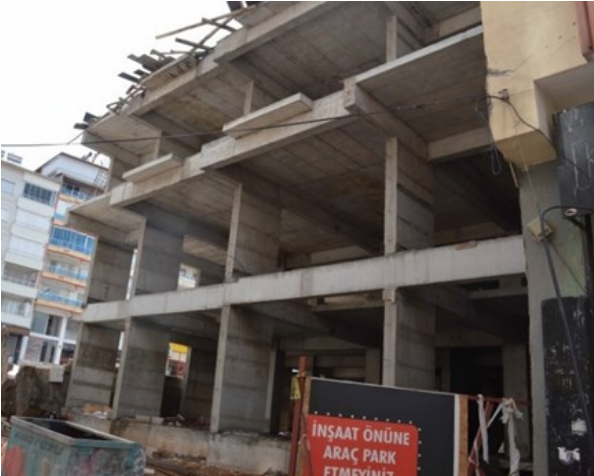
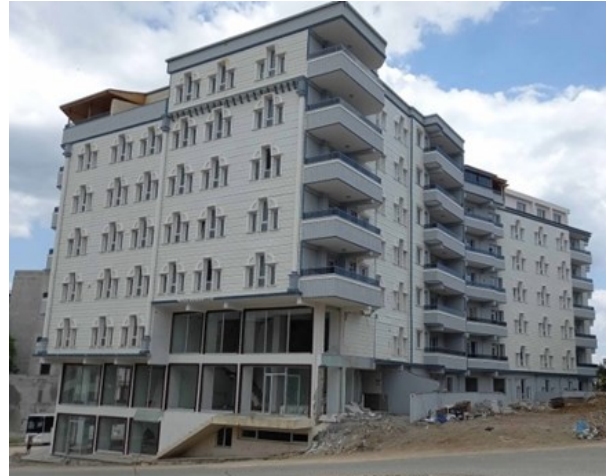
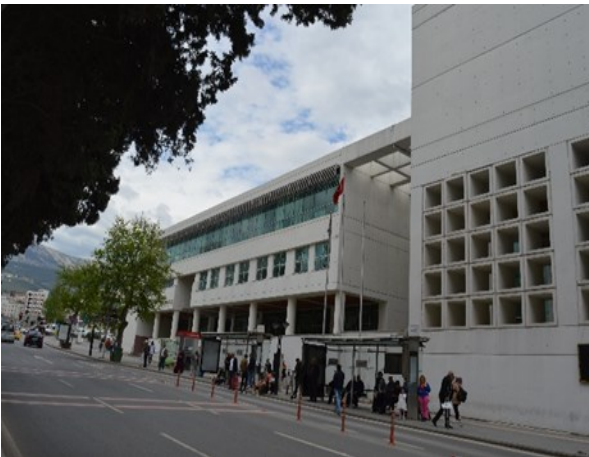
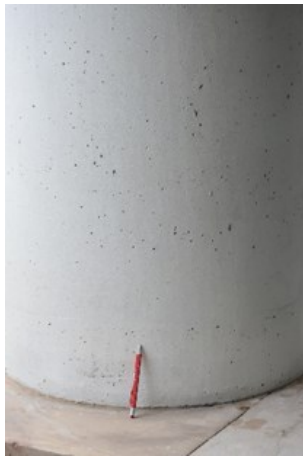
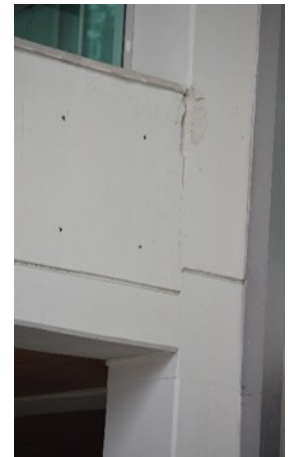
Similarly, the Kahramanmaraş Town Hall, a highly irregular in plan and in elevation RC structure, with large column sections, extensive shear wall elements and of well executed construction quality, suffered only minor damage (hairline flexural cracks at the base and minor joint movement) despite its proximity to the causative fault.

**Figure 5.1.7** Buildings with RC shear walls with no apparent structural damage.

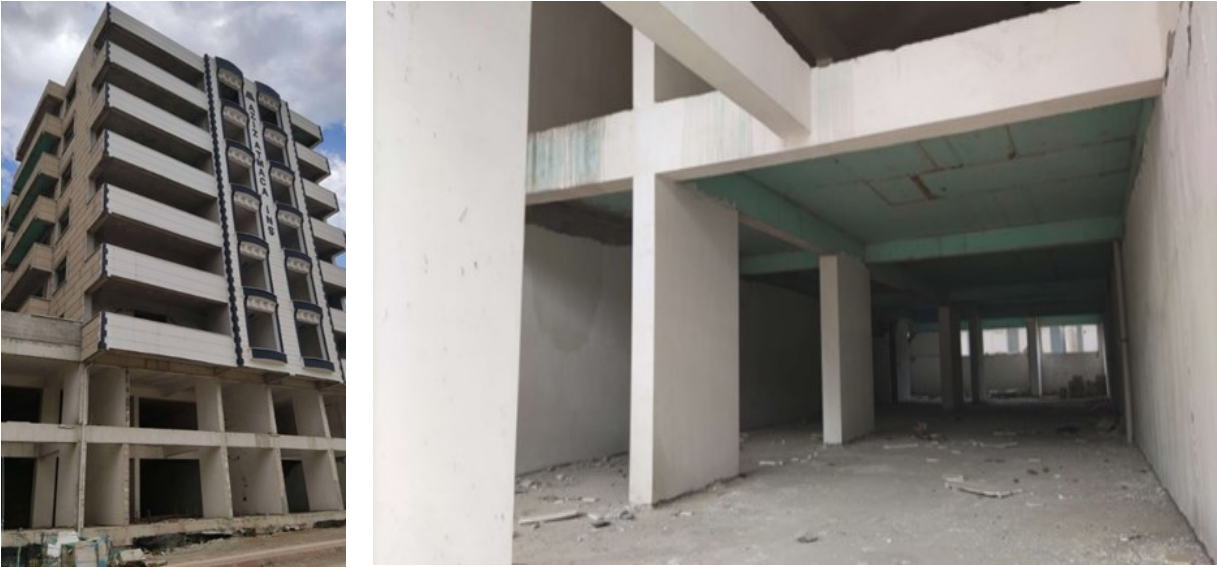
Buildings with more RC shear walls had a better seismic performance and resulted in reduced damage even in respect to the infill walls, as may be observed in Figures 5.1.7 and 5.1.8. It is noted that the building in Islahiye displayed in Figure 5.1.9, which was constructed later than 08/2020 (according to Google Earth), did not show any apparent damage, while many buildings in the close vicinity collapsed or were seriously damaged.

**Figure 5.1.8** Building with RC shear walls in Islahiye with no apparent structural damage (constructed later than 08/2020 (source Google Earth) close to seriously damaged buildings. Photo: A.Papachristidis.

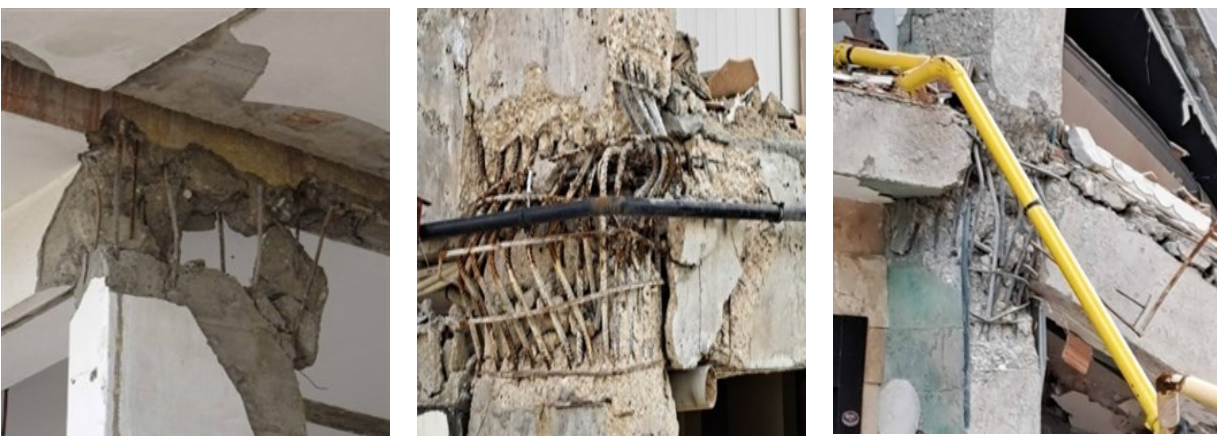
In RC structural elements, damage was observed mainly in the vertical elements, both columns and shear walls, and also in frame joints caused by inappropriate detailing of the shear reinforcement. Sparsely spaced and/or not well closed stirrups resulted in concrete crushing and buckling of the longitudinal reinforcement. Figures 5.1.8 and 5.1.10 display such failures of joints, and columns, respectively.

**Figure 5.1.9** Damage in joints of RC frames because of sparsely spaced stirrups and opening of ties, followed by buckling of the longitudinal reinforcement.

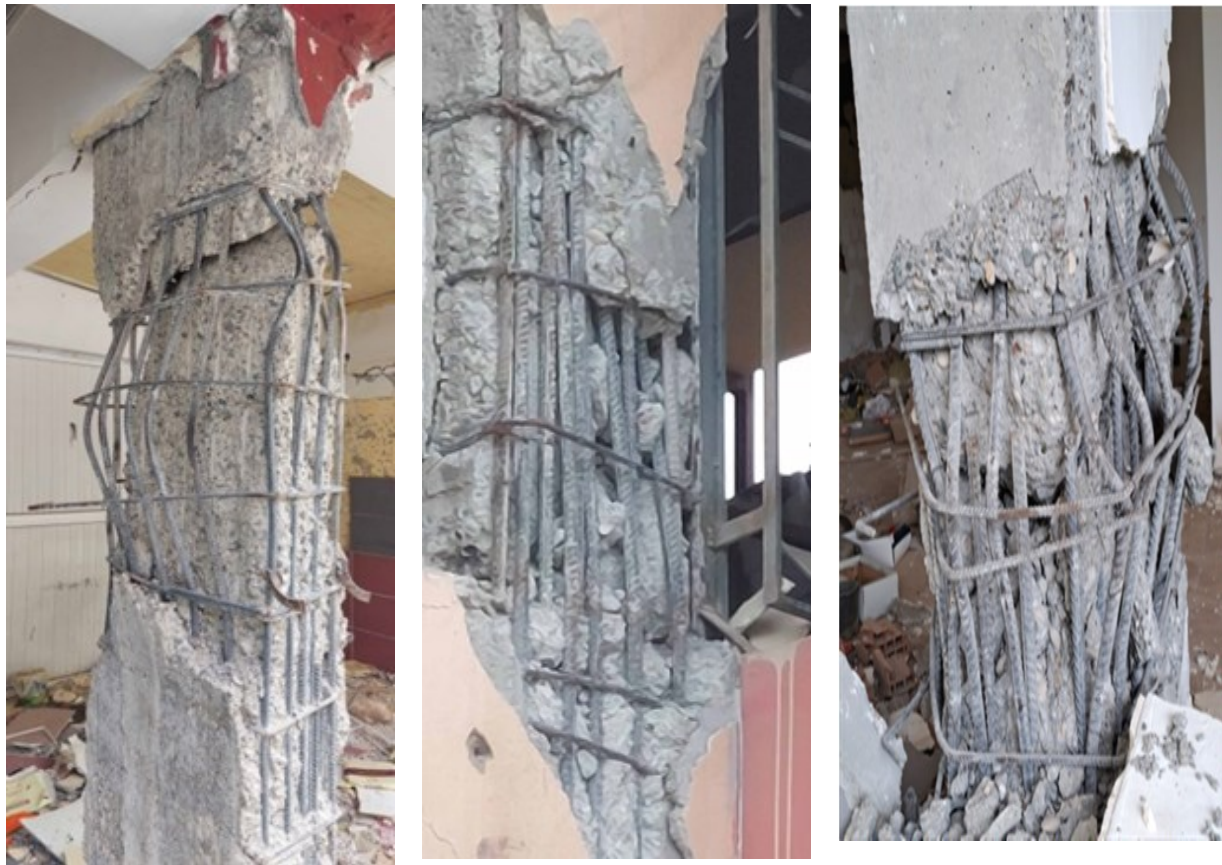
**Figure 5.1.10** Damage in RC columns because of sparsely spaced stirrups and opening of ties, followed by buckling of the longitudinal reinforcement.

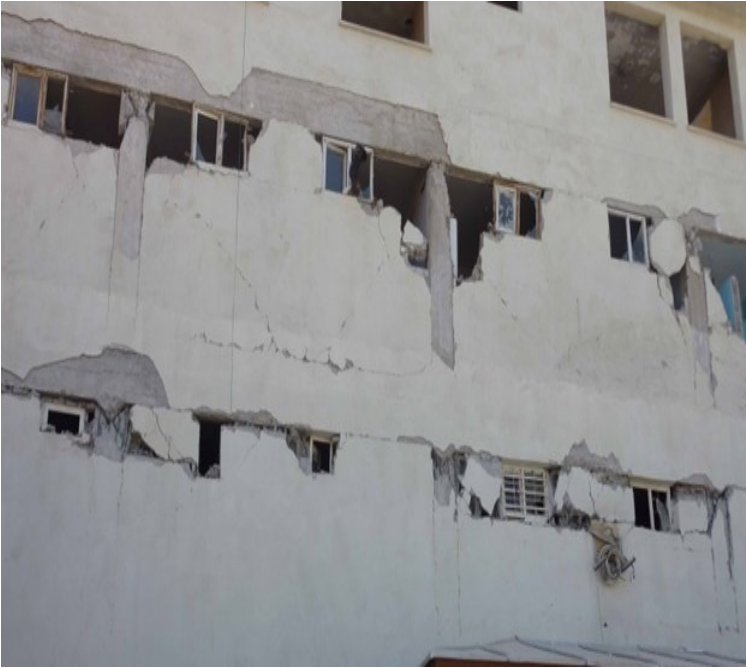
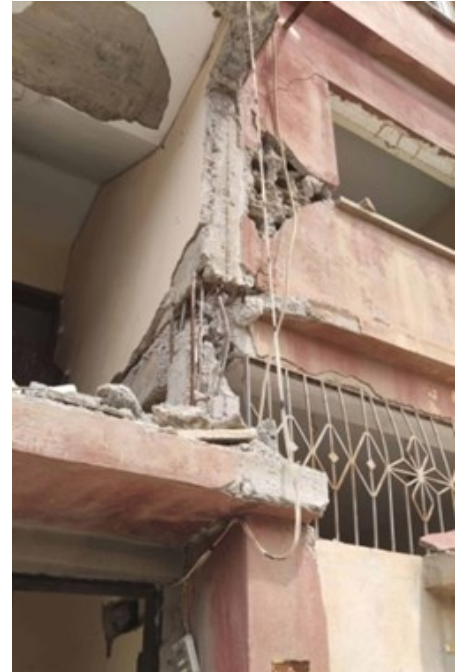
Damage was also observed in columns which behaved as short or captive because of the presence of local restrictions in displacement along only a certain part of the column's height. Figure 5.1.11 displays damage in the free part of columns which had in one or in both sides masonry walls that did not extend to the whole height of the column.

**Figure 5.1.11** Local shear damage in RC columns, because the partial infills did not extend to the whole height of the column, resulting in captive column effect.

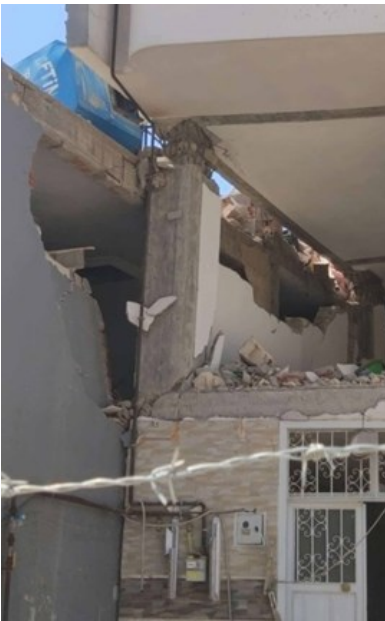
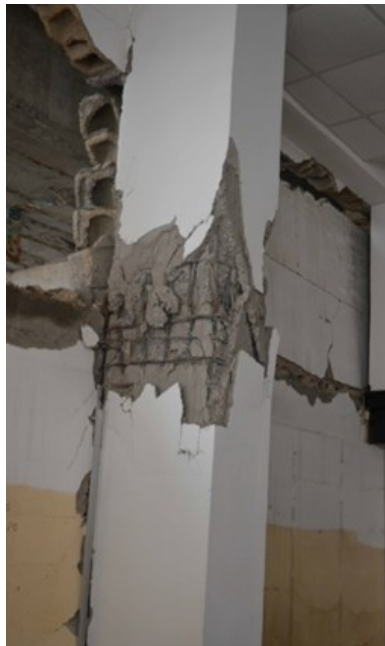
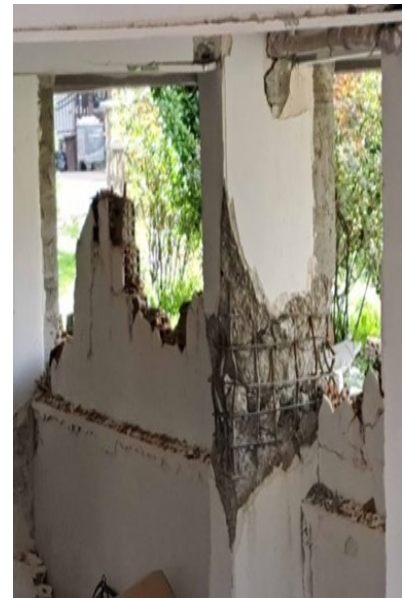
**Figure 5.1.12** Local shear damage in RC columns, because of displacement restrictions in-height, resulting in captive column effect.

In the columns shown in Figure 5.1.12 damage occurred because of local restrictions along their height because of, e.g. pounding of an adjacent slab, or the ground level at the external part of the building. Furthermore, local crushing of infill walls in contact to a part of a column may result in subsequent local damage of the column, owing to increased shear force and stress concentration, as shown in Figure 5.1.13. However, when the overall lateral stiffness was sufficient, the existence of short columns per se did not lead to damage of the columns, as may be seen in the building in Kahramanmaraş depicted in Figure 5.1.14.

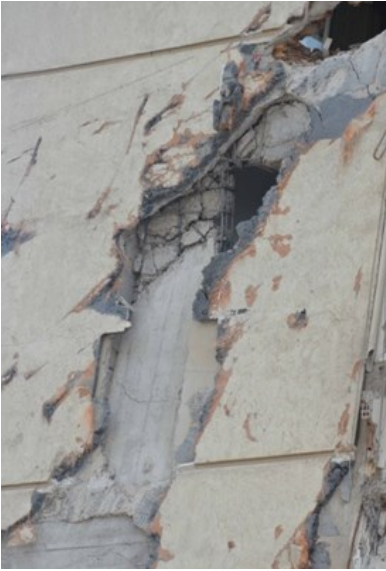
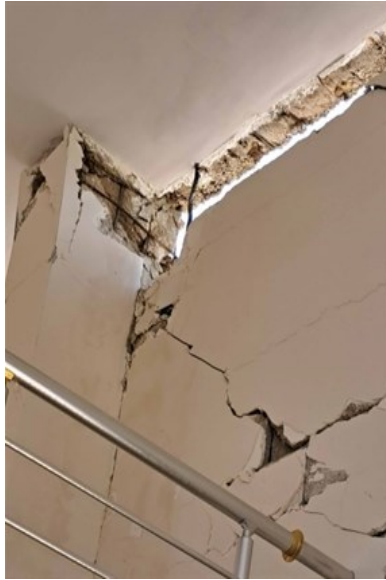
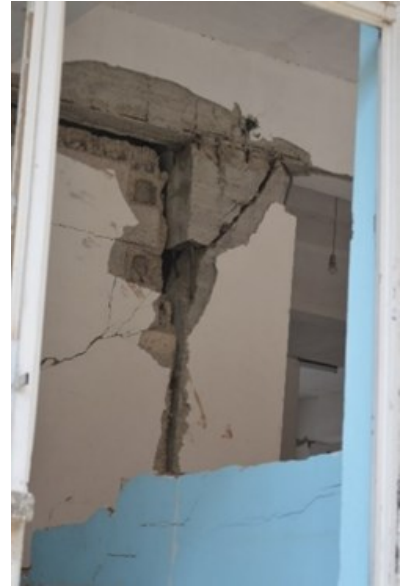
**Figure 5.1.13** Local shear damage in RC columns at the critical region below the joint, subsequent to local crushing of adjacent infill walls which resulted in captive column effect.

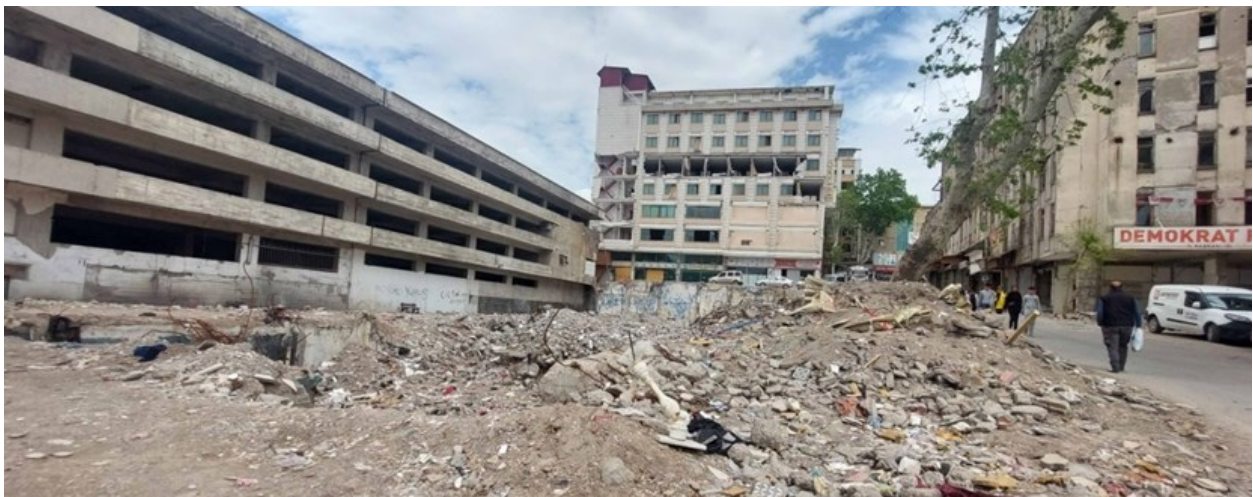
**Figure 5.1.14** Building with short columns in a row which, apparently, did not suffer any damage. Photo: E.Garini.

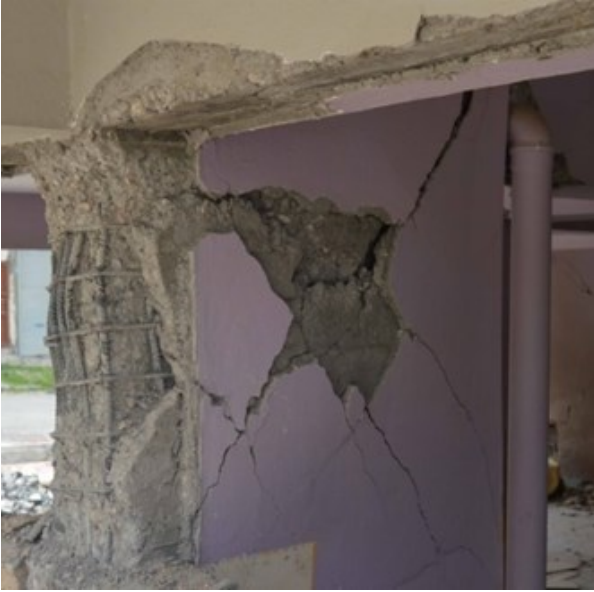
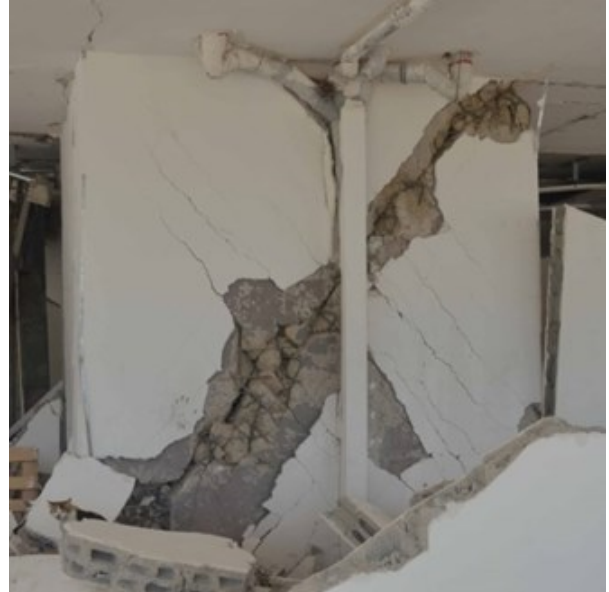
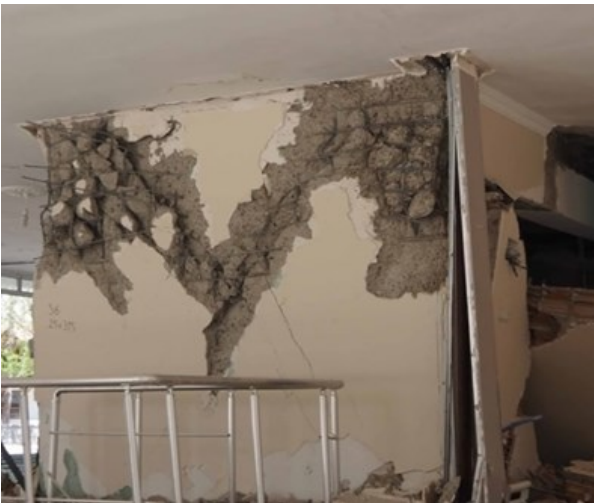
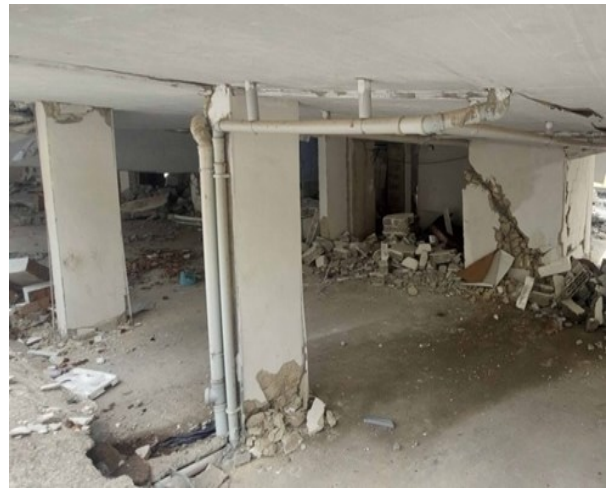
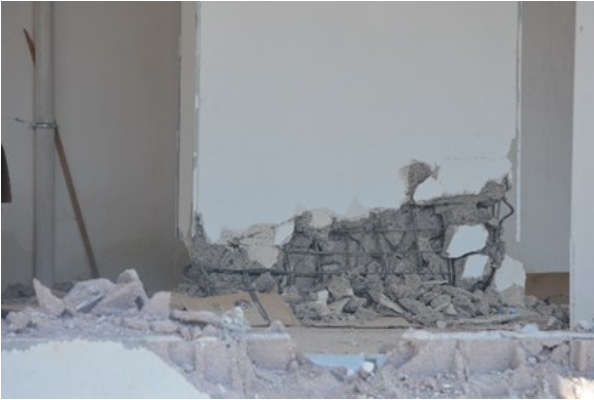
**Figure 5.1.15** Diagonal and sliding shear failures of RC shear walls.

Figure 5.1.15 displays RC walls that have suffered shear damage. In newer structures, the extent of damage in shear walls was, in general, less, as may be seen in Figure 5.1.16.

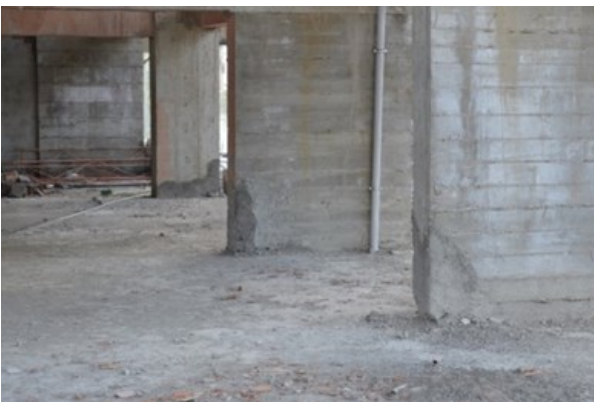
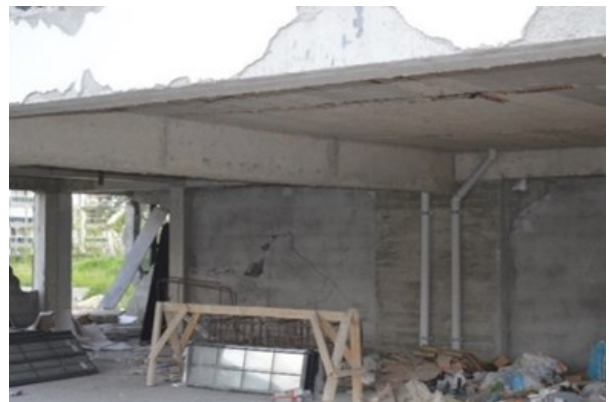
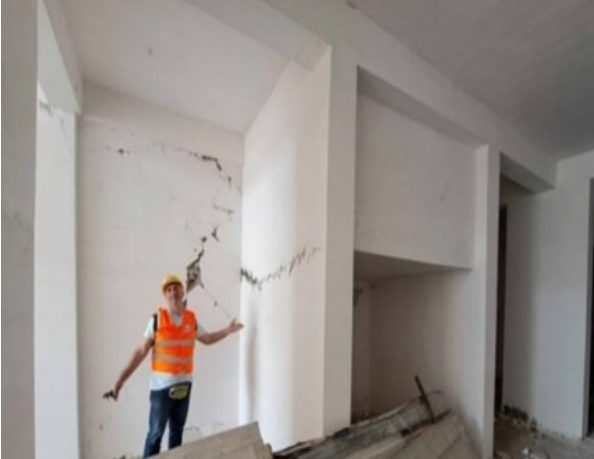
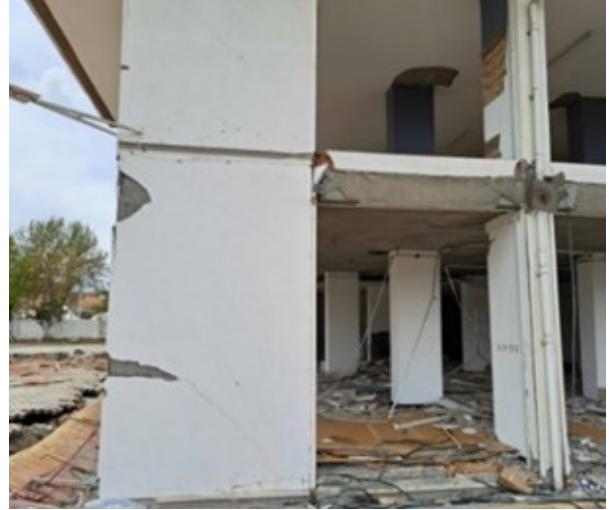
**Figure 5.1.16** Damage in RC shear walls in recently constructed structures.

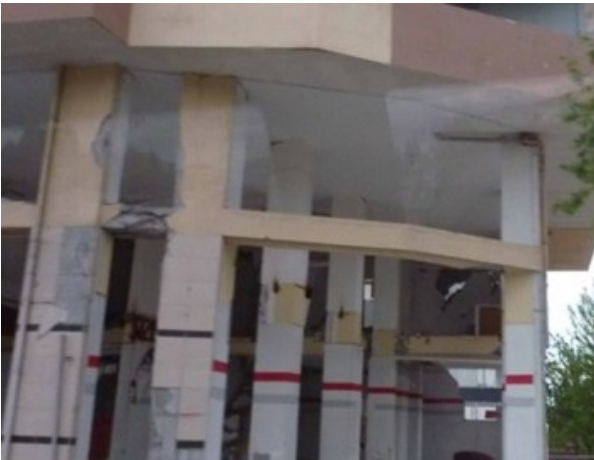
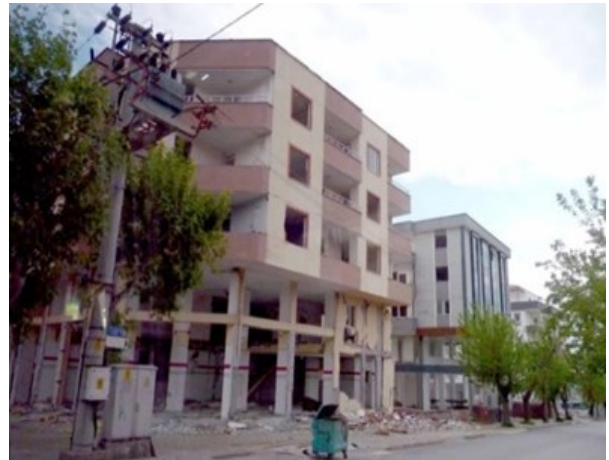
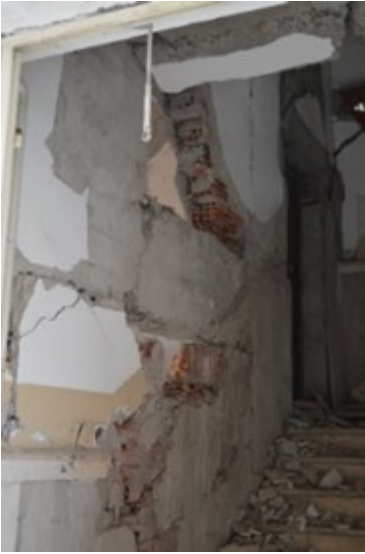
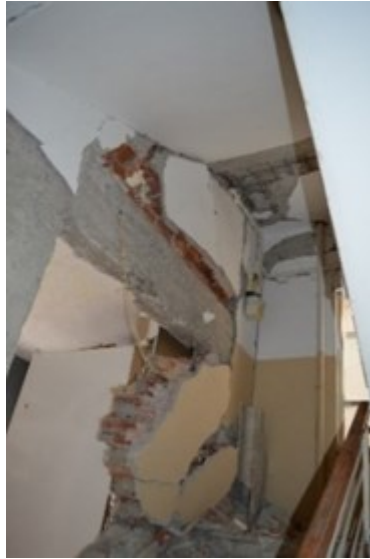
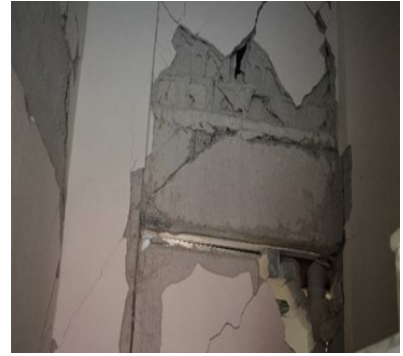
**Figure 5.1.17** Damage of short RC beams (intended or unintentional, due to infill opening

Damage in RC beams was seldom observed, and it was generally attributed to specific structural particularities. Some examples are provided: Figure 5.1.17 depicts the failure of short (coupling) beams either intentional (by geometric dimensions) or unintentional, due to the presence of an infill opening: The low shear span to depth ratio of the beams resulted in increased shear force, and subsequent diagonal shear failure.
