NATIONAL  
TECHNICAL  
UNIVERSITY  
OF ATHENS

# The February 6<sup>th</sup> Kahramanmaraş earthquake sequence in Türkiye

*Technical Report*

Aristidis Papachristidis, Anastasios Sextos

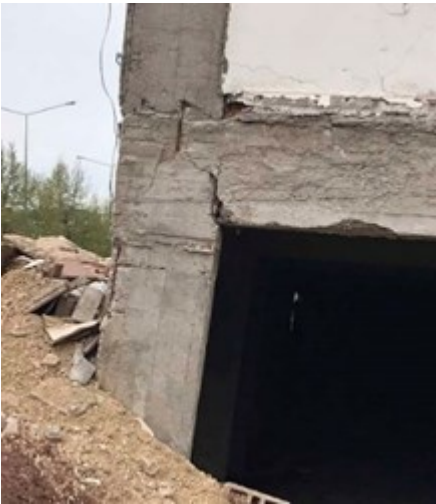
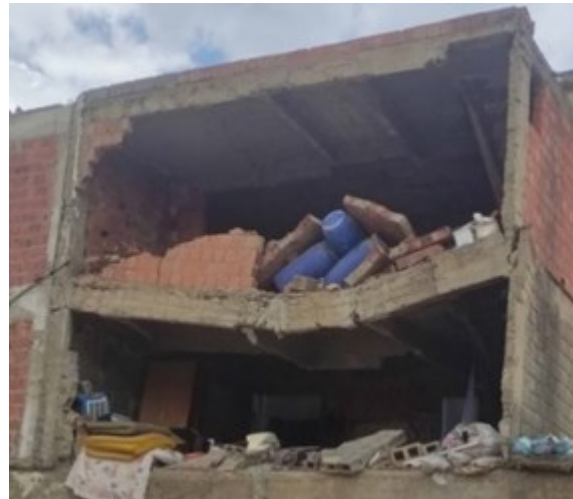
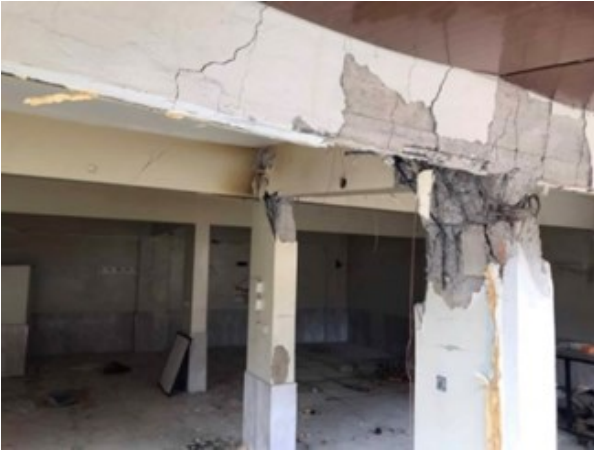
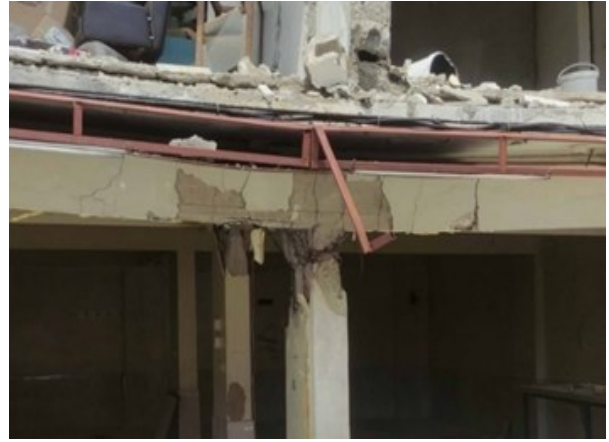
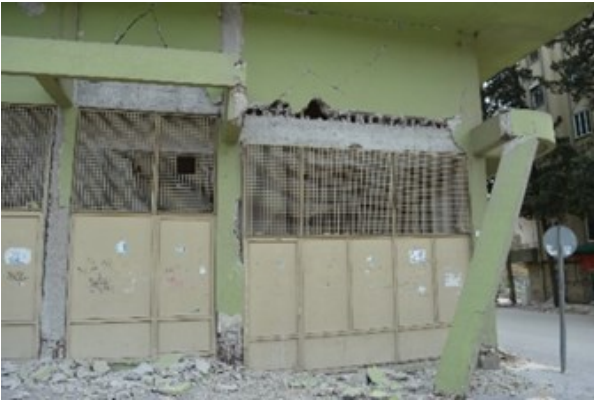
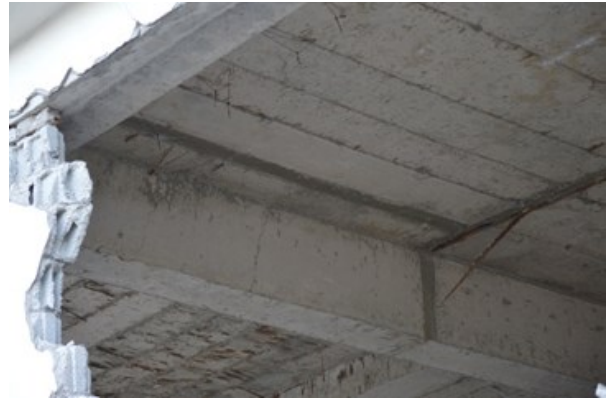
**Figure 5.1.18** Damage in beams because of : i) flexural frame action at the beam ends, ii) mid span hinging due to large deflections of slabs, iii) and iv) support failure, v) insufficient end reinforcement anchorage, vi) tensile cracking due to diaphragm load transfer.

Figure 5.1.18 displays beams depicting different modes of local failure due to their function as vertical – seismic load transfer elements: vertical flexural cracks in the bottom, because of large deflections of the slabs caused by a variety of reasons, i.e.: i) settlement of the foundation (in Golbasi); ii) excessive load on the slab owing, among others, to the collapse of the infill wall; iii) and iv) failure and crushing of the top of column that supports the beam, v) collapse from the support due to insufficient end reinforcement anchorage or shear; vi) tensile flexural cracking from transferring diaphragm loads to the vertical elements.

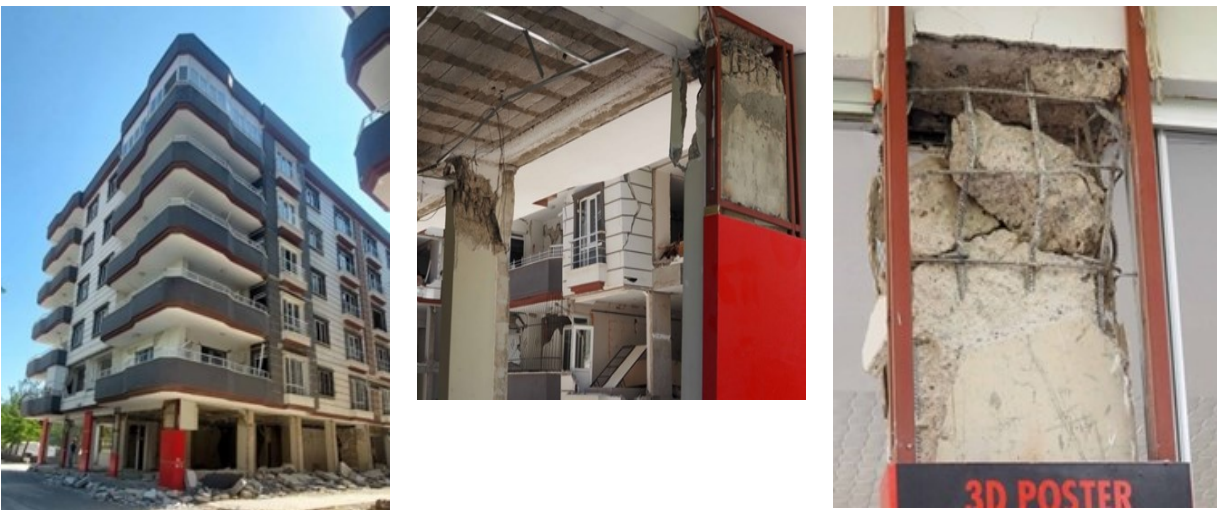
**Figure 5.1.20** Shear damage in top of columns in the ground story of an RC building with filler-joint (asmolen) floor system (Nurdagi).

In buildings with filler-joist (asmolen) slabs, which usually do not have any beams, often shear failure at the top of columns was observed, as shown in Figures 5.1.20 and 5.1.21. However, in the building shown in Figure 5.1.22, in which adequate lateral stiffness was provided, no structural damage occurred.

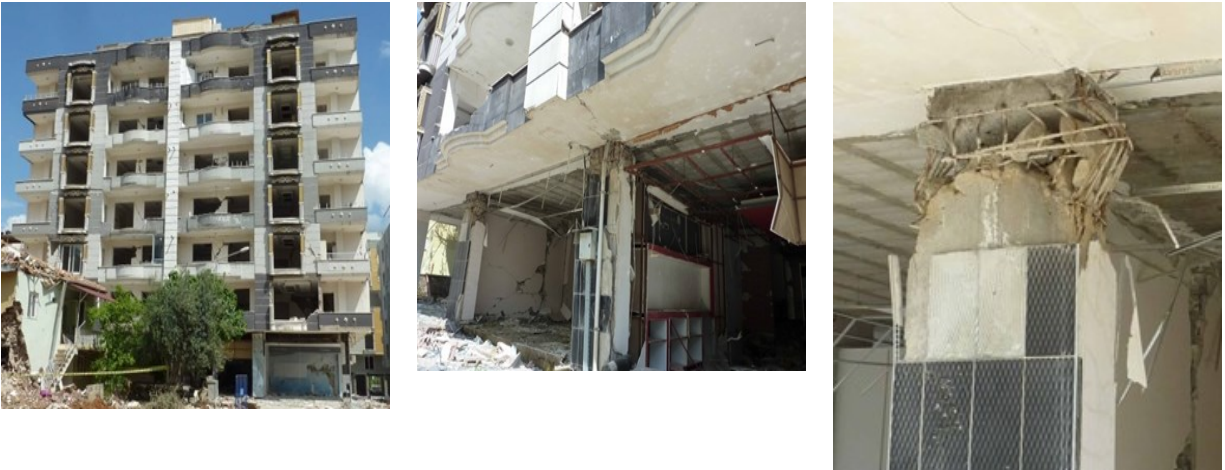
**Figure 5.1.21** Damage at top of columns in filler-joist floor system in Islahiye. Photo: C.Giarlelis.

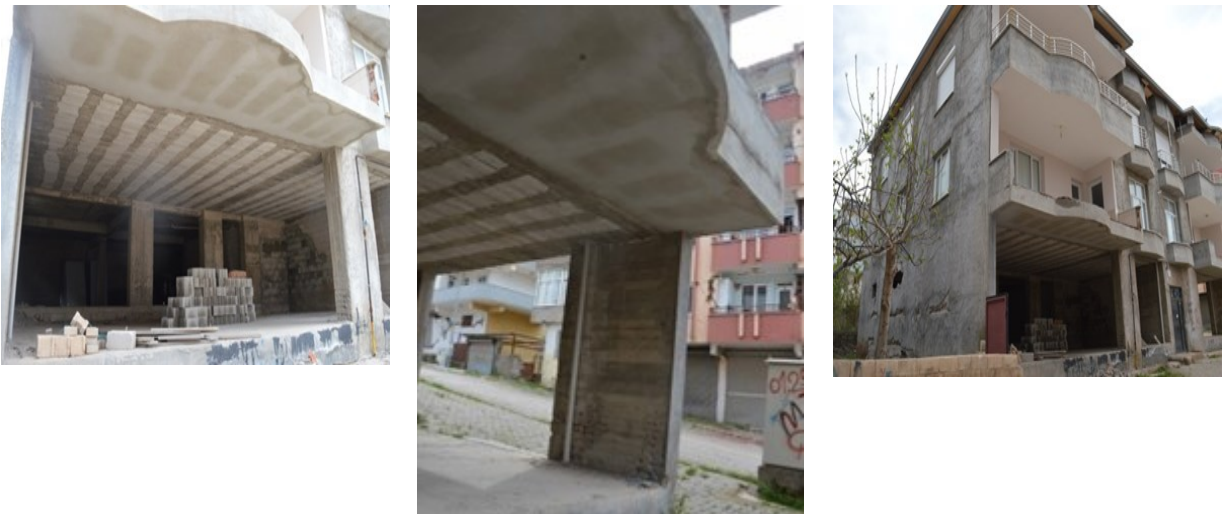
**Figure 5.1.22** Building with filler-joist (asmolen) floor system without any apparent damage (Golbasi). Photo: C.Zeris

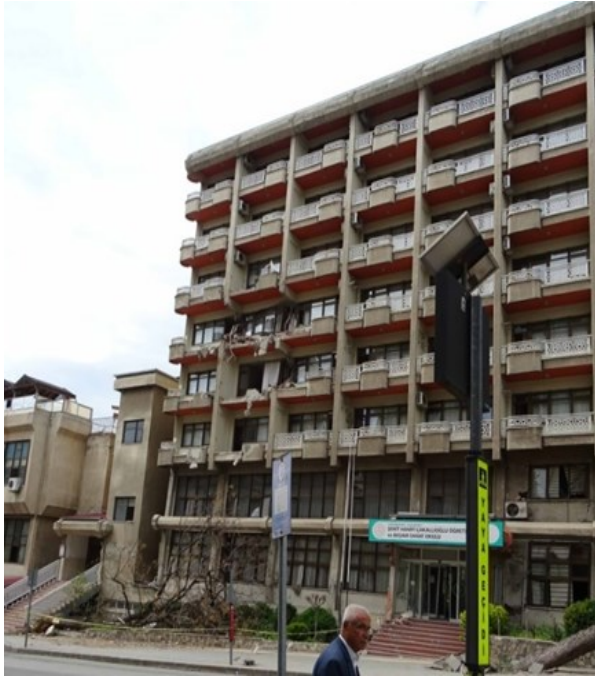
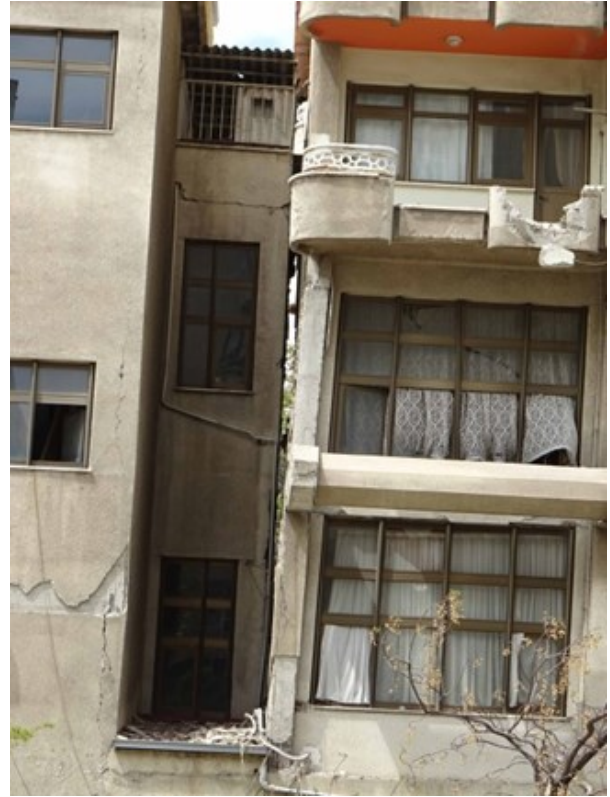
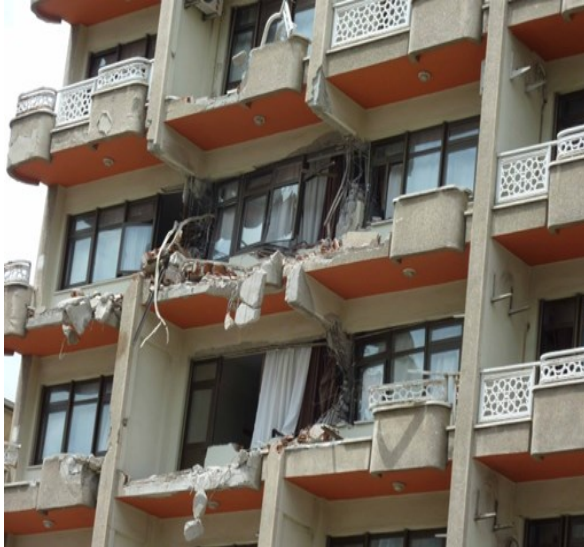
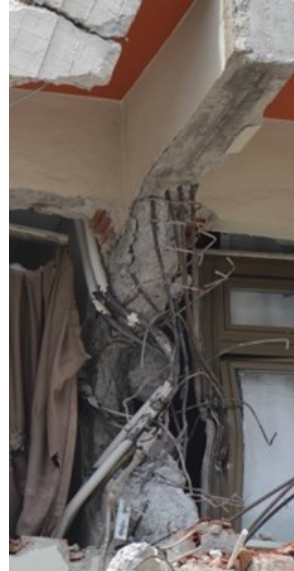
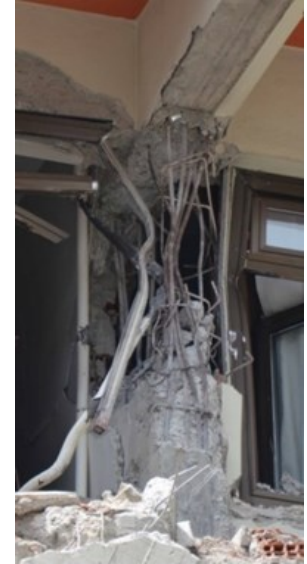
In general, seismic joints between neighboring buildings were either insufficient or nonexistent. Two different consequences of adverse interaction between adjacent buildings are discussed: In Figure 5.1.24 the two buildings were in contact with only a small, if any, seismic gap between them, which proved insufficient. Because of the restriction in lateral displacement induced by the low rise building, the 8-story building suffered considerable damage at mid-height between the second and fifth stories, including shear damage in captive columns.

**Figure 5.1.24** Damage at mid-height of an 8-story building in Kahramanmaraş due to pounding of the adjacent structure.

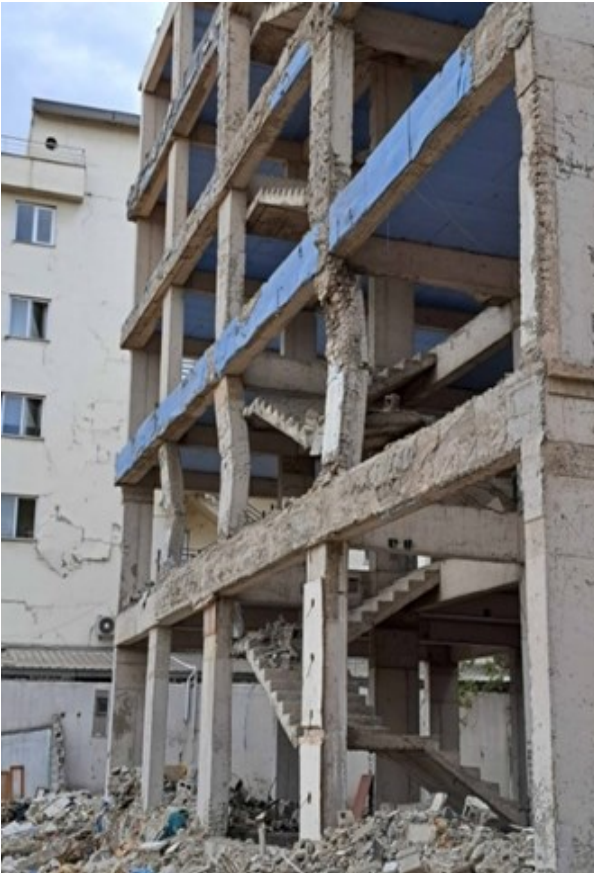
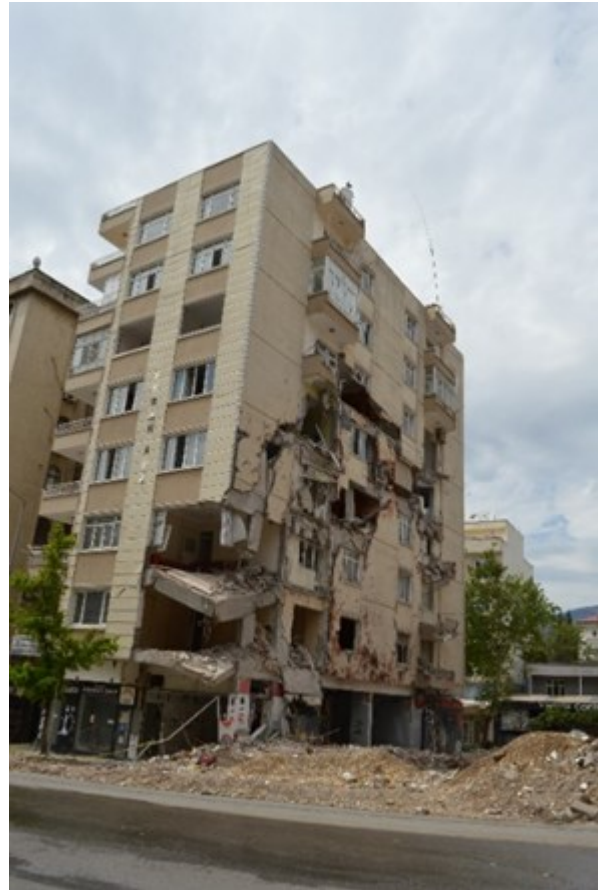
In the case of adjoining buildings which were separated at a certain distance apart, it was observed in certain instances that when a building collapsed, a part of it fell on or collided with the other building, thereby inducing to the latter significant damage. Examples of this type of damage between two buildings may be seen in Figure 5.1.25.

**Figure 5.1.25** Damage in buildings caused by the impact at collapse of the adjacent building.

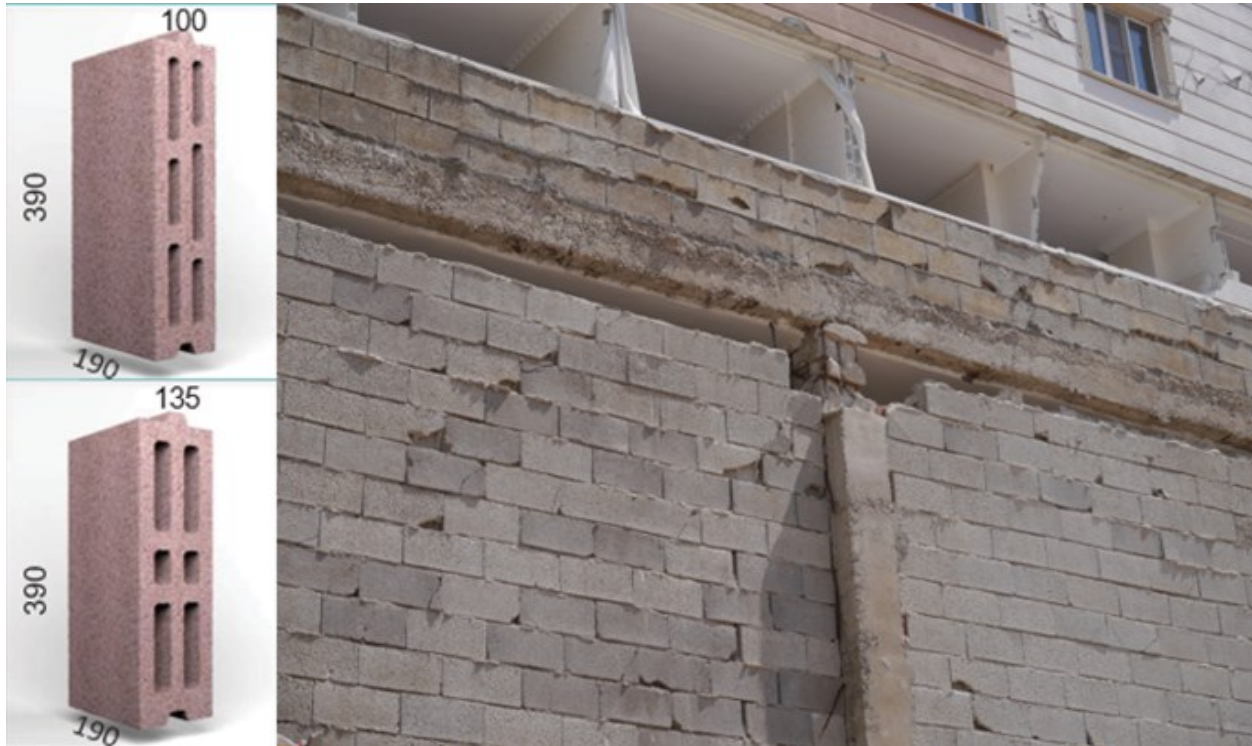
**Figure 5.1.26** Damage of outer walls, due to lack of wedge at the top

Such premature failure of the external infill walls led to a drastic deterioration of the seismic capacity of the buildings, and, therefore, is an important factor contributing to the increased damage observed.

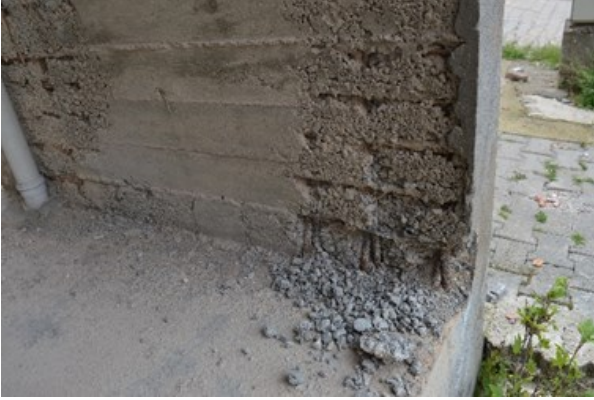
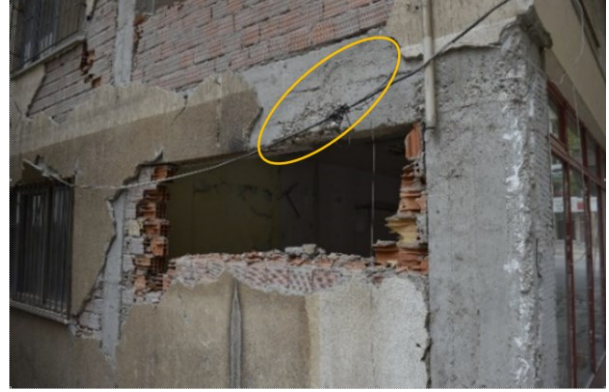
As several past earthquake reconnaissance reports that were followed by inspection together with taking material samples (cores and steel coupons) from damaged buildings in the same region (Hatay, Erzincan) have pointed out ([5.3], [5.4]), the material quality was often (especially in older structures) substandard: concrete compressive strength was below the minimum code specified at the time of construction (namely, B225 or C16, and up to C25), and nonductile grades for the reinforcement. This fact, together with the design choice of adopting gravity resisting frame systems without ductility – at higher design load, led to considerable local damage in vertical elements (Fig. 5.1.28).

**Figure 5.1.28** Damages in RC elements related to bad workmanship and supervision: i) Wall edge member lack of compaction and ii) improper diagonal cold joint that led to diagonal shear failure.

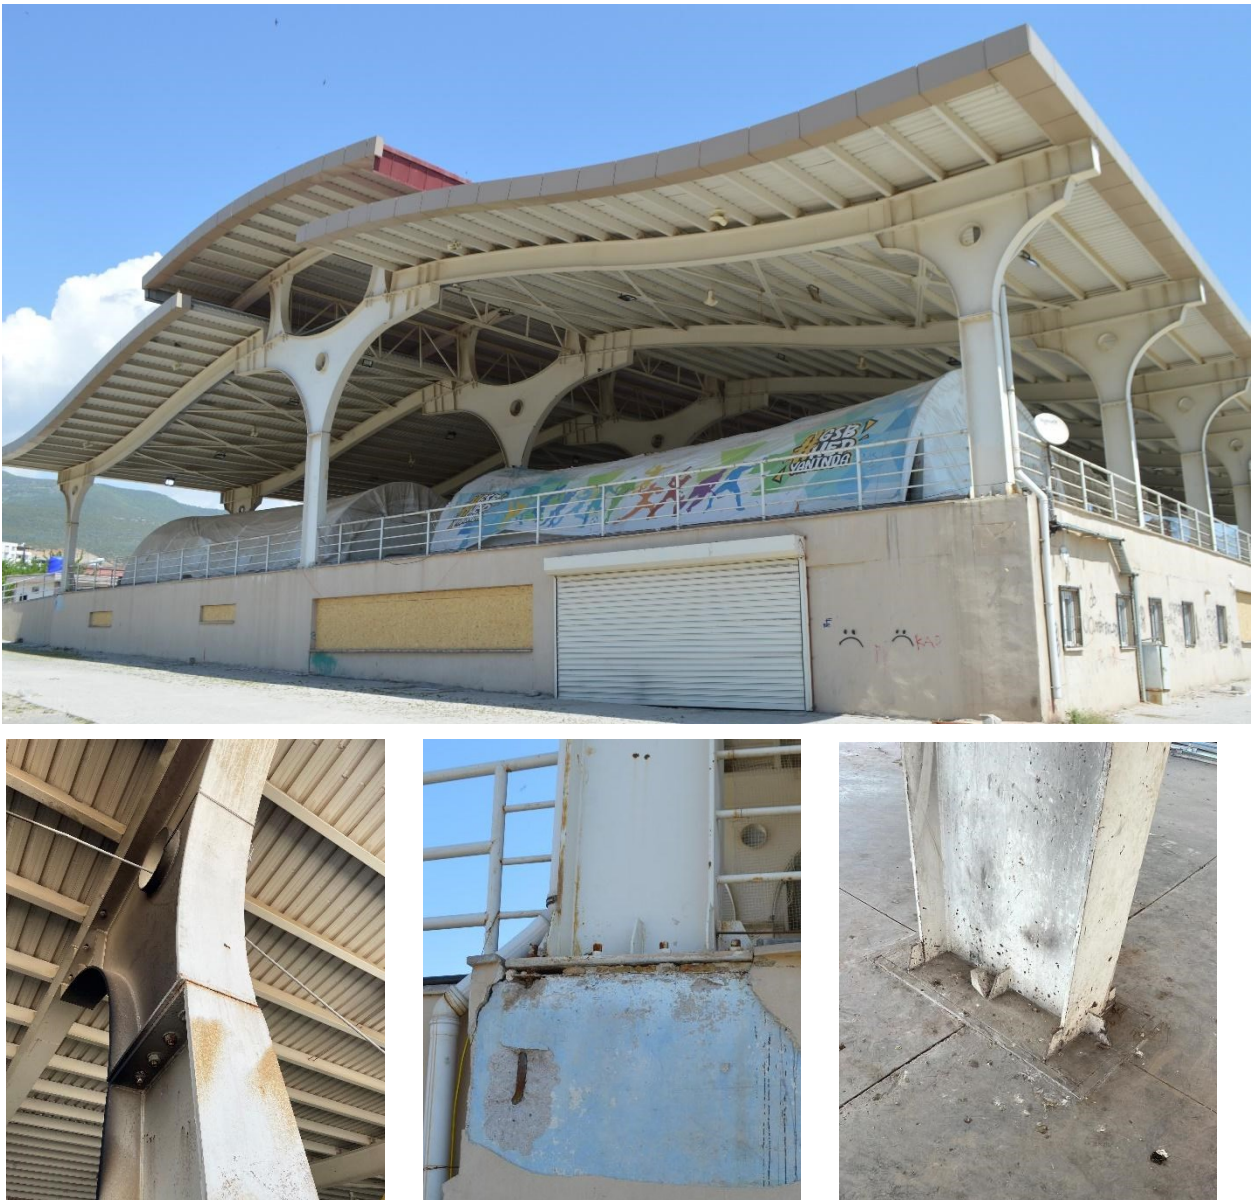
**Figure 5.2.1** Roof structure of the municipal market in Nurdağı, with structural details showing no significant damage from the earthquake.

Figure 5.2.1 shows the roof structure of the municipal market in the city of Nurdagi. Even though the structure lacks bracing members in the longitudinal direction it behaved exceptionally well, with no visible damage from the earthquake. Small problems observed were probably dated before the event and of reduced structural importance. Due to its structural integrity, the structure was selected to facilitate civil services provided with tents. Similarly, a roof structure used for parking in the city of Islahiye was in excellent condition, continuing to shelter cars and tents after the event.

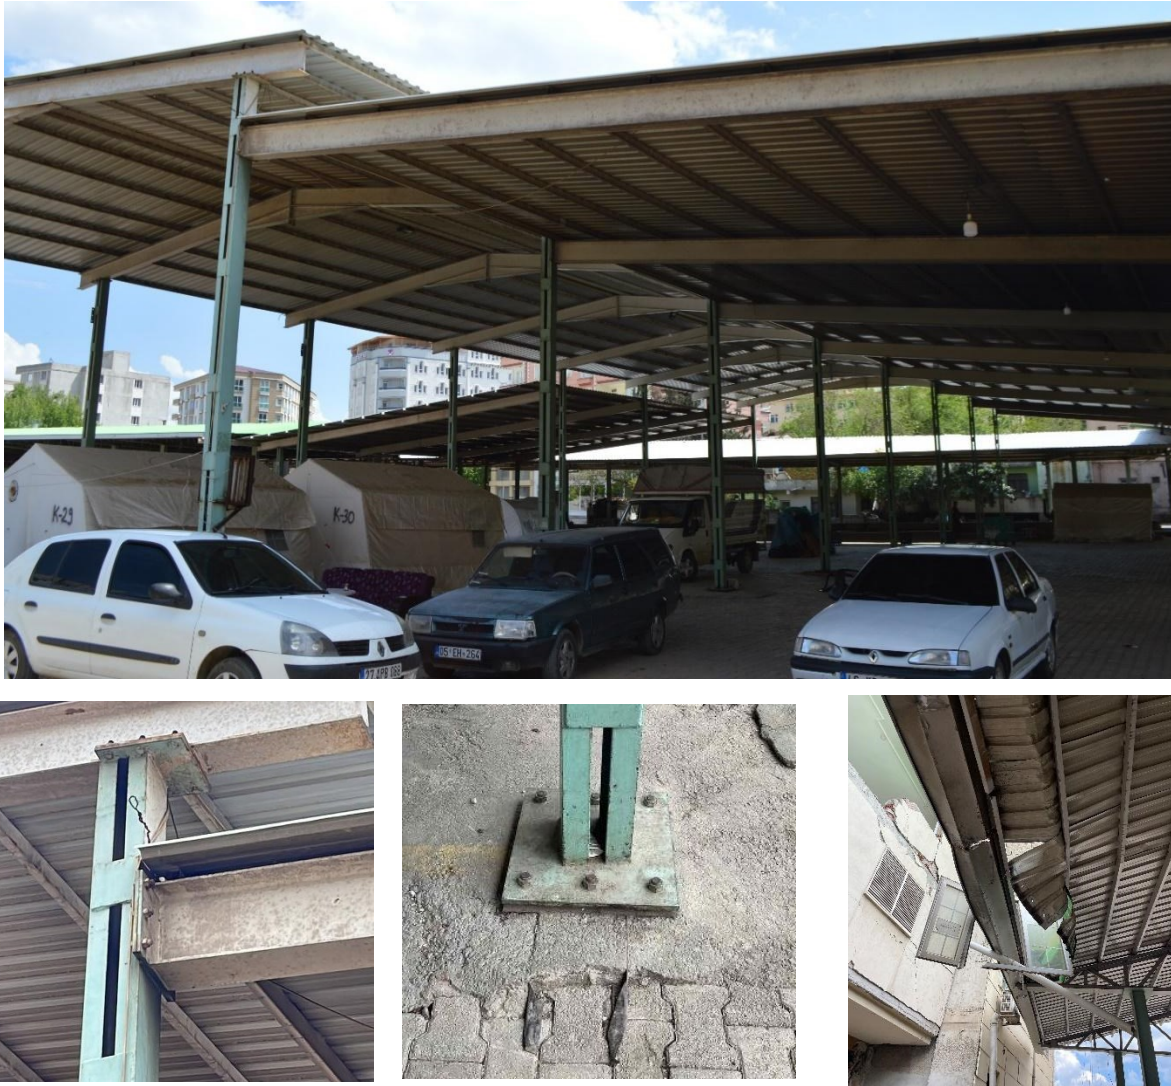
**Figure 5.2.2** Roof structure of outdoor parking in Islahiye, with structural details showing no significant damage from the earthquake other than the ones caused by an adjacent building.

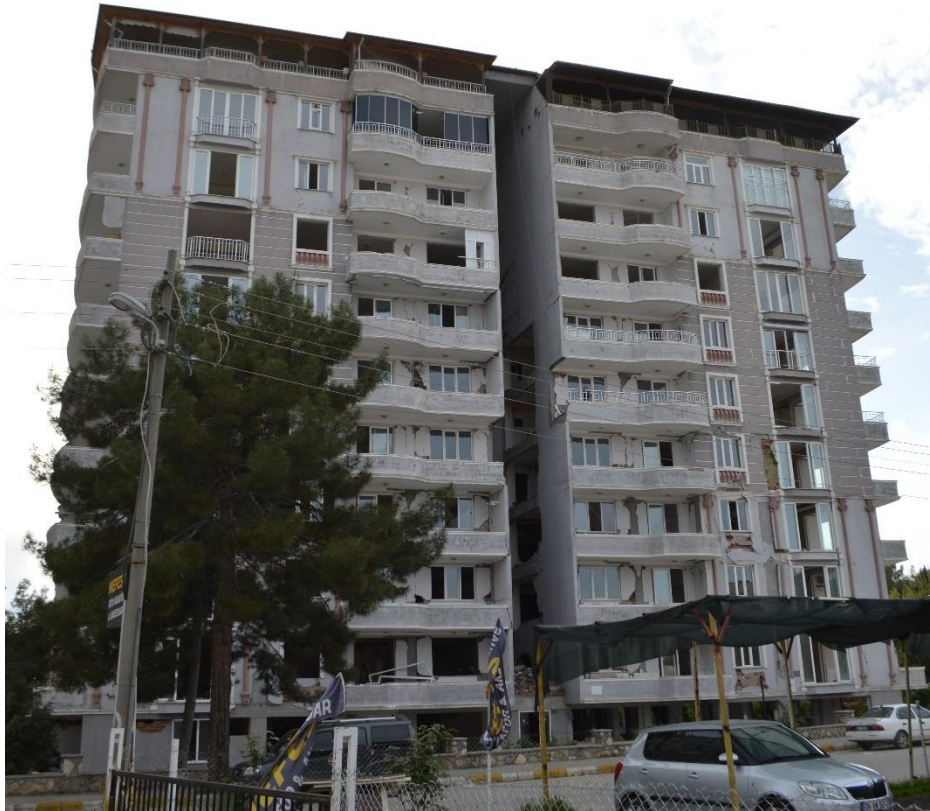
**Figure 5.2.3** Top floor roof on a 10-story building in Adiyaman. Despite the damage to the main building and the increased top-floor acceleration, no significant damage can be observed.

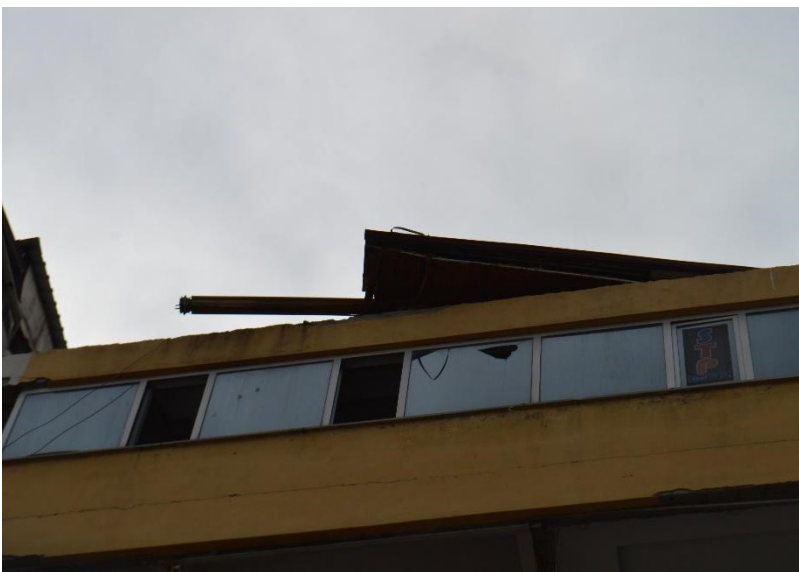
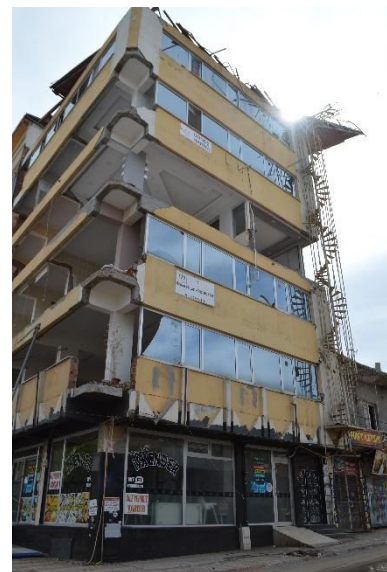
Although not many steel buildings were observed, it was quite common for reinforced concrete or masonry buildings to have steel appendages. Such structures are not critical for the stability of the main building, nevertheless, their failure can cause life safety or serviceability issues. In this case, several failures were observed which are attributed to the failure of the main building or poor detailing of the connections between the two parts (Figures 5.2.3 to 5.2.7)

**Figure 5.2.4** Top floor roof on a 6-story building in Pazarcık. Total collapse due to poor anchorage.

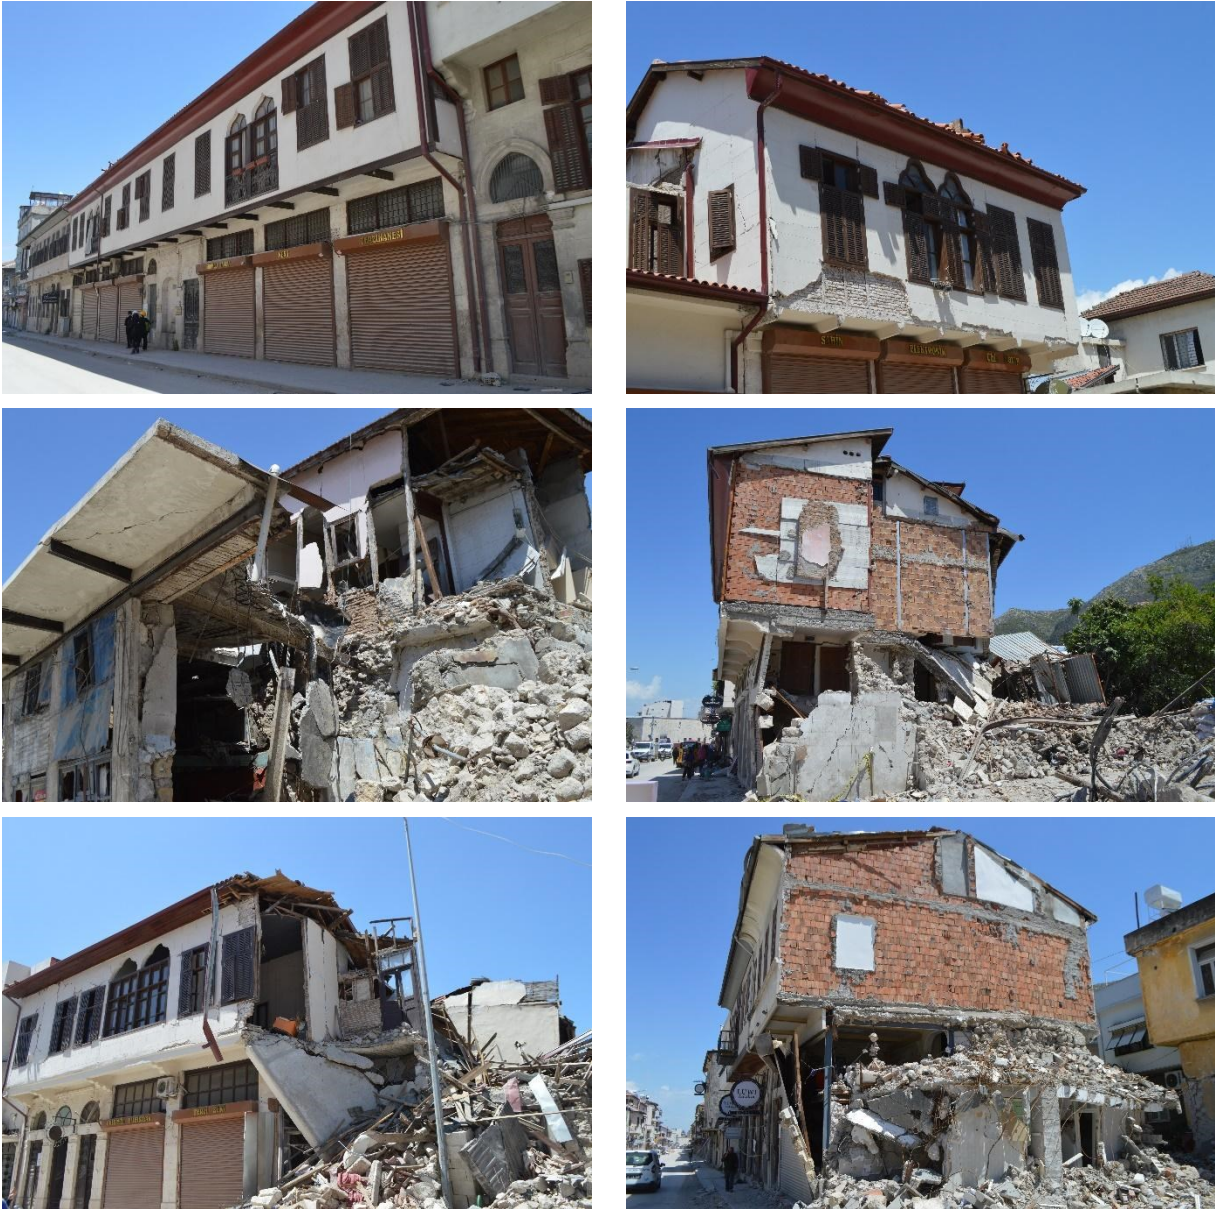
A special type of building was observed along Kurtuluş Avenue in Antakya. Although there were various typologies, probably depending on the era of construction of each building, their common characteristic was the projection of the first floor over the ground floor towards the avenue. The buildings consist of masonry or brick outer walls with or without timber elements. Most of the slabs were reinforced concrete, supported by steel I-beams which also supported the cantilever. The damage to the buildings varied from negligible to total collapse (Figure 5.2.8). At the time of the reconnaissance mission, it was not easy to identify clear causes for this versatile behaviour, other than the possible difference in the quality of construction and the unfavourable response of the corner buildings.

**Figure 5.2.8** Various 2-story buildings along Kurtuluş Avenue in Antakya.

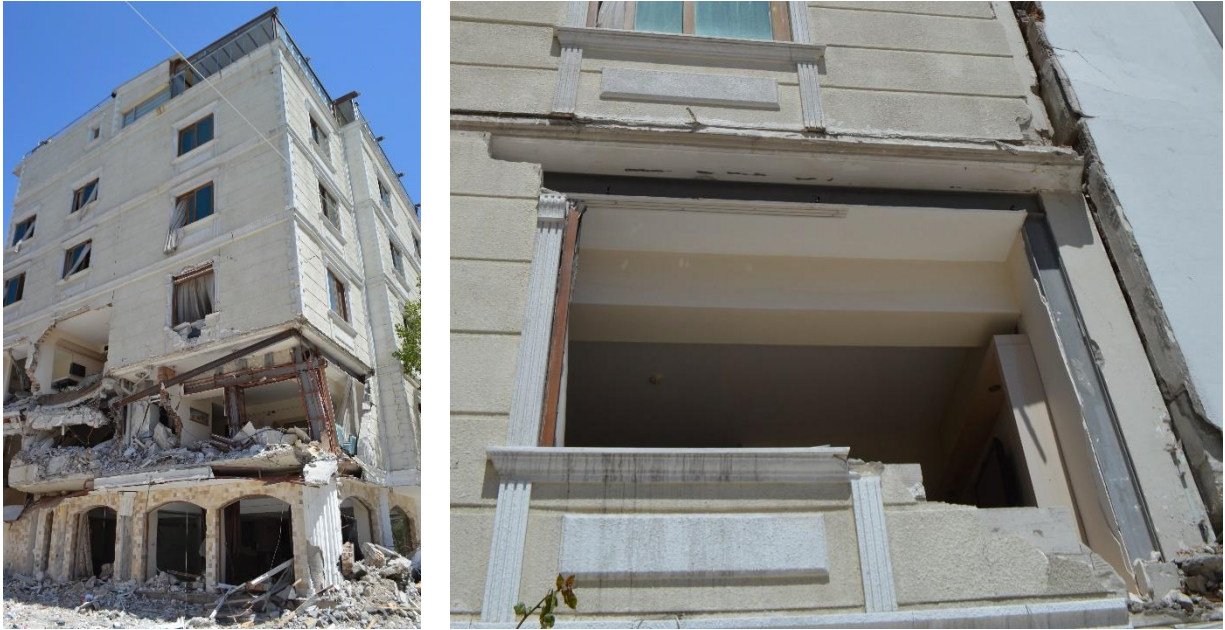
As far as concrete buildings strengthened with steel elements are concerned, only a single building was recorded, in the city of Antakya. The building had heavy structural steel frames integrated with the concrete frame and lighter steel members which facilitated the placement of the façade. Severe damage was observed in the second story where the system was placed with the non-structural elements destroyed. Even though the building did not collapse, repairing seems difficult due to the significant permanent lateral deformation.

**Figure 5.2.9** Concrete building was retrofitted with steel elements before the event (Antakya).

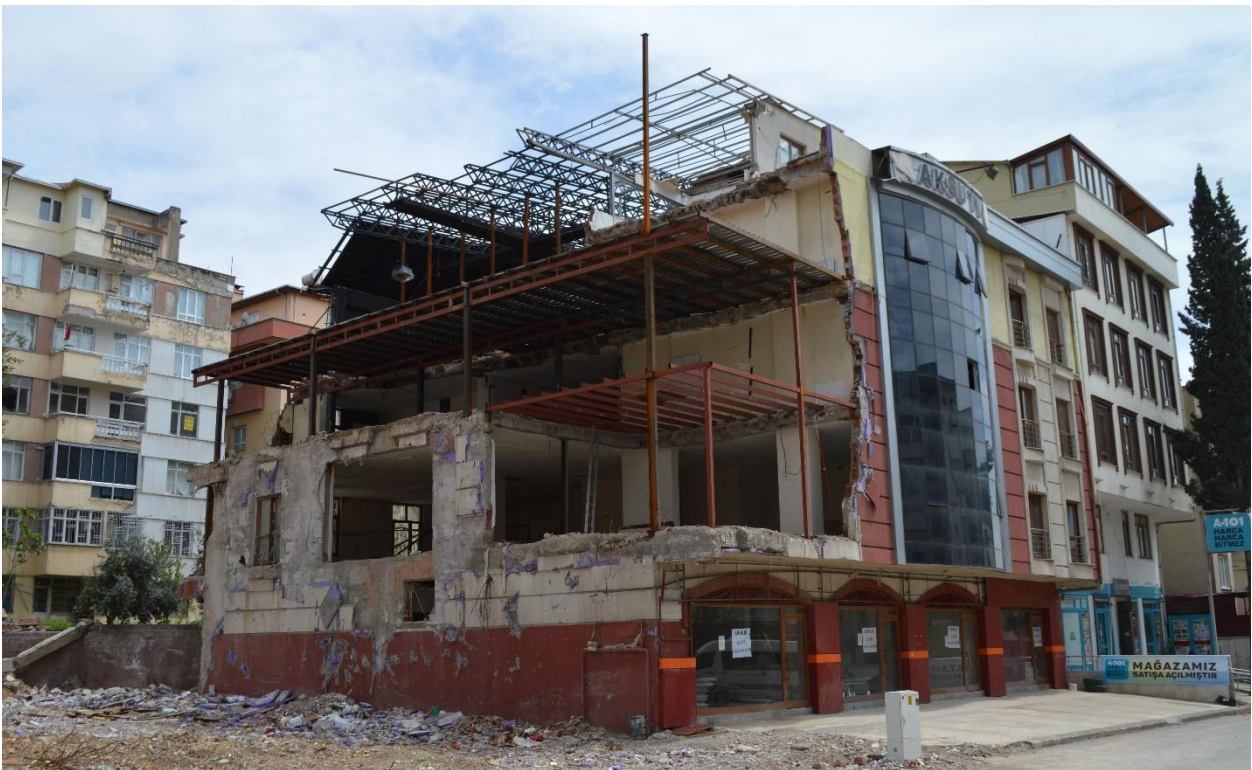
**Figure 5.2.10** Restoration of concrete buildings with steel frames (Kahramanmaraş).

A different case was recorded in Kahramanmaraş where a building, which probably suffered damages due to pounding from an adjacent building that collapsed, was repaired with the use of steel elements. Part of the building was demolished, and composite slabs and steel frames were placed to return the building to its initial status.

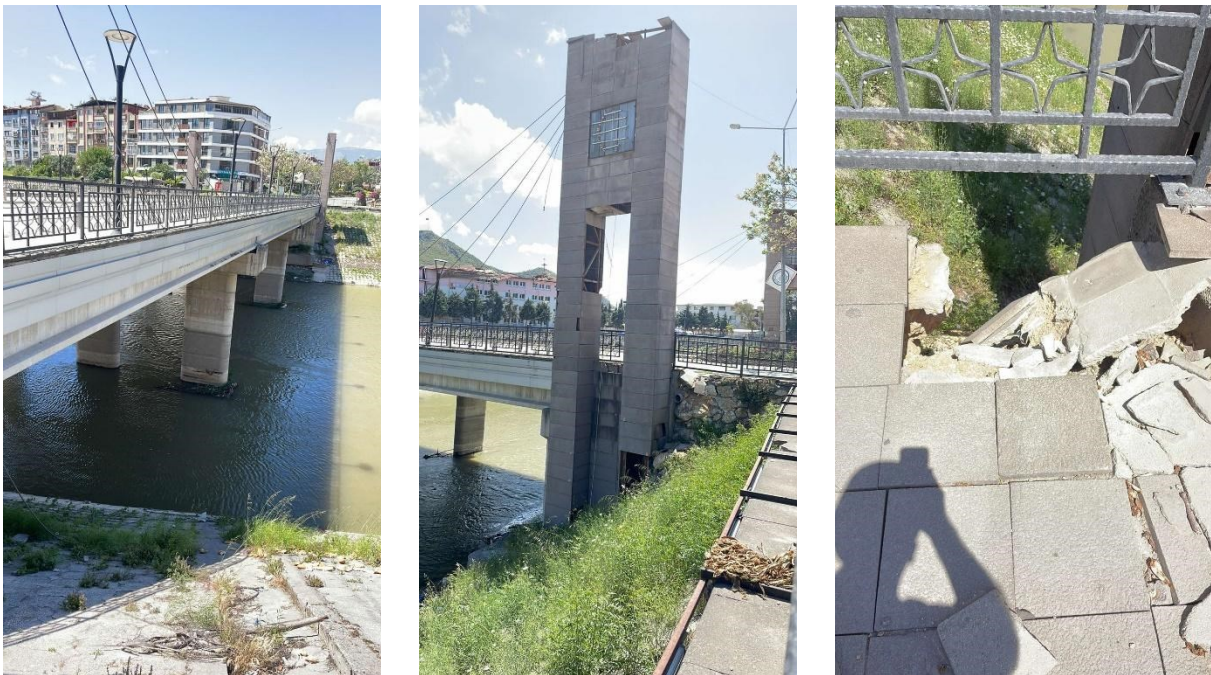
Although bridges were not the main focus of the Greek reconnaissance mission, no significant problems were detected other than small permanent deformations of the bearings and activation of the seismic stoppers. This was more the case for steel bridges which were in service without visible problems (Figures 5.2.11 to 5.2.15).

**Figure 5.2.12** Road bridge with steel tower (Antakya).

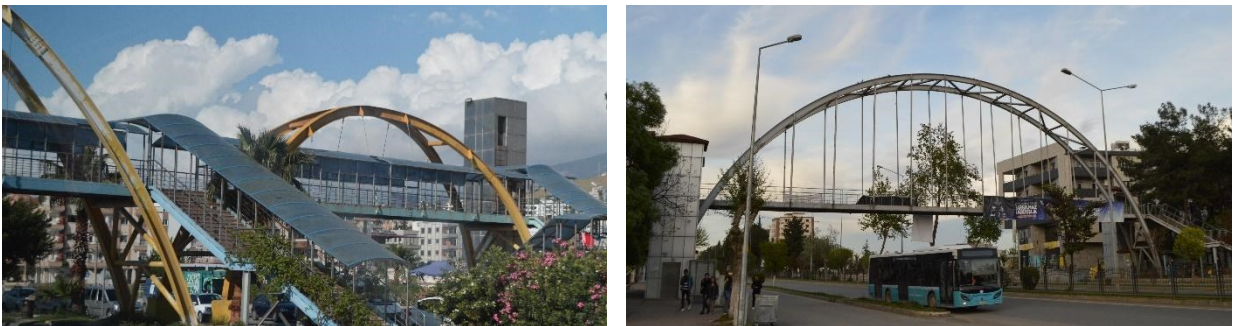
**Figure 5.2.14** Pedestrian steel arch bridges in normal service, Iskenderun (left) and Adiyaman (right).

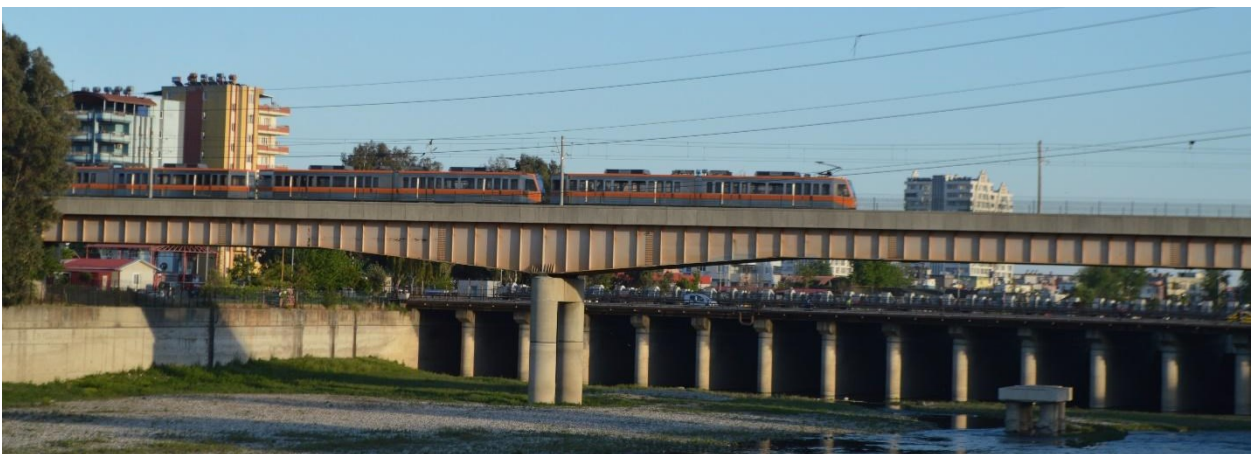
**Figure 5.2.15** Railway steel bridge in normal service (Adana).

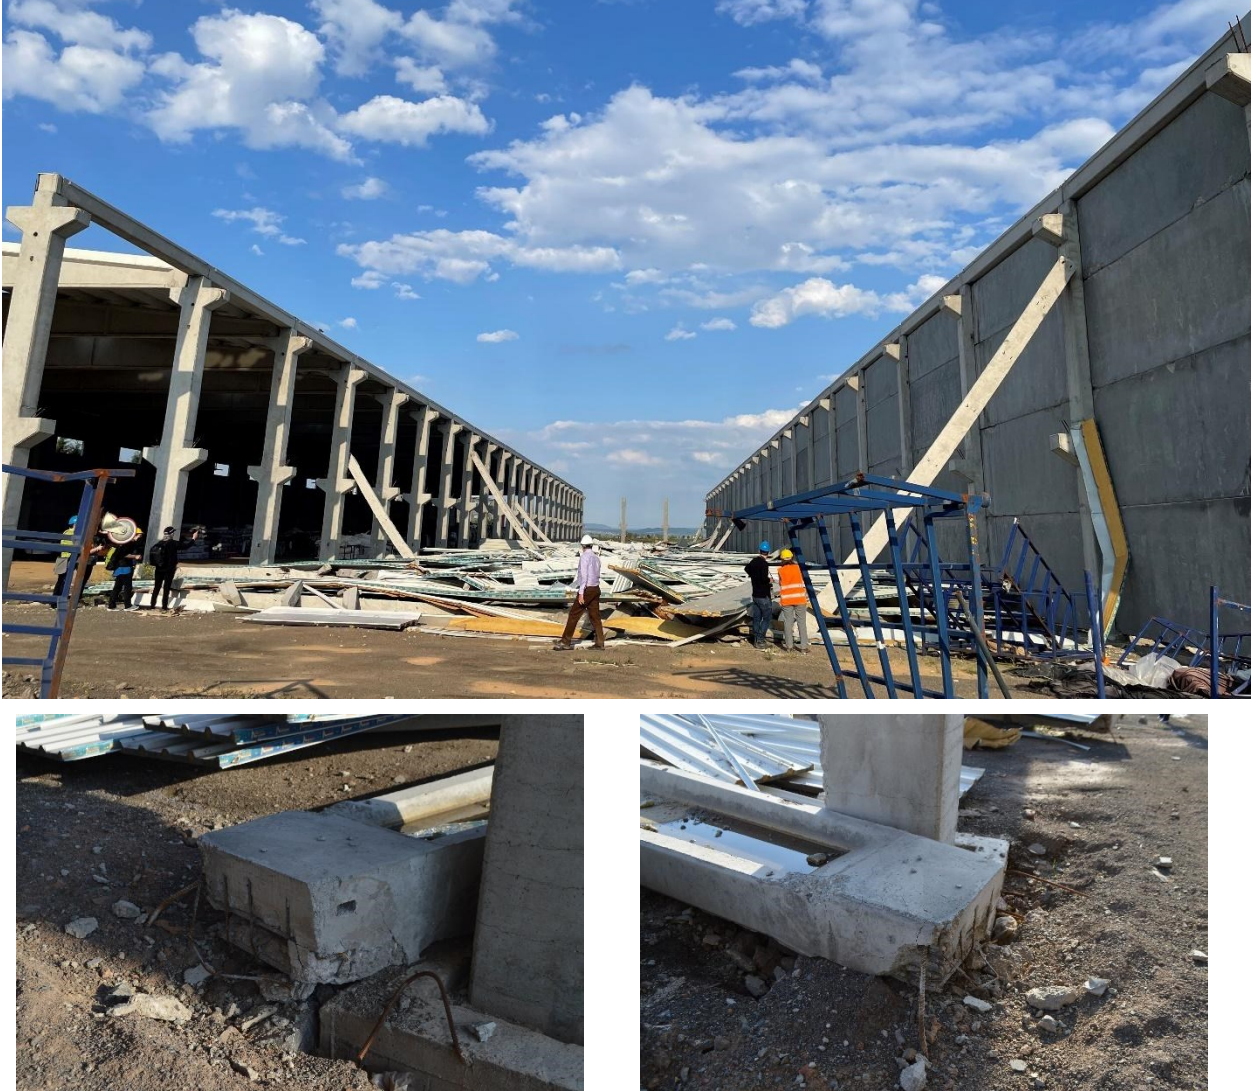
As in all types of buildings, industrial buildings in Turkey primarily consist of prefabricated/prestressed reinforced concrete members (Figure 5.3.1). The stability of this type of structure mainly depends on the stiffness of the foundation and the connection between the column and the beam. As it was observed, the latter connection was realized through two rebars extruding from the bracket, which were inserted in two holes at the edge of the beam. These holes were left void, as no mortar was observed, which allowed significant movements of the beams and led to the total collapse of entire bays (Figure 5.3.2). This can be also attributed to the significant vertical component of the earthquake which significantly decreased or even eliminated the friction force at the beam-bracket interface. Several additional types of failure were recorded in other buildings of the same area both on structural and non-structural elements (Figure 5.3.3).

**Figure 5.3.2** Total collapse of the middle bay of a reinforced concrete industrial building and details of the prestressed beam end (Kahramanmaraş).

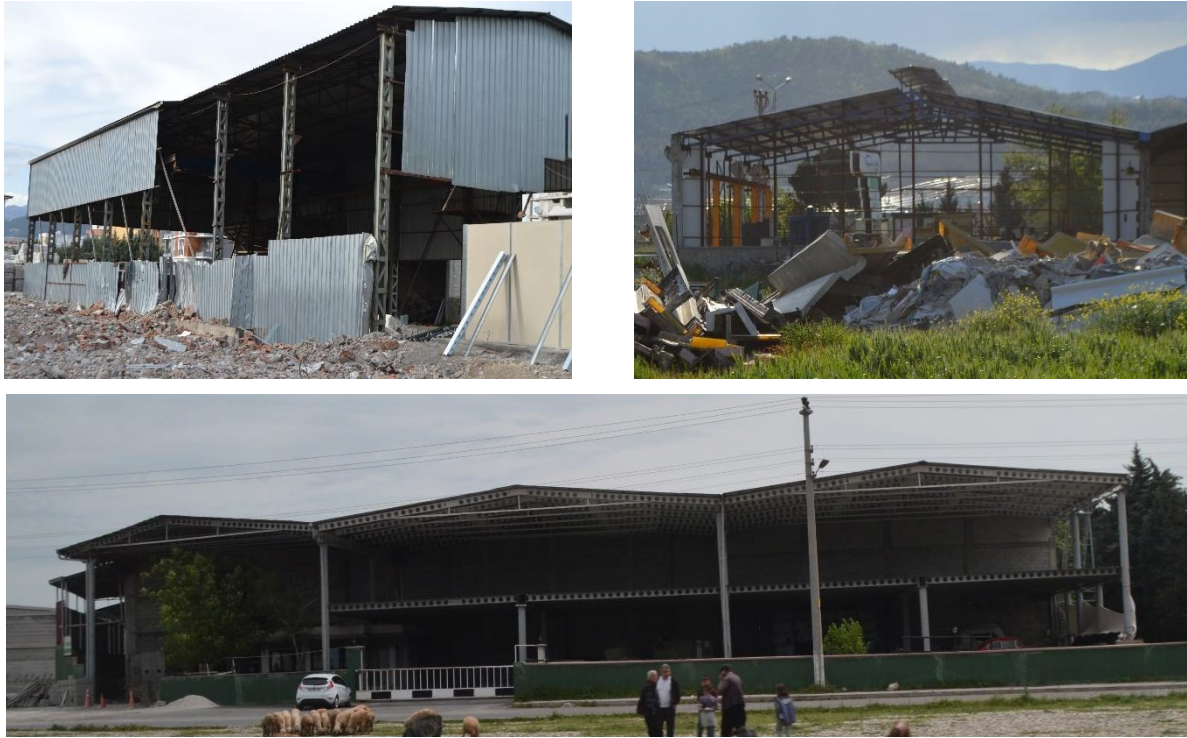
Several steel industrial buildings were observed with no significant structural damage, especially if they were not built with an unconventional structural system. Nevertheless, many of them had significant damage to their panels (Figure 5.3.4). The same observation applies to the steel silos and tanks that were observed along the way. Although some collapses were recorded, most of the structures seemed intact (Figure 5.3.5).

**Figure 5.3.4** Structural steel industrial buildings in Adiyaman (top left) and Kahramanmaraş.

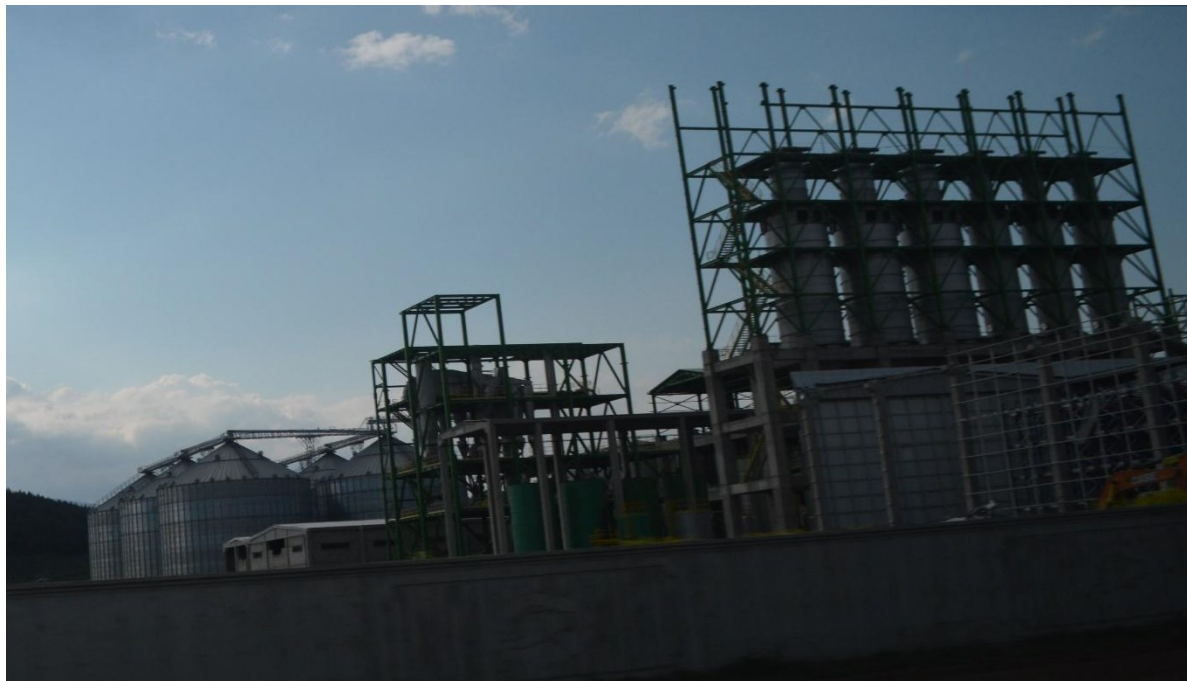
**Figure 5.3.5** Storage facilities in Kahramanmaraş.
