NATIONAL  
TECHNICAL  
UNIVERSITY  
OF ATHENS

# The February 6<sup>th</sup> Kahramanmaraş earthquake sequence in Türkiye

*Technical Report*

Aristidis Papachristidis, Anastasios Sextos

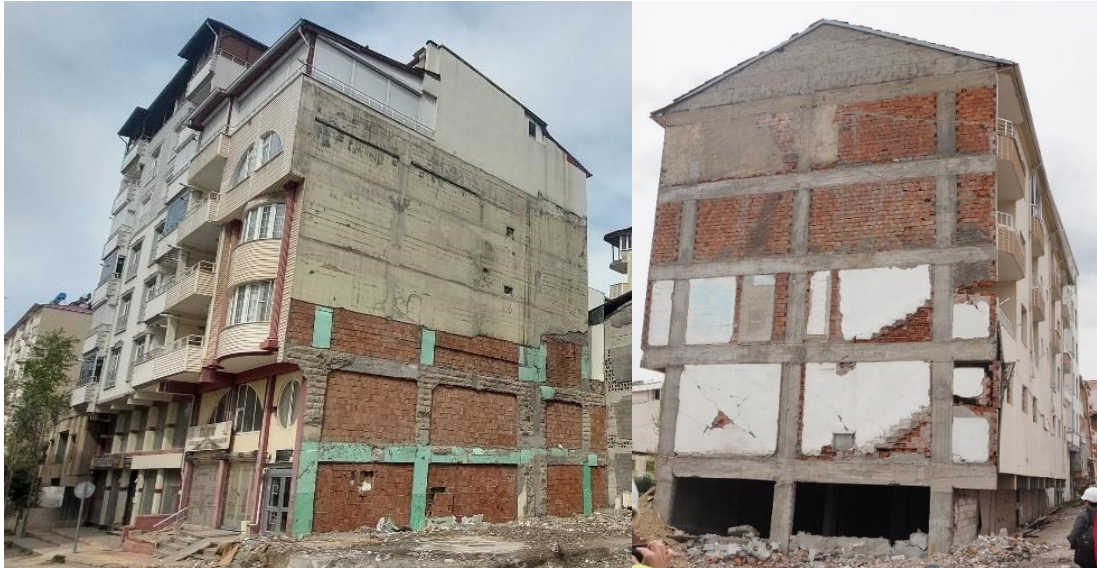
It is noted that the infill walls are not in all cases constructed with attention to details: The connection of the infill to the surrounding frame, and mainly in the upper part of the infill leads to the formation of gaps, while the construction of RC tie beams in the mid-height of the walls are not common (Figure 5.4.5). On the other hand, also local carving of the masonry has been located, serving the need of installing the plumbing and electrical features (Figure 5.4.6).

**Figure 5.4.5** Walls constructed with the use of RC tie beams.

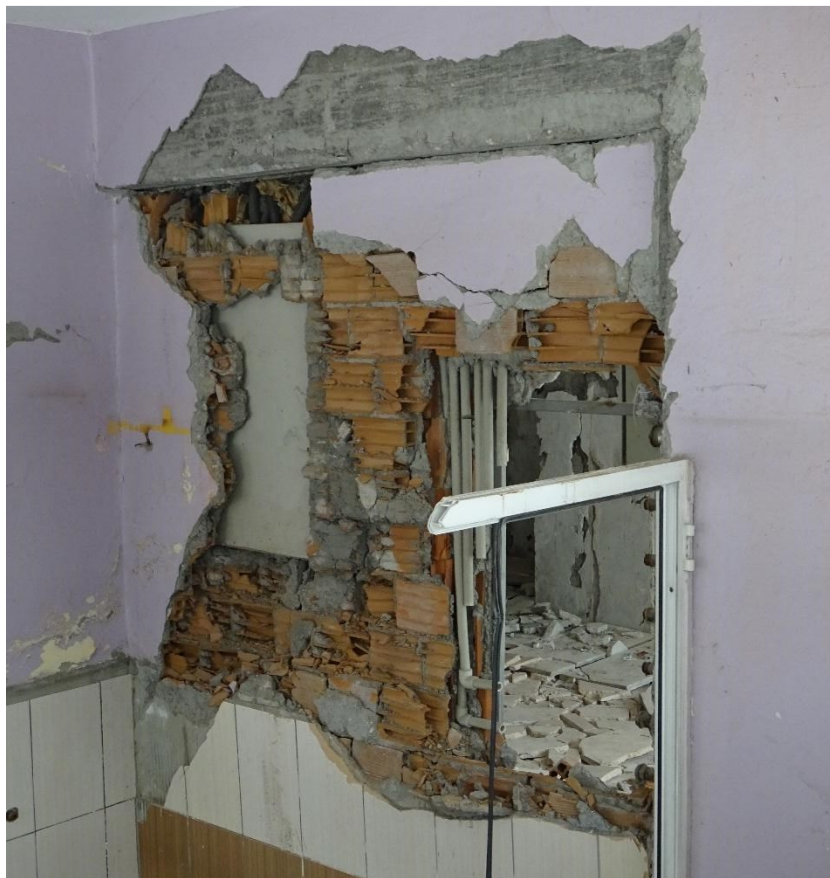
**Figure 5.4.6** Carving of the infill walls for installation of electrical and plumbing fixtures.

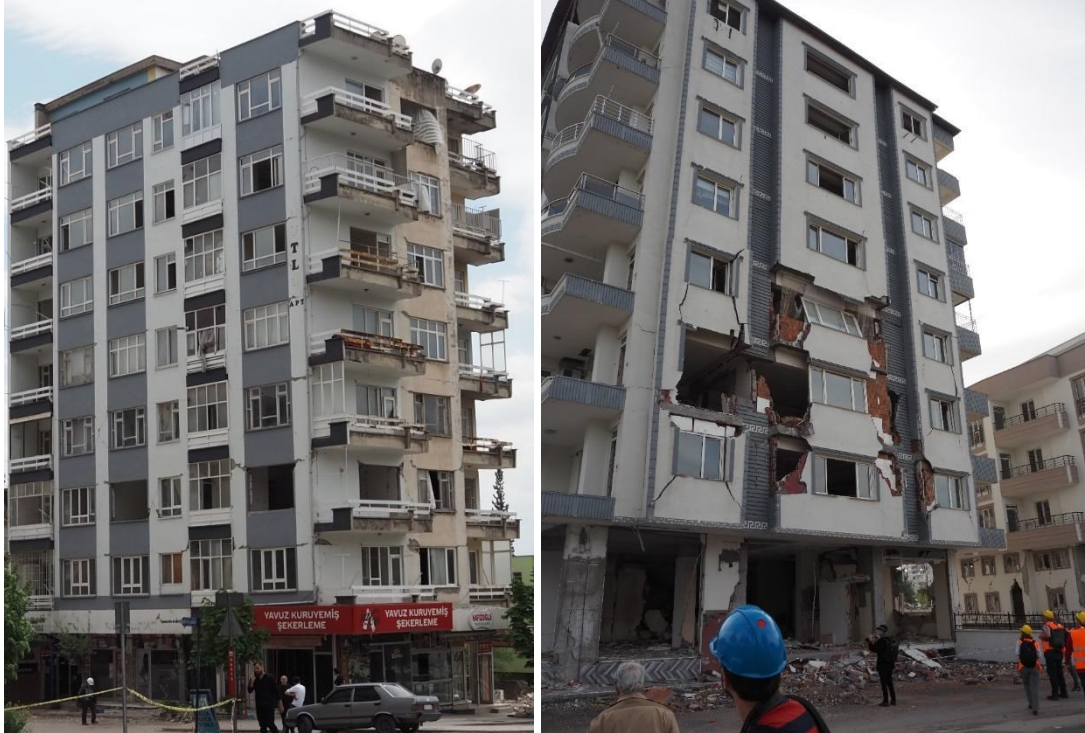
Additionally, it is common to see that the plan of the upper floors is larger than the plan of the ground floor. Overhangs, constructed upon cantilever slabs, are made of non-load bearing masonry (Figure 5.4.7). This masonry is very vulnerable when subjected to earthquake loading.

**Figure 5.4.7** Overhangs, constructed upon cantilever slabs.

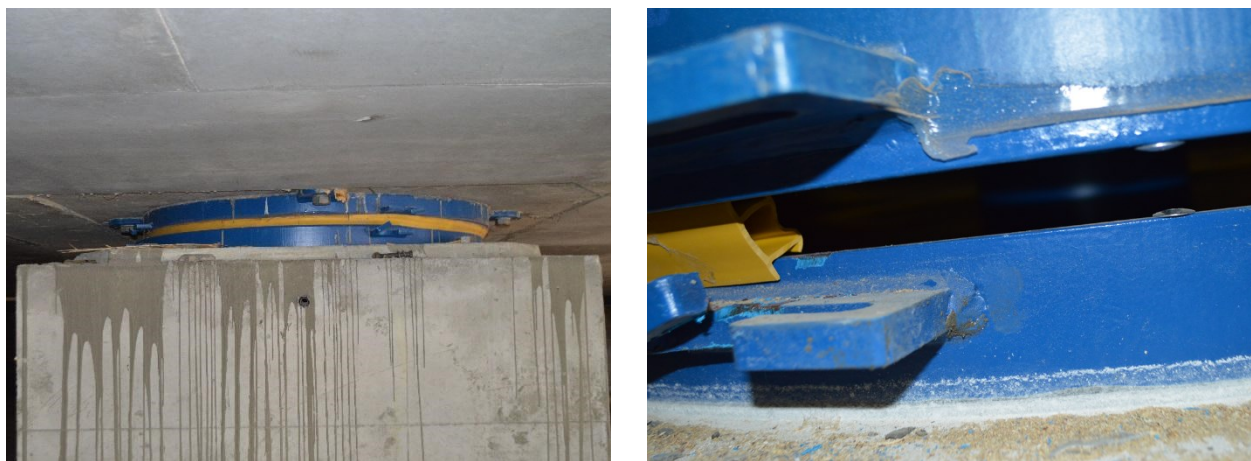
**Figure 5.5.4** Kahramanmaraş KDC Hospital (a), (b) broken isolator locks, showing that the isolation system was activated during the earthquake sequence.

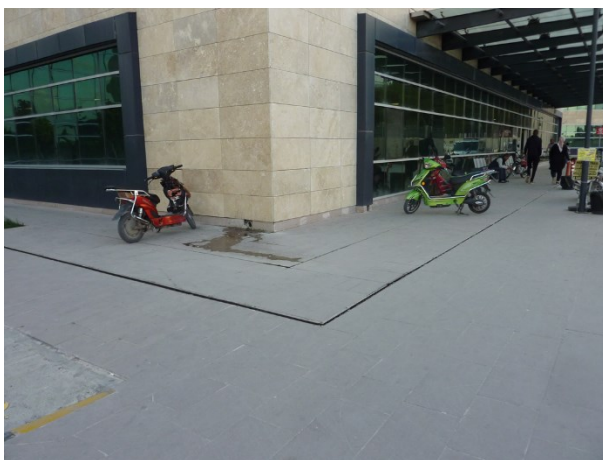
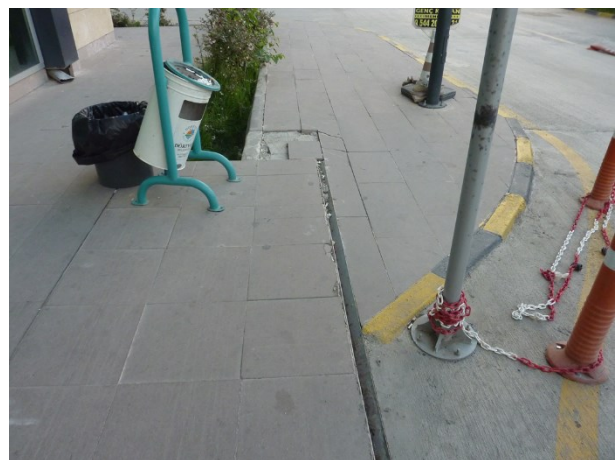
Hatay Dörtyol State Hospital (Fig 5.5.5) is another seismic isolated facility that has been constructed in 2019. It has a total number of 340 double pendulum bearings (Fig 5.5.6) (TIS). The facility has demonstrated an excellent performance during the earthquake sequence, remaining operational. The only signs of the earthquakes were a limited number of tiles that came off or had crushed edges at the seismic joint and a residual displacement (Fig 5.5.7). The latter has been estimated at 30-40mm (Fig 5.5.8).

Figure 5.5.7 Dört Yol State Hospital (a) seismic joint, (b) slightly damaged tiles at the seismic joint

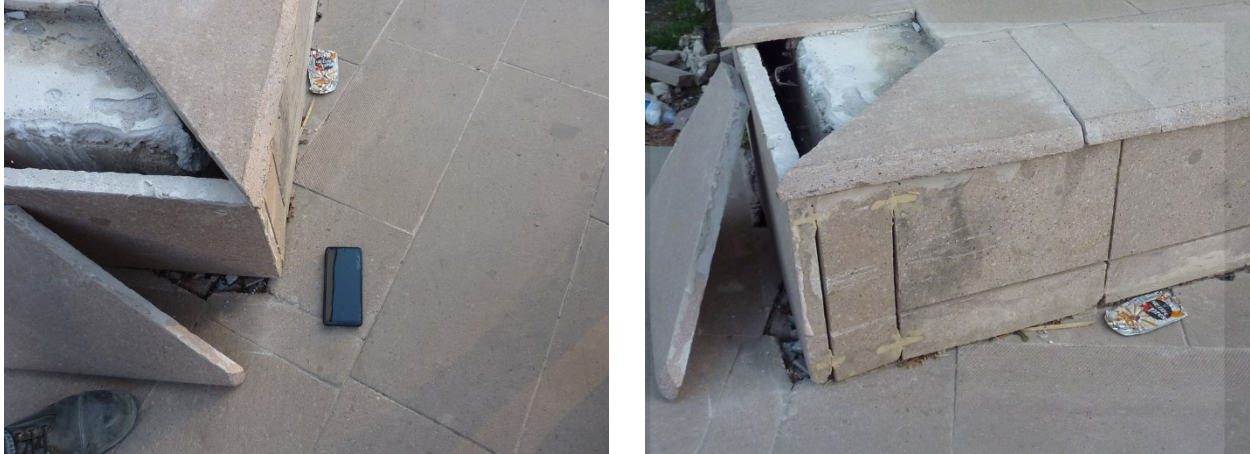
**Figure 5.5.8** Dörtyol State Hospital (a), (b) permanent displacement and damaged tiles at the seismic joint

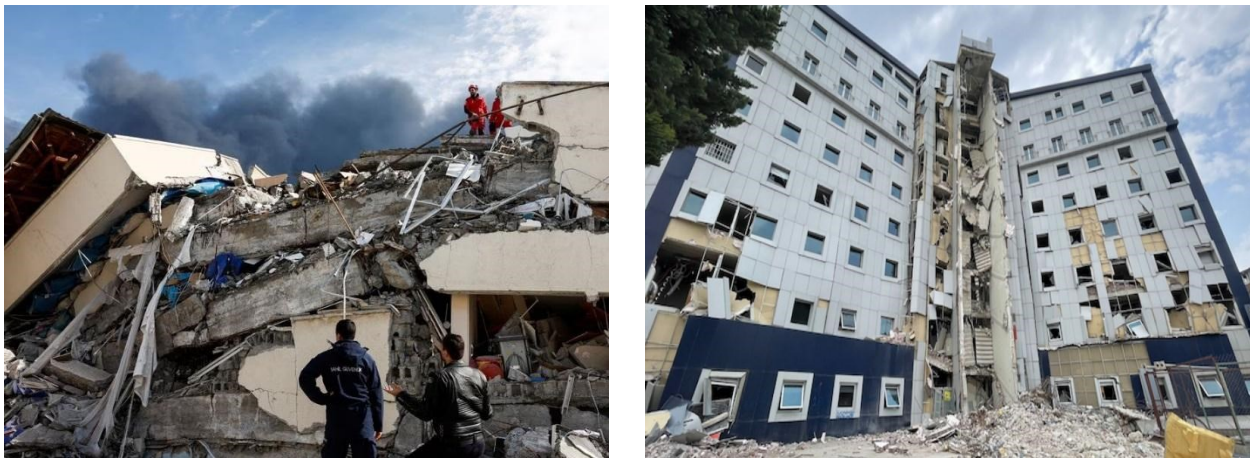
Unlike seismic isolated hospitals, most of the conventionally designed medical facilities, faced structural or non-structural damage that made them non-operational. A large number collapsed or had been demolished due to the extensive damage. Characteristic are the cases of the collapse of the Iskenderun State Hospital (Fig 5.5.9a) and the partial collapse of a private hospital in Antakya (Fig 5.5.9b).

**Figure 5.5.9** (a) Collapse of the Iskenderun State Hospital (credits: REUTERS/Tessier) (b) partial collapse of a private hospital in Antakya (Credits: Sumer et al.)

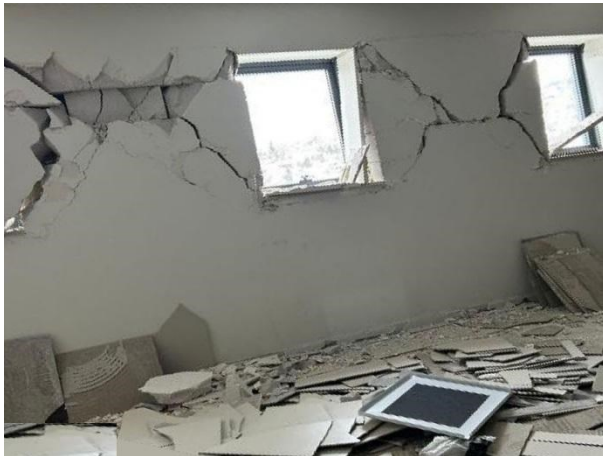
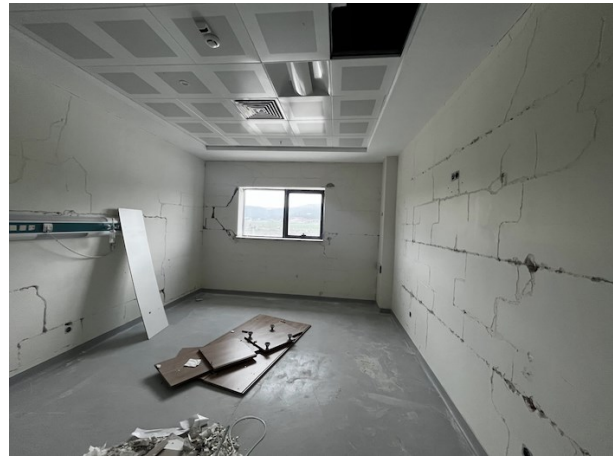
However, if heavy structural damage could have been prevented by better design and construction this is not the case for non-structural damage. Medical facilities that performed well from a structural point of view were rendered non-functional due to damage to infill walls, suspended ceilings and EM equipment. Characteristic examples of non-structural damage that prevented the function of a medical facility are the Pazarcık State Hospital (Figs 5.5.10-5.5.11) and the Nurdağı State Hospital (Fig 5.5.12).

**Figure 5.5.11** Pazarcık State Hospital (a), (b) heavy damage to the infill walls, suspended ceiling and EM equipment (photo credits: Sumer et al.)

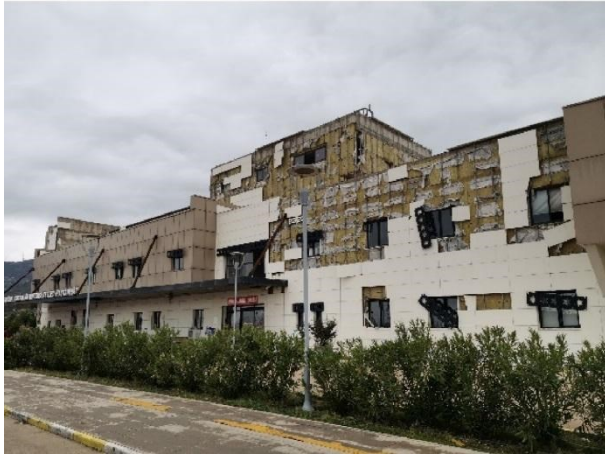
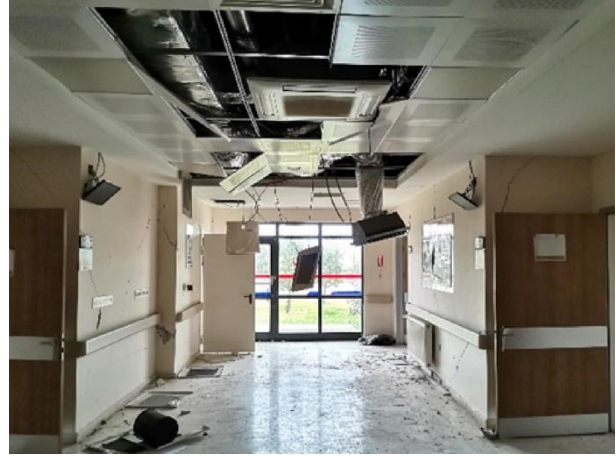
**Figure 5.5.12** Nonstructural damage to the fixed-base building F2 of the Nurdağı State Hospital (a) Façade (b) damaged suspended ceiling (Credits: Qu et al.)

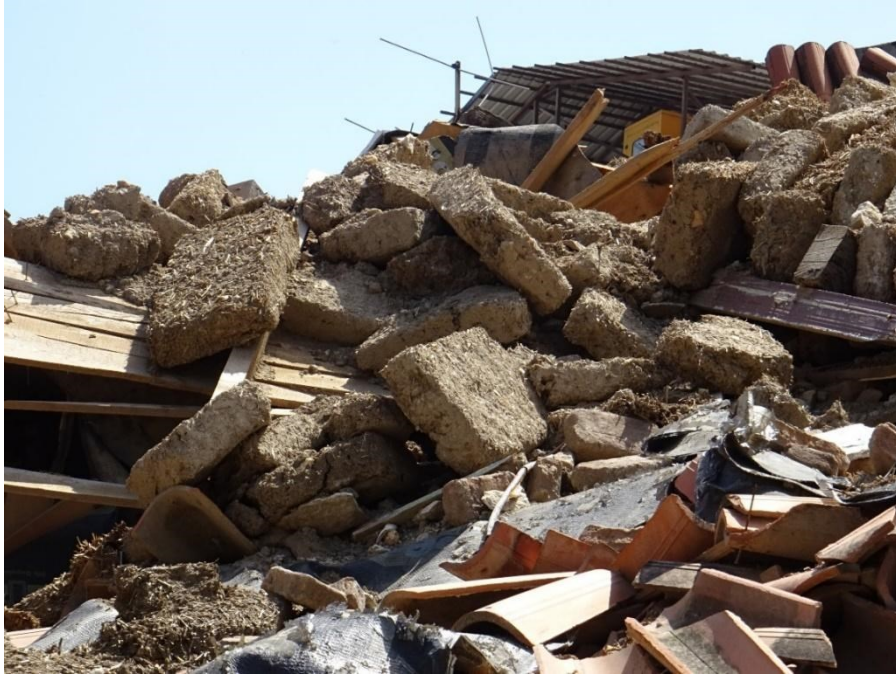
**Figure 5.6.7** Antakya, collapsed building, partly made of adobe containing straw.

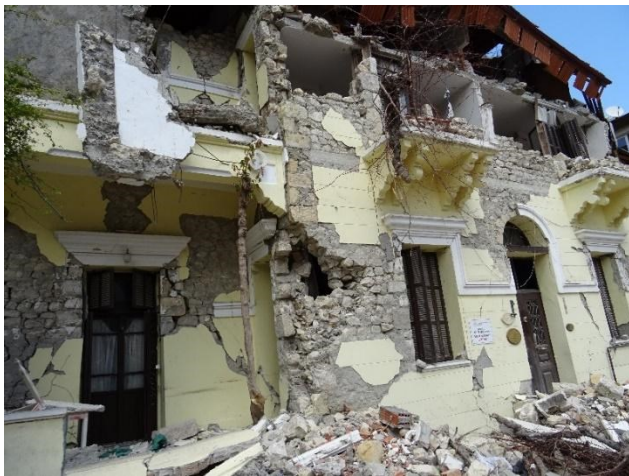
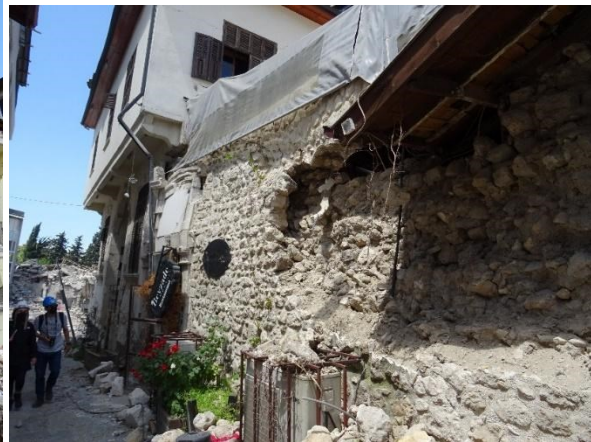
**Figure 5.6.11** Antakya, stone masonry (ground floor) and adobe (first storey)

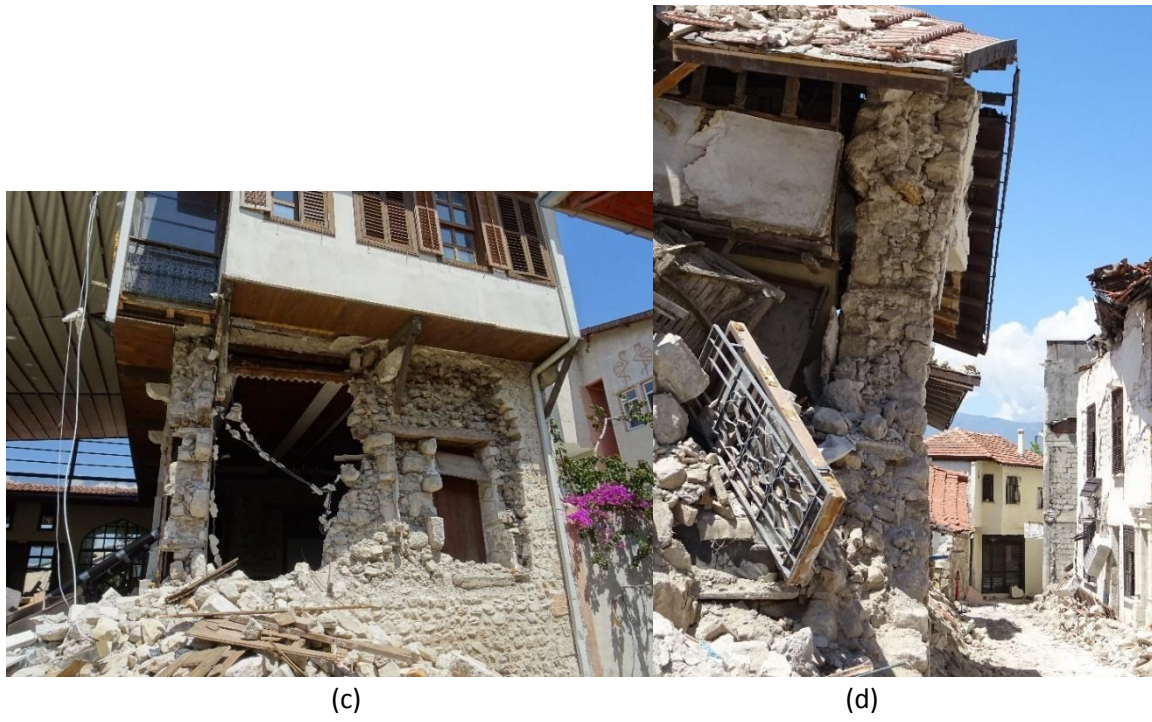
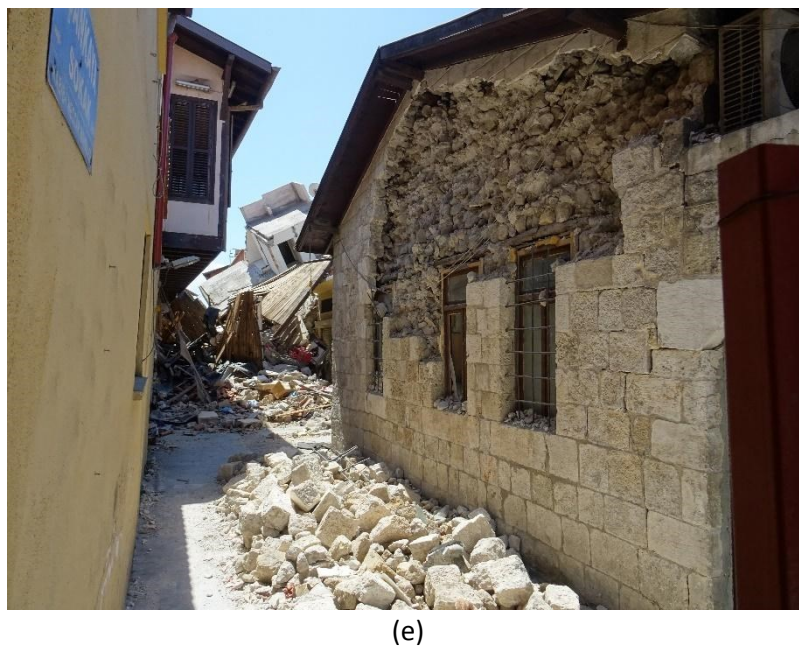
**Figure 5.6.12** Antakya, stone masonry in buildings of the historical centre

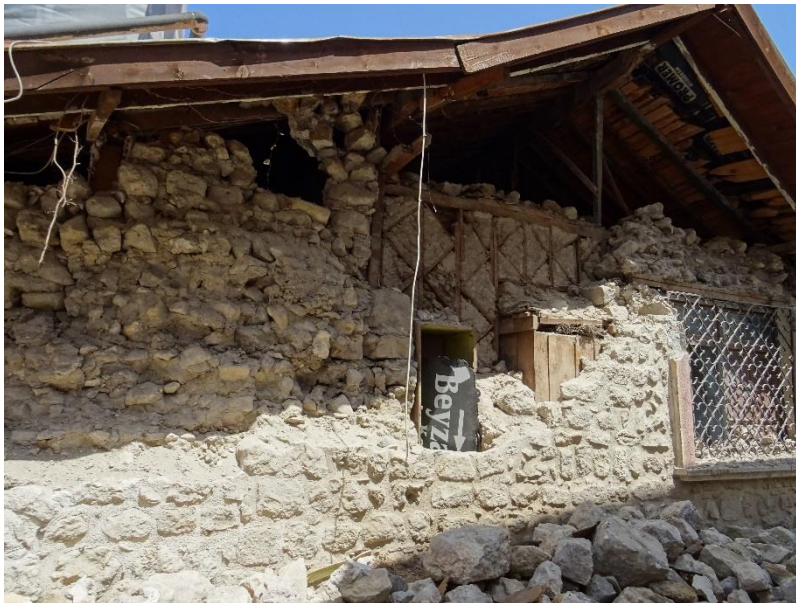
**Figure 5.6.14** Antakya, three-leaf masonry with the interior leaf made of timber-framed masonry

In few buildings, in Antakya, a different construction typology was identified, as shown in Figure 5.6.14. The exterior leaf is made of rubble stone masonry, while the interior leaf is made of timber-framed masonry. Similar construction type is identified (Figure 5.6.15 and Figure 5.6.16) in the island of Lesbos (Greece), both in Plomari and Vrissa (severely damaged due to the June 12<sup>th</sup>, 2017 earthquake).

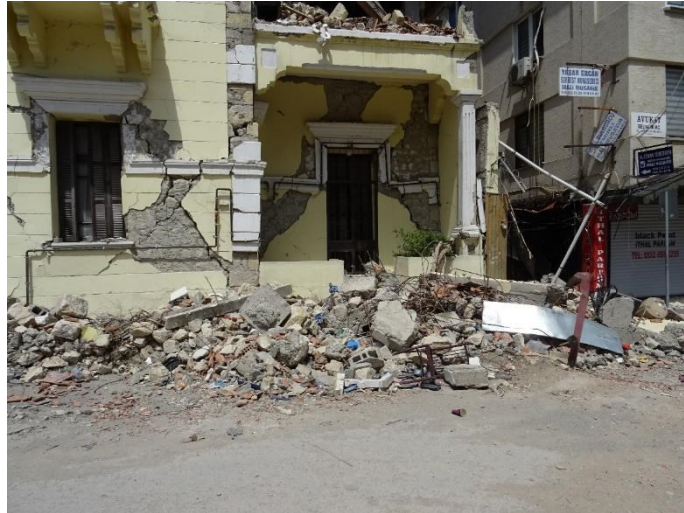
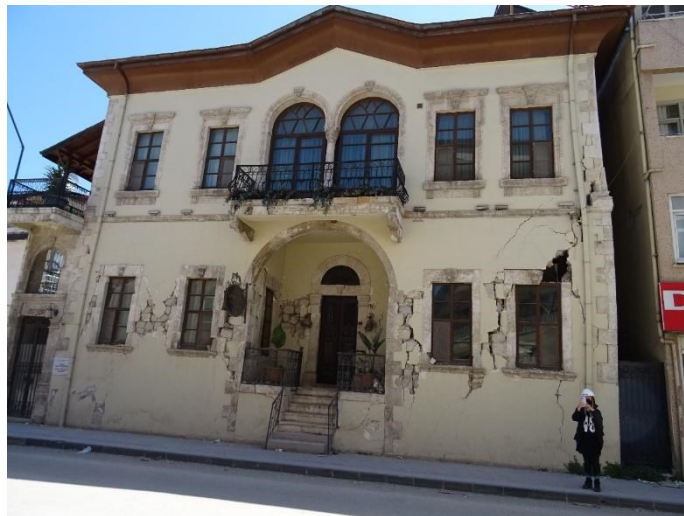
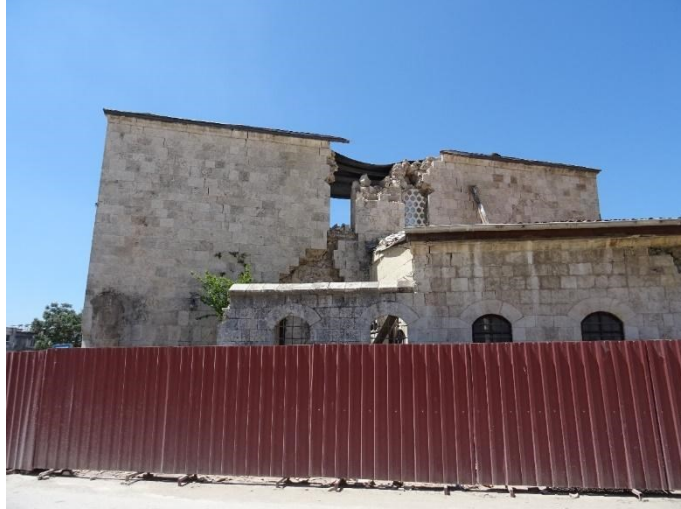
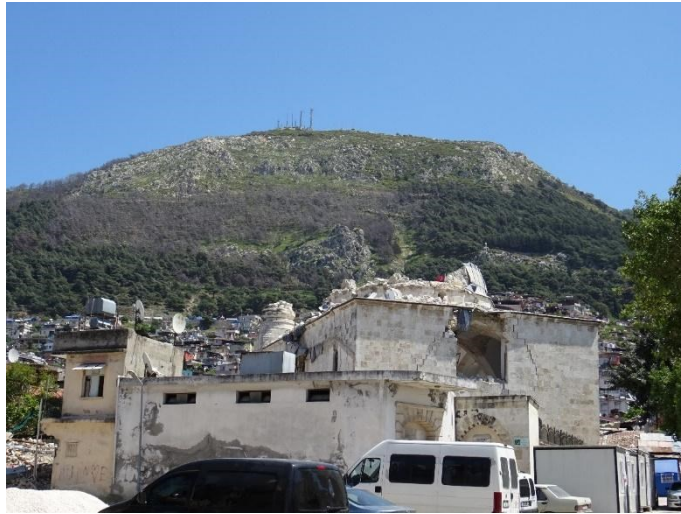
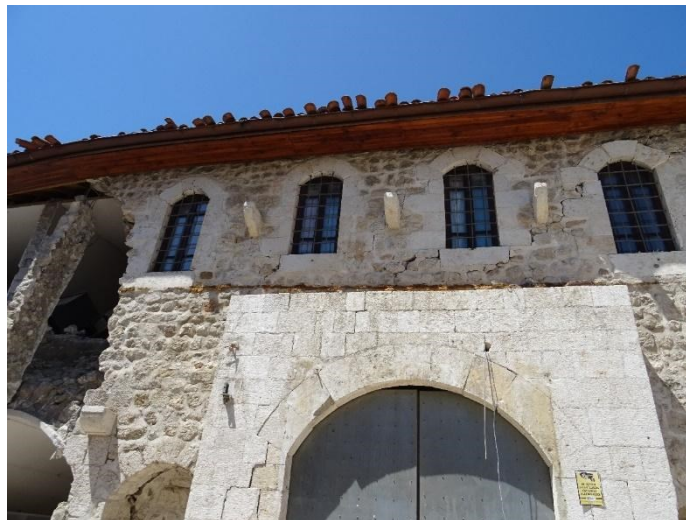
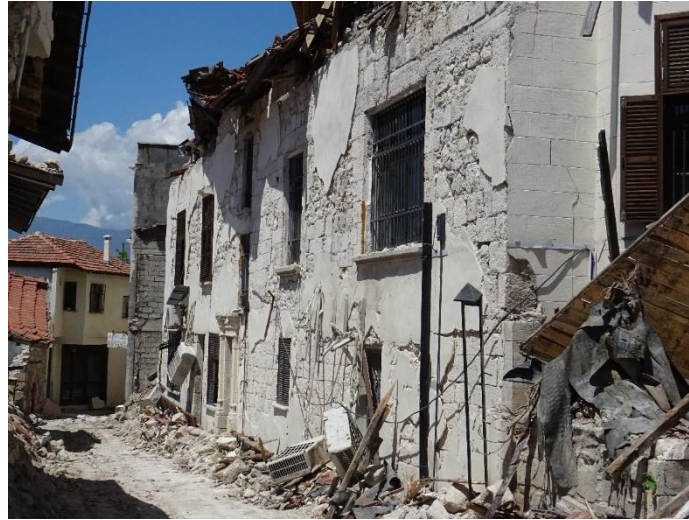
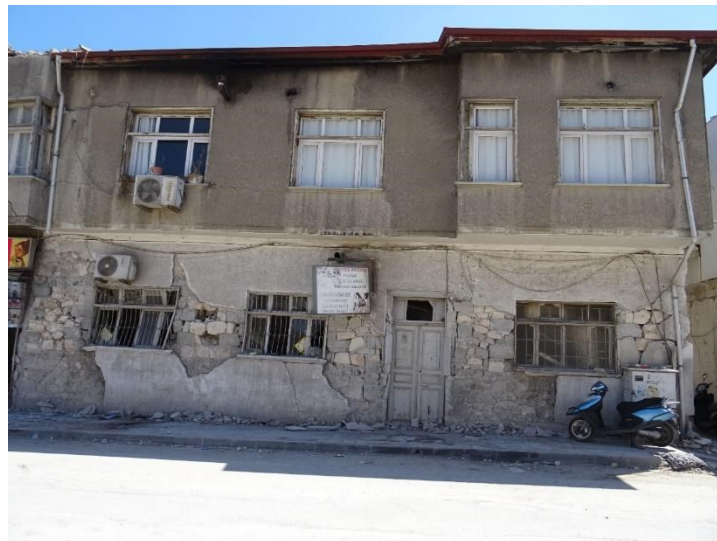
This typical damage, consisting of diagonal or bi-diagonal cracks in the walls, appears in varying degree, ranging from simple diagonal cracks of rather limited width (e.g., Figure 5.6.17c and 5.6.17d) to the occurrence of large cracks and disintegration of the walls or piers (e.g., Figure 5.6.17b and 5.6.17g). It is also observed that the oblique cracks may extend to the floor (e.g., Figure 5.6.17b and 5.6.17g).

**Figure 5.6.17** Typical damage due to in-plane shear cyclic deformation of walls.

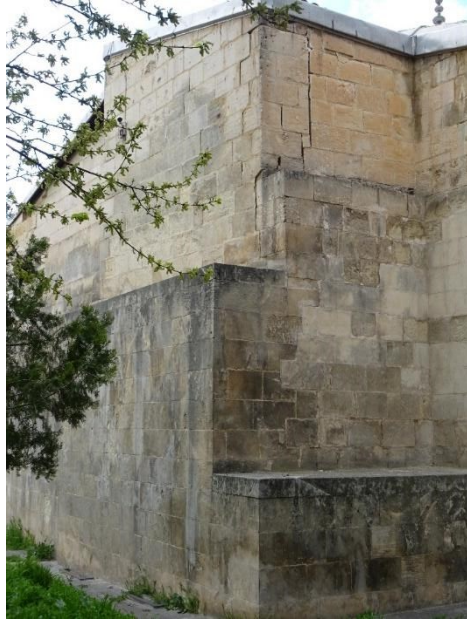
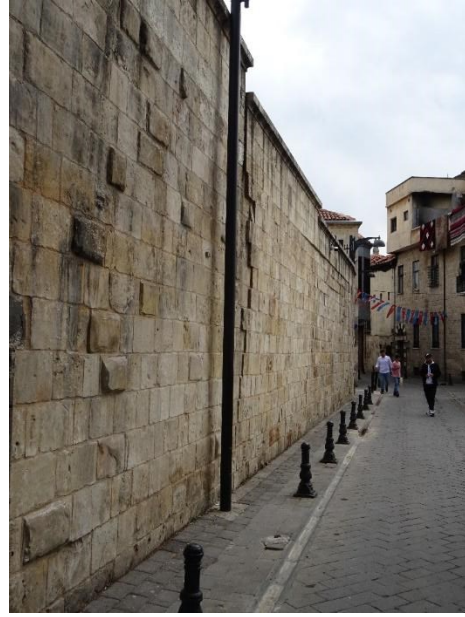
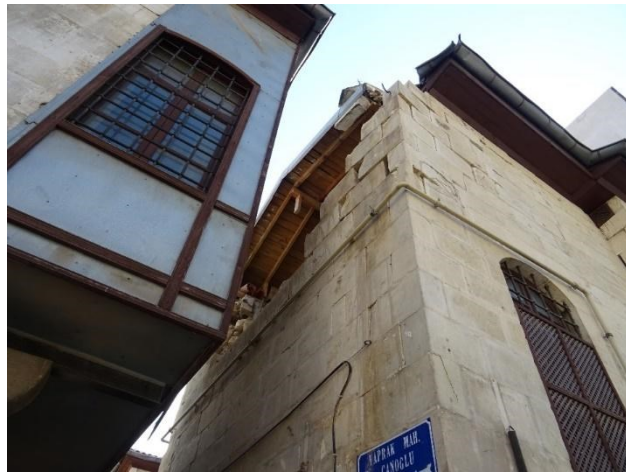
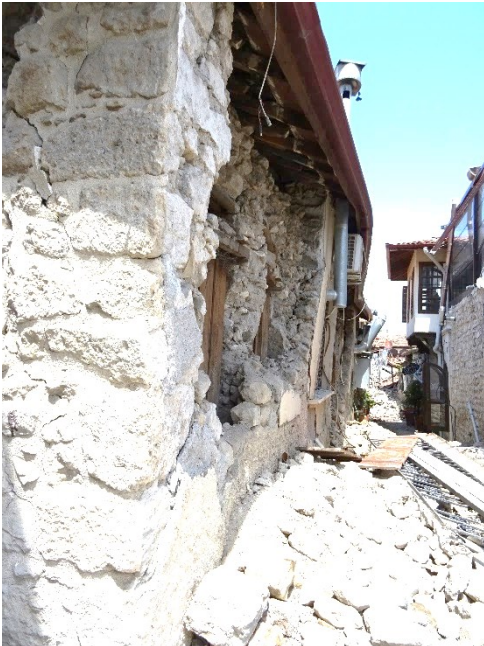
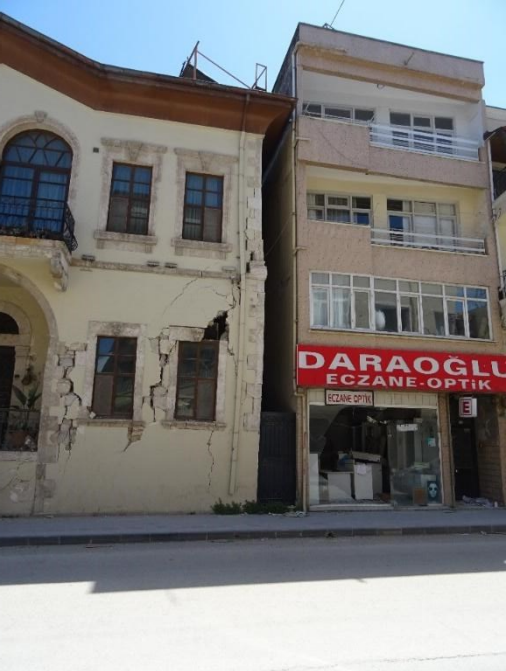
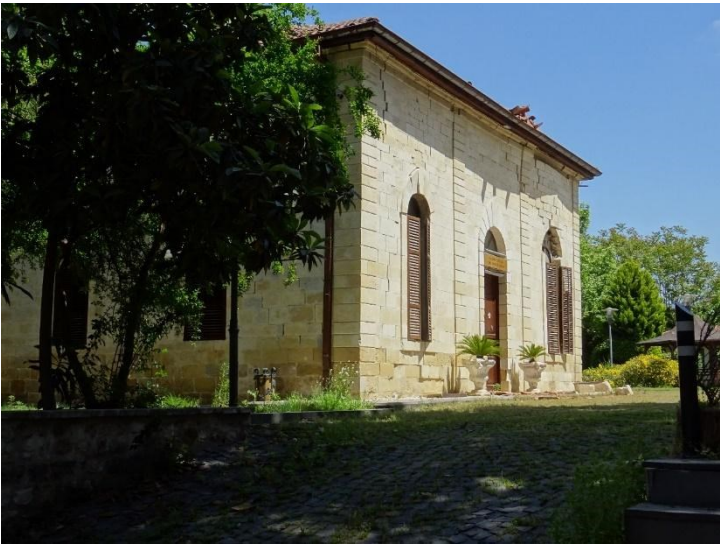
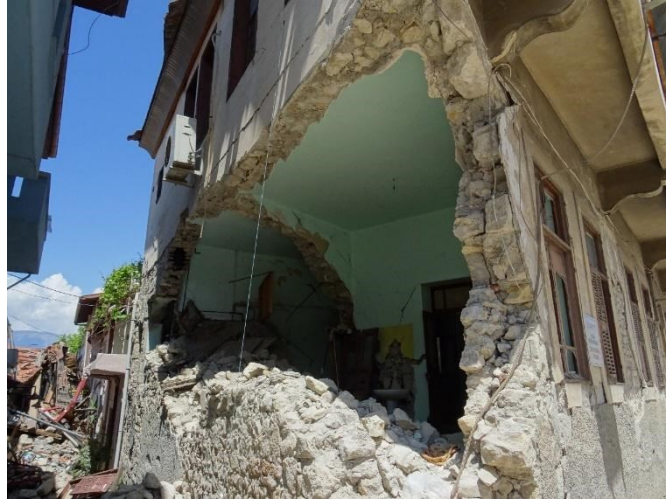
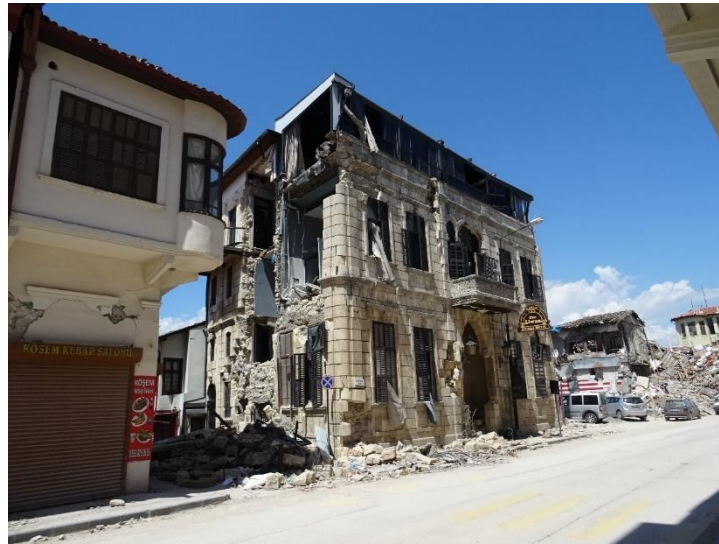
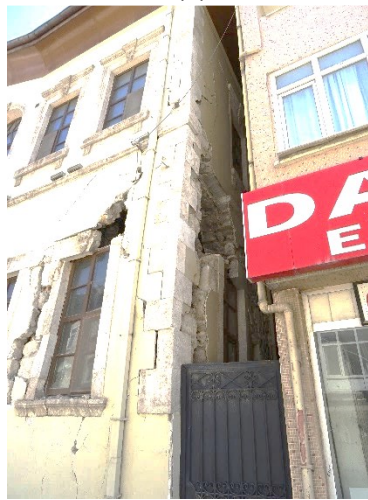
It is noted that in many buildings, there were combined in-plane and out-of-plane failures of walls. This was the case, mainly, in the historical centre of Antakya. The damage due to out-of-plane actions presents various degrees of severity, as shown in the photographs of Figure 5.6.18. It should also be noted that out-of-plane collapse of walls is frequently the cause of collapse of the roof and, hence, of injuries and/or casualties.

**Figure 5.6.18** Various degrees of damage due to out-of-plane action of the earthquake, in buildings (a) to (c) at Gaziantep, (d) to (i) Antakya

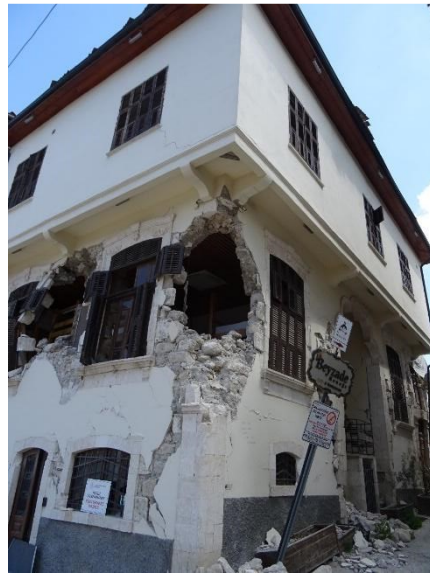
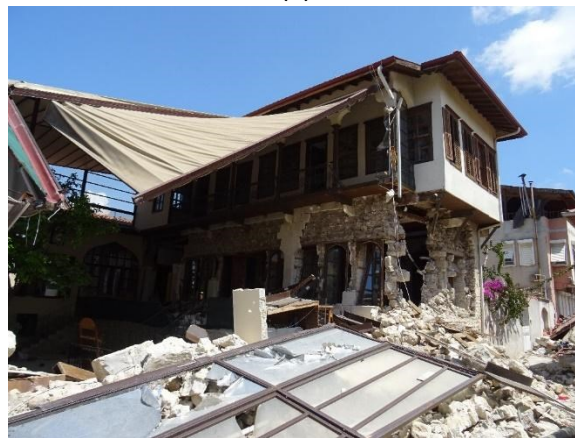
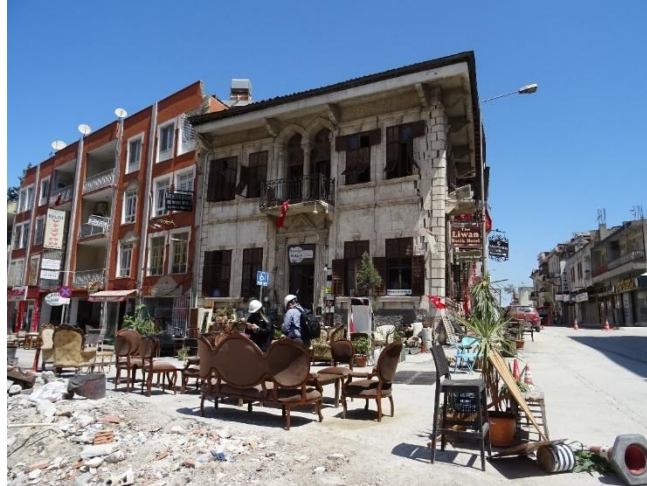
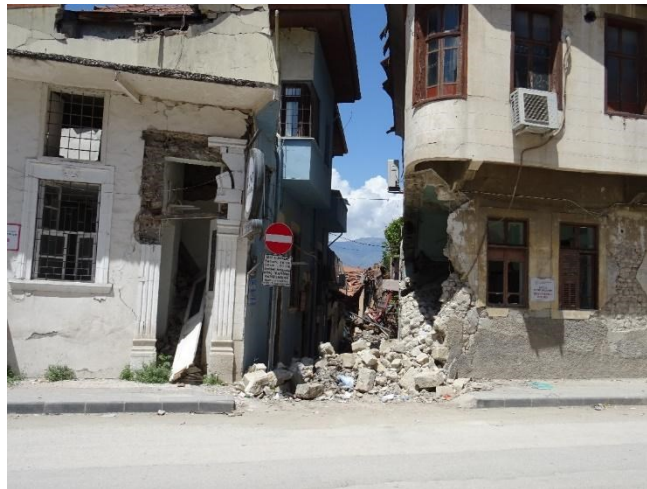
This is a specific and quite frequent damage that may cause partial collapse of the building. Indeed, the pier at the corner of the building is subjected to a combination of in- and out-of-plane actions, as well as to significant variation of its axial load during the earthquake. As a result, it may be disintegrated, or it may collapse. The effect of such a collapse on the overall stability of the building depends, among others, on the availability of other walls of significant sectional dimensions. The detrimental effect of openings close to the corners of buildings is illustrated in the photographs of Figure 5.6.19.

**Figure 5.6.19** Unreinforced masonry building in Antakya. The detrimental effect of openings close to the corners.

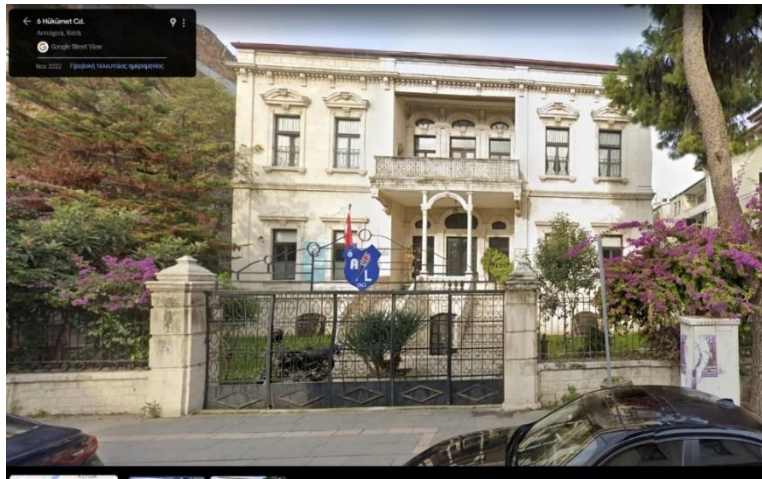
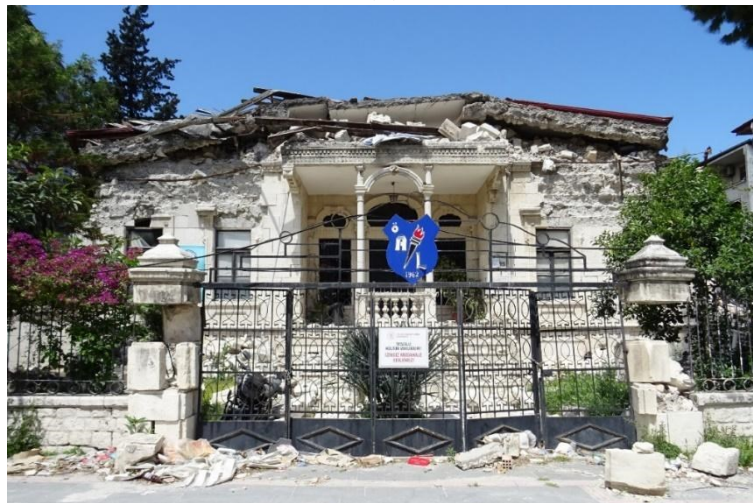
(b) the failure mode shows that the reinforced concrete slab was simply resting on the walls. Although the purpose of the intervention was to provide a stiff diaphragm at the top of the building, the addition of a significant mass, unconnected to the non-strengthened masonry walls of vulnerable construction typology has led to the partial or complete collapse of the upper storey of several buildings.

similar case is shown in Figures 5.6.21, 5.6.23 and 5.6.24. In Figure 5.6.22, the walls at the façade of the building have collapsed out-of-their plane. The RC slab has lost its support.

**Figure 5.6.21** Antakya, a historic building (a) before the earthquake (Google map, street view) and (b) after the earthquake

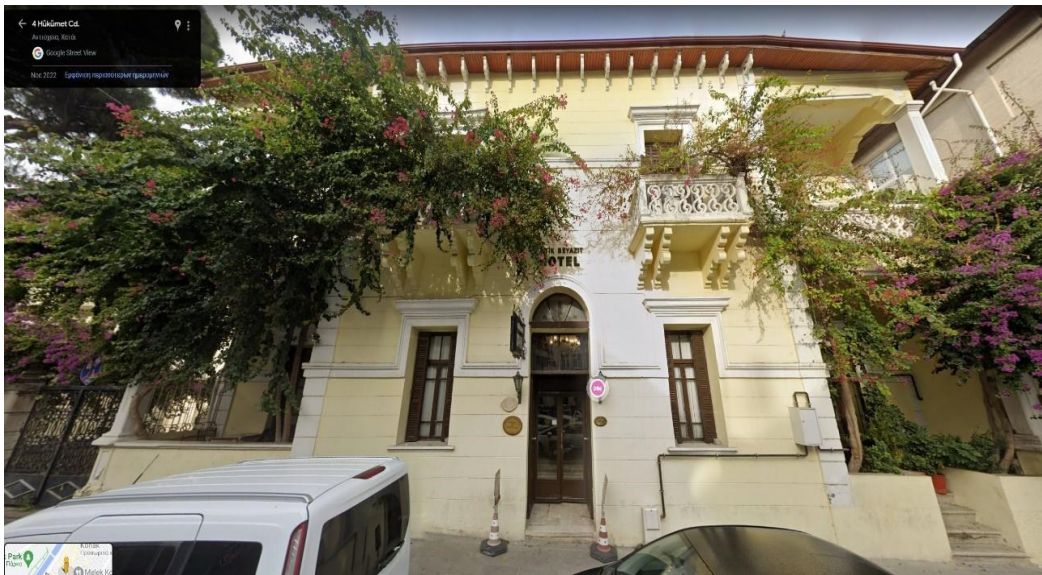
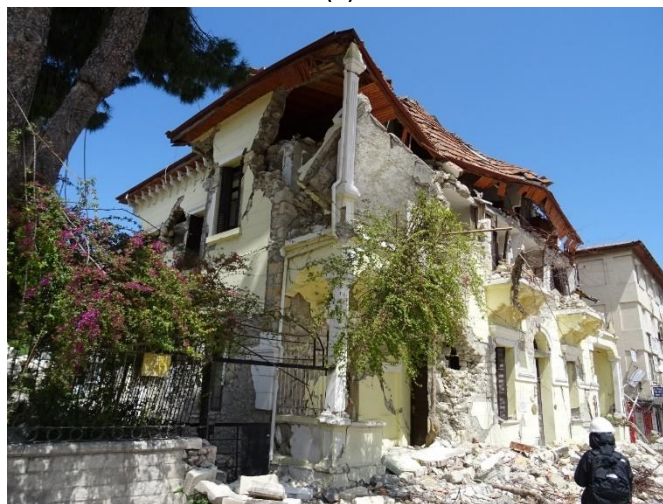
**Figure 5.6.22** Antakya, a historic building (a) before the earthquake (Google map, street view) and (b) after the earthquake

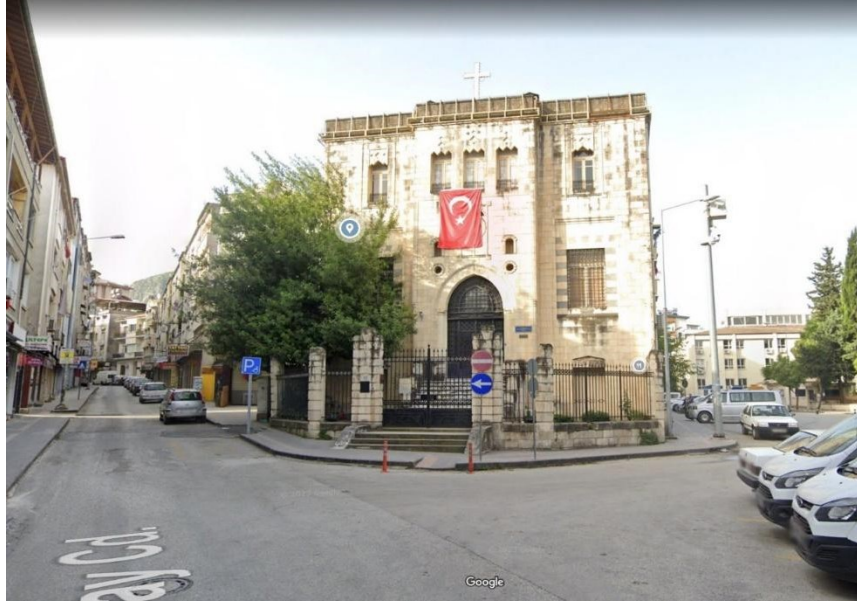
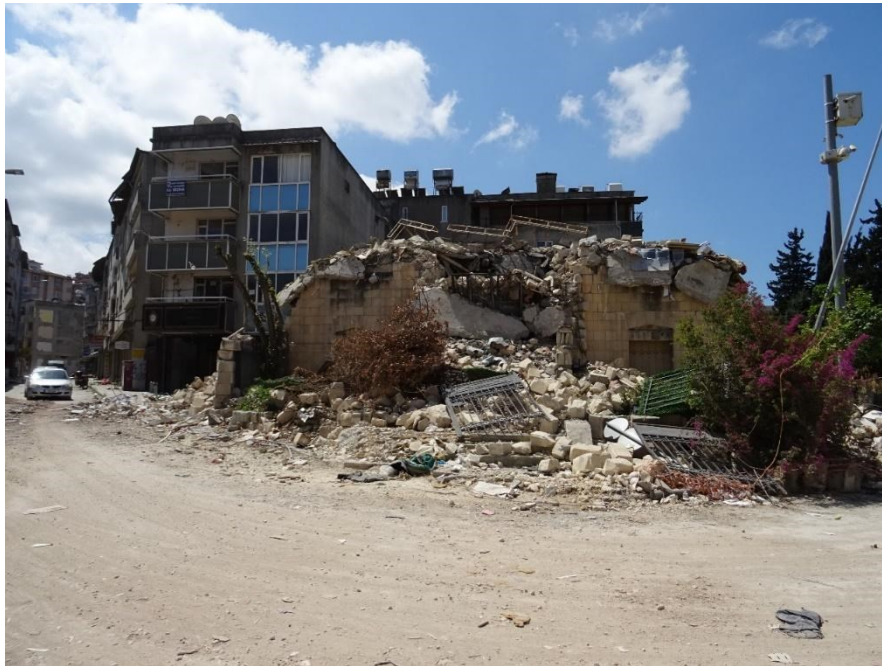
**Figure 5.6.23** Antakya, the collapse of both storeys of a historic building (Protestant church). Fragments of RC slab(s) are visible on the ruins, (a) the building before the earthquake (Google map, street view), (b) after the earthquake

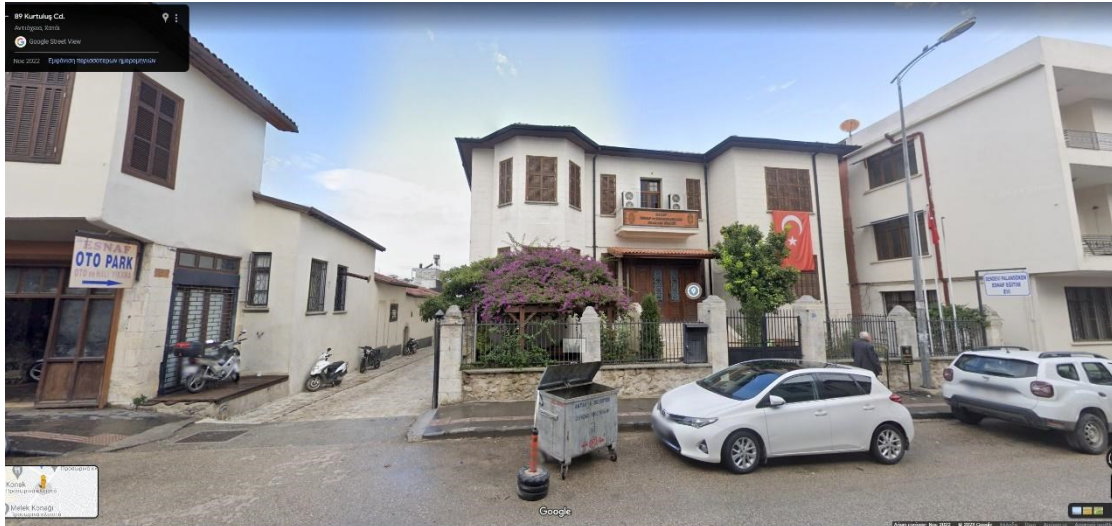
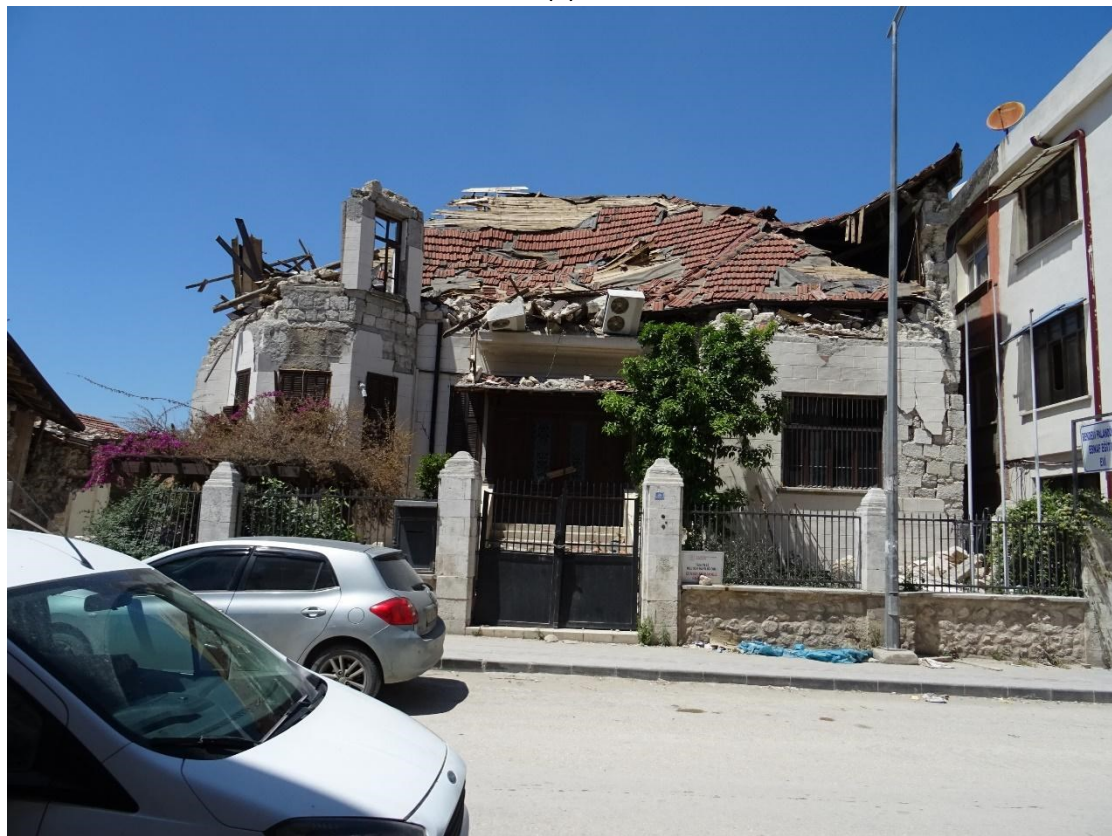
**Figure 5.6.24** Antakya, historic building (a) before the earthquake (Google map, street view), (b) after the earthquake.

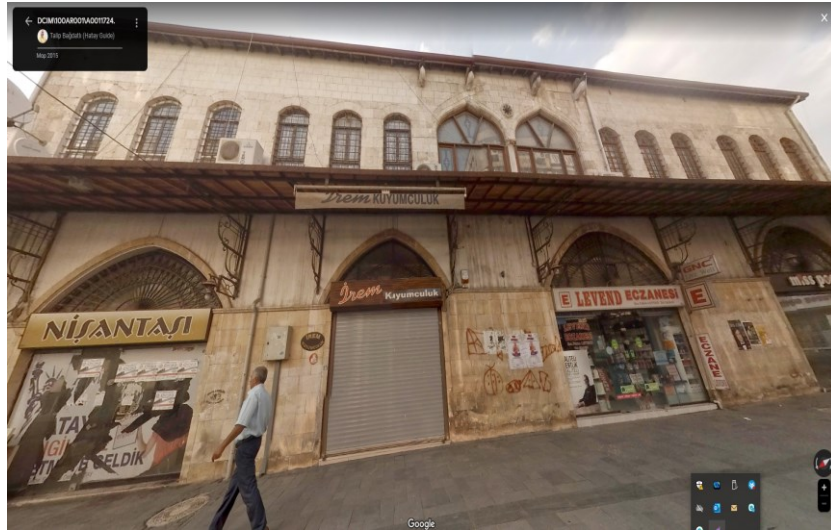
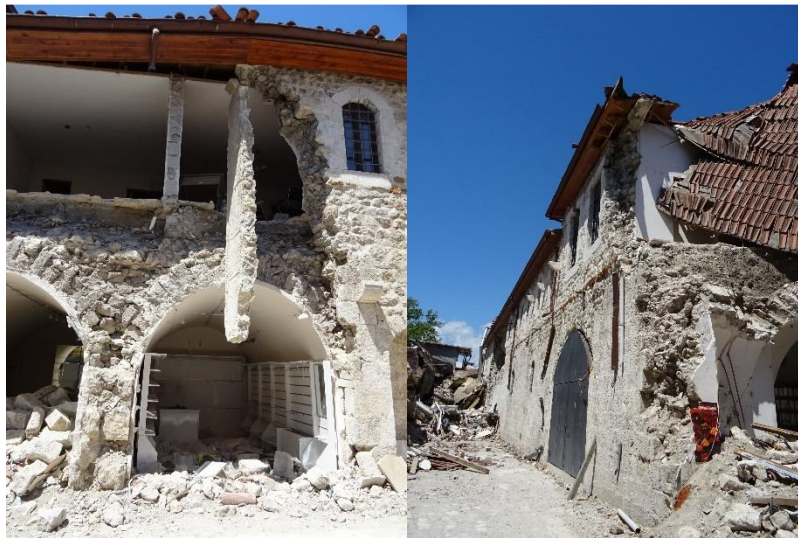
Another case, that of a historic “han” (inn), is shown in Figure 5.6.25. The RC tie beam constructed at the top of the second floor has collapsed (Figure 5.6.25b), following the out-of-plane collapse of the façade wall. In the second photo of Figure 5.6.25b, one can see that the RC tie beam was constructed only on top of the interior leaf of the masonry wall. It seems that cement mortar was used as filling material over the vaults.

**Figure 5.6.25** Old inn (han) in Antakya: (a) Before the earthquake (Google map, street view), (b) after the earthquake

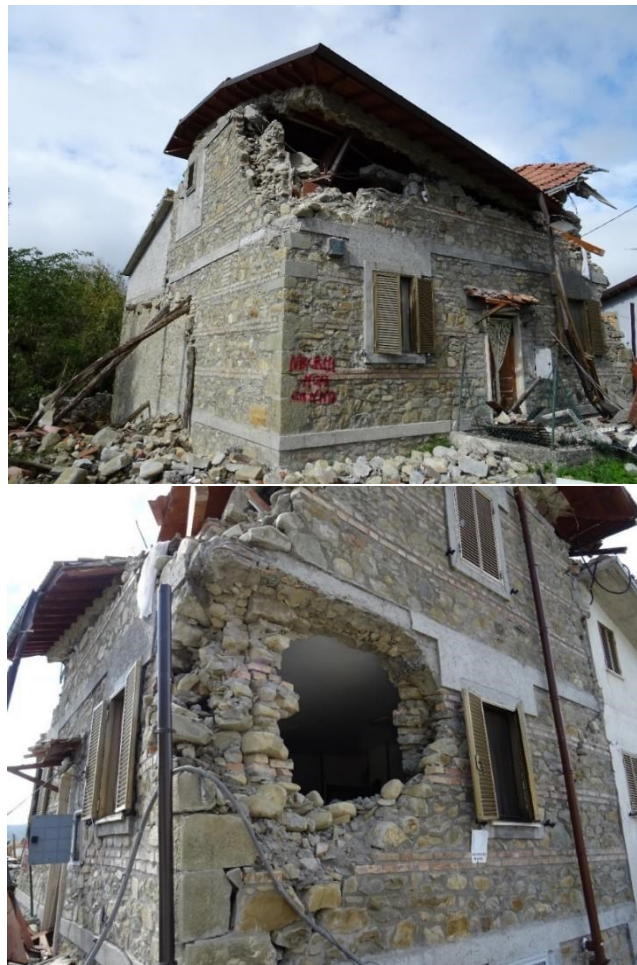
An example of interventions using RC is shown in Figure 5.6.27: A RC slab has replaced the timber floor of the first storey. RC tie beams were provided to masonry at three levels, along with stiff RC lintels to the openings in both storeys. The photo shows that the roof is made of timber, and it is sitting on the RC tie beam. The three-leaf stone masonry is not taken care of. The intervention could not prevent the out-of-plane collapse of the upper storey masonry walls along two sides of the building, Partial collapse of the wall at the corner of the building did occur in the lower storey as well.

**Figure 5.6.27** Illica, Italy, after the 2016 Rieti earthquake: The effect of interventions to a masonry building
