NATIONAL  
TECHNICAL  
UNIVERSITY  
OF ATHENS

# The February 6<sup>th</sup> Kahramanmaraş earthquake sequence in Türkiye

*Technical Report*

Aristidis Papachristidis, Anastasios Sextos

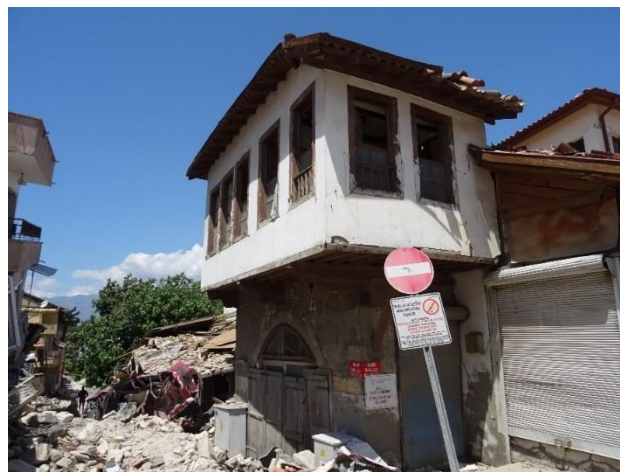
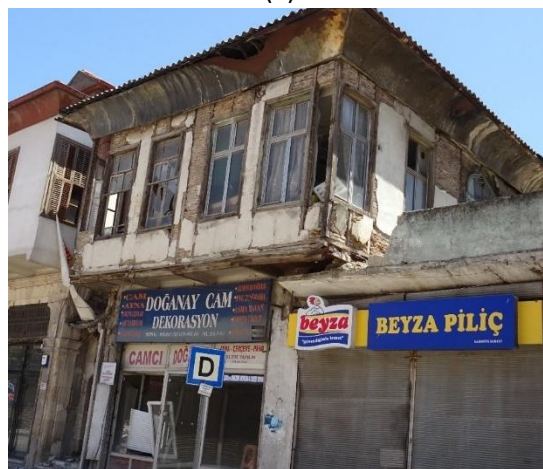
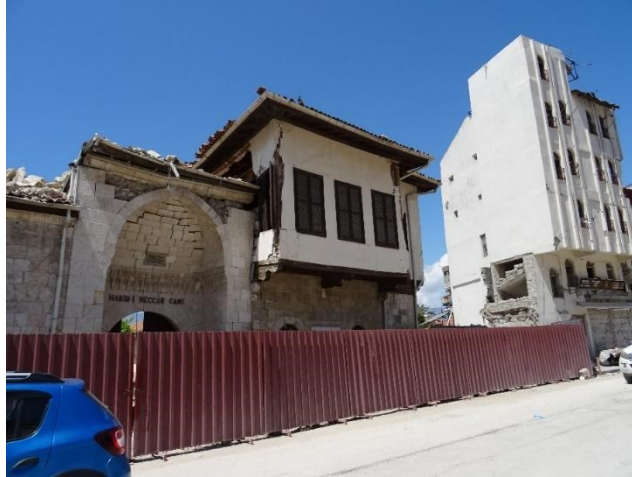
**Figure 5.6.29** Antakya, buildings constructed according to the historical structural system, (a) Typical building, (b) Building in continuous system. Most probably, the large doors in the ground floor are not original. The building may have survived thanks to the adjacent buildings, (c) The damage in the upper storey is due to the interaction of the building with the adjacent entrance to the Habib-i Nejjar Mosque.

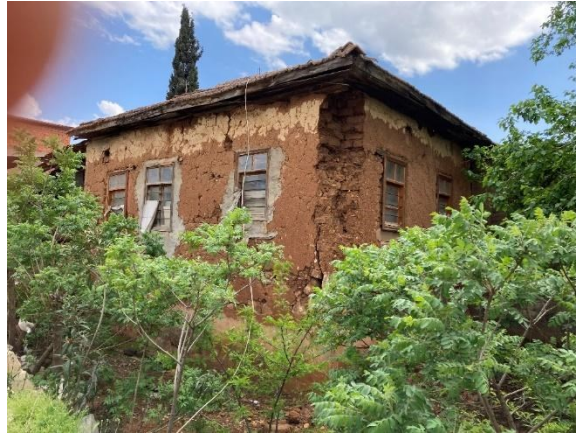
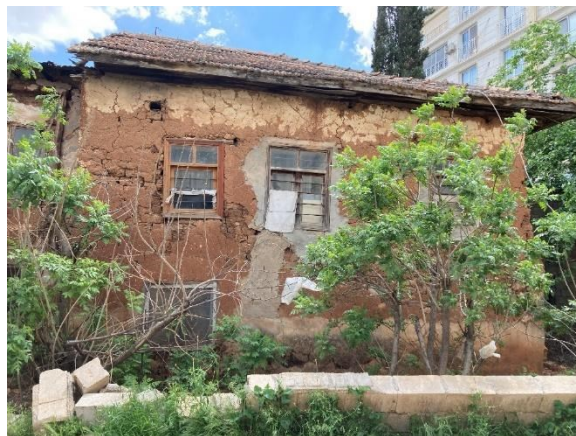
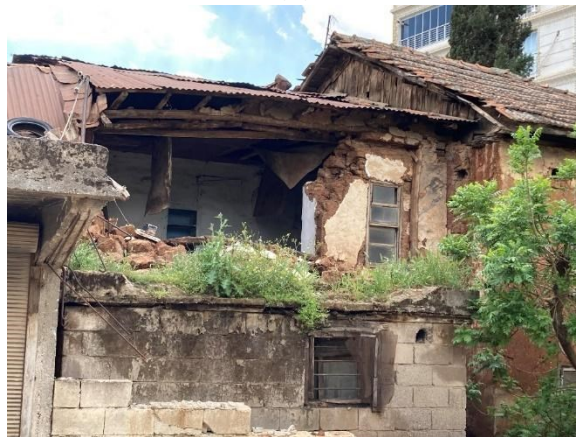
A small number of adobe buildings are still in use at Islahiye. Reportedly, their total number does not exceed twenty. The few inspected buildings (Figure 5.6.30) present damage typical for unreinforced masonry buildings, namely, vertical cracks in the walls due to out-of-plane actions and tendency of separation of perpendicular walls (Figure 5.6.30a), shear cracks (Figure 5.6.30b) and out-of-plane collapse of walls (Figure 5.6.30c).

**Figure 5.6.30** Islahiye, adobe buildings and their damage.

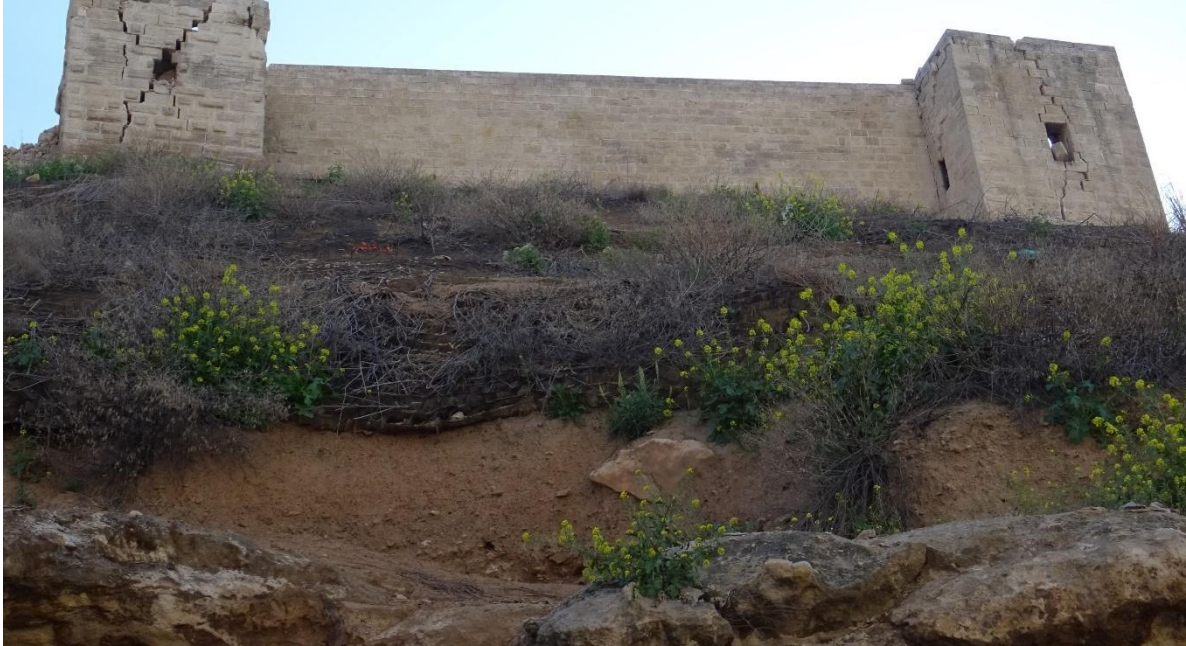
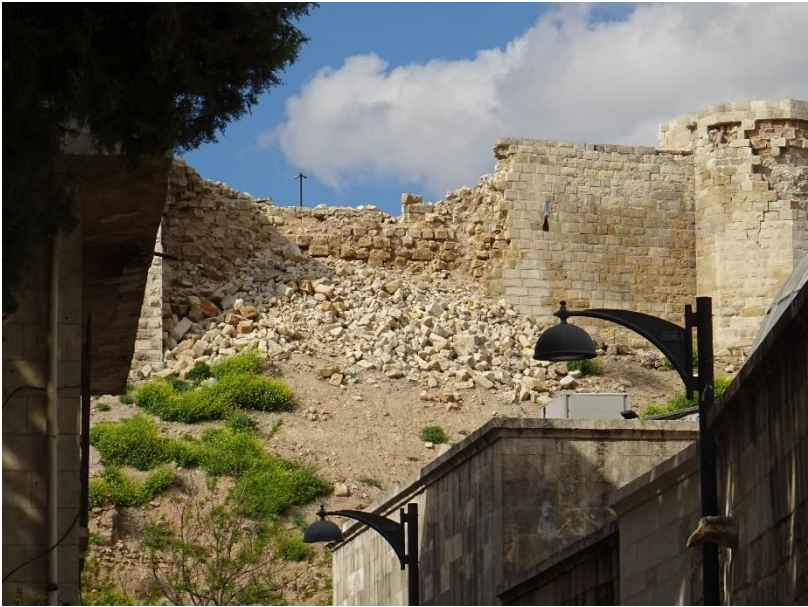
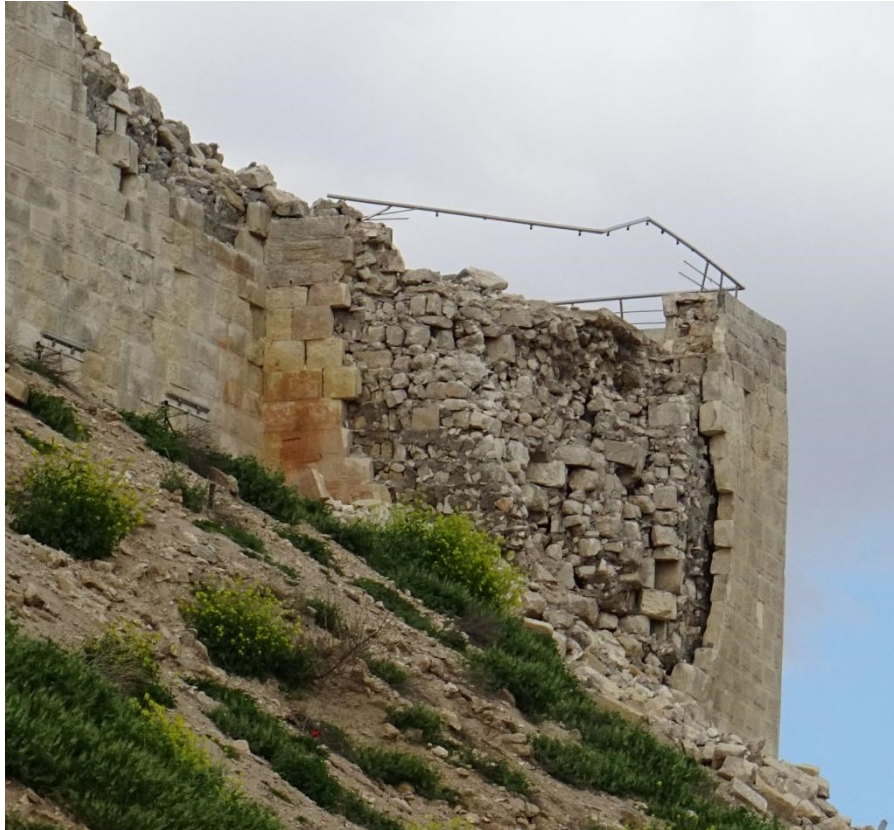
The castle (Figure 5.6.31), dating back to the Roman era, was preserved in a seemingly good state, having been subjected to several interventions during its lifetime. However, the history of the monument, including events that have affected its structural behaviour is not known to the team. Extensive and severe damage has occurred, as shown in Figure 5.6.32. Shear cracks (Figure 5.6.32a) out-of-plane collapse of the exterior leaf of masonry (Figure 5.6.32b), disintegration of thick masonry elements (towers, Figure 5.6.32c). The masonry typology and the observed damage prove that strengthening of this vulnerable masonry was not among the measures taken to protect the monument against earthquakes.

**Figure 5.6.32 Gaziantep Castle, Damage observed in various parts of the monument**

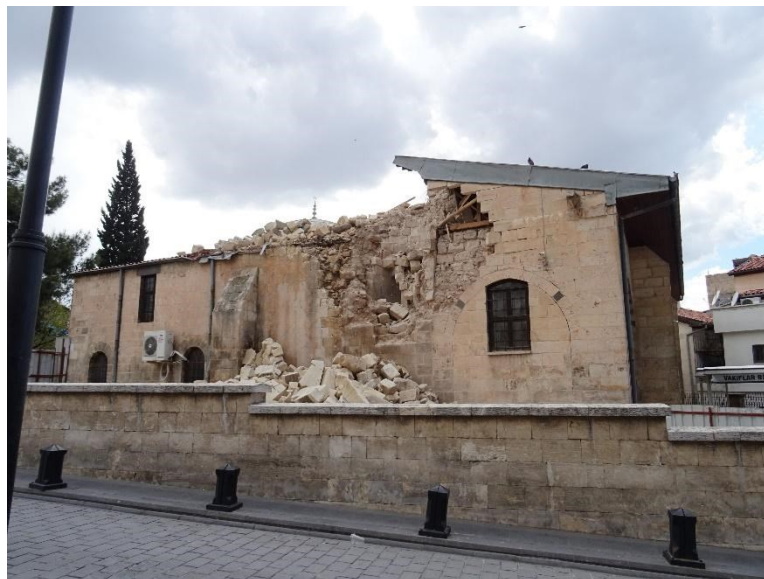
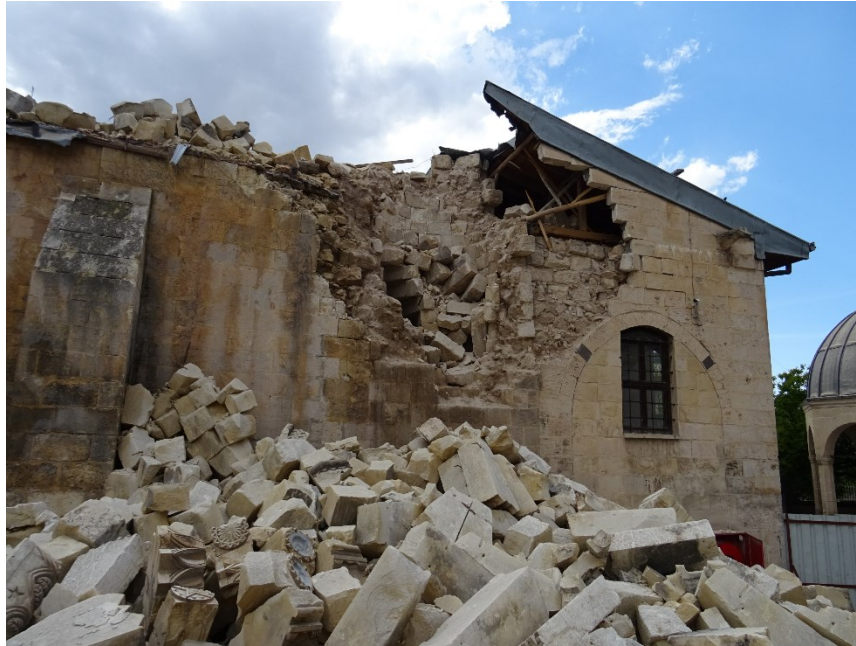
The 17<sup>th</sup> century mosque (Figure 5.6.33) was in good state before the earthquake. Its current state is apparently due to the collapse of the minaret (Figure 5.6.34). The current situation, and the limited access to the monument do not allow for further causes of damage to be identified, although there are some typical cracks in the walls due to in-plane shear. Furthermore, the damage to the perimeter masonry reveals the vulnerable (three-leaf) masonry typology identified in historical buildings as well.

**Figure 5.6.34** The mosque after the earthquake, damage due to the collapse of the minaret

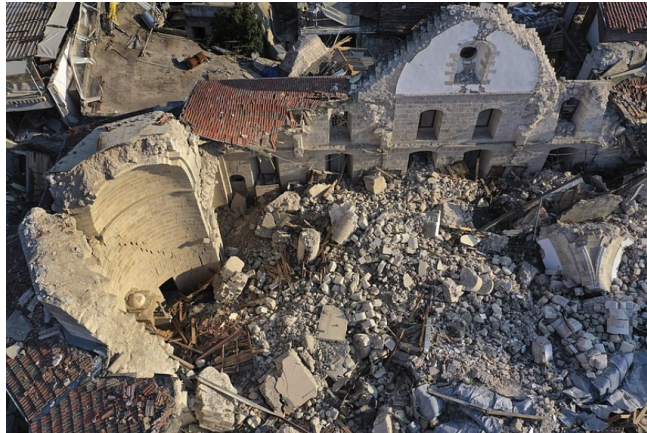
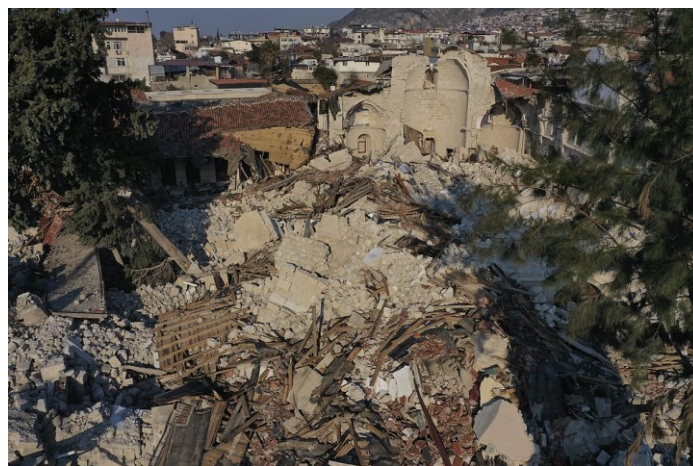
**Figure 5.6.36** The Greek Orthodox church at Antakya, after the earthquake (source: timesfreepress.com)

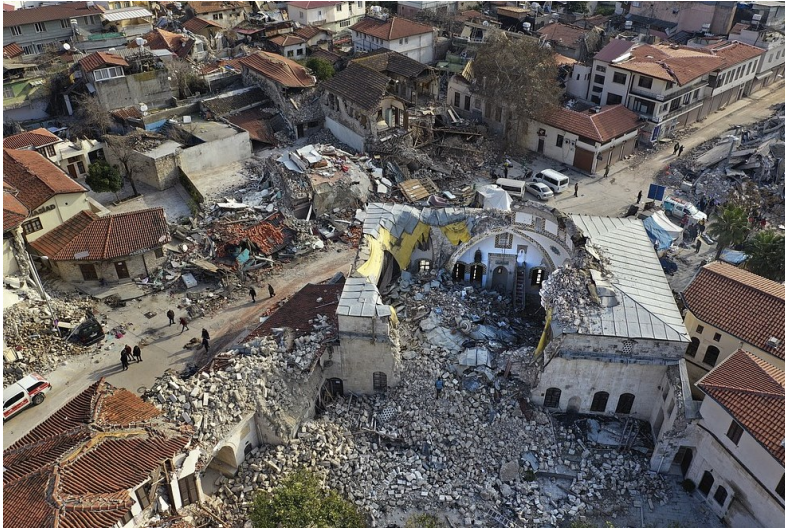
**Figure 5.6.38** Aerial view of the monument after the earthquake (source: timesfreepress.com)

The monument was severely damaged (Figure 5.6.38). Although it is certain that the observed damage is due to the collapse of the minaret, one may observe the poor quality of masonry that was completely disintegrated, as well as damage typical for unreinforced masonry structures (e.g., shear cracks, Figure 5.6.39). It is admitted though that the current state of the monument does not allow for further interpretation of the damage and partial collapse.

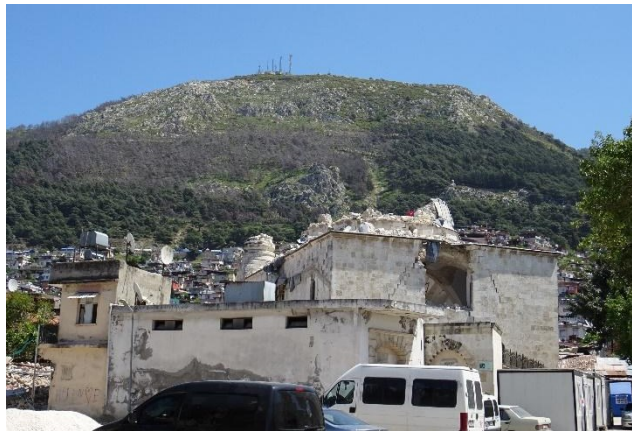
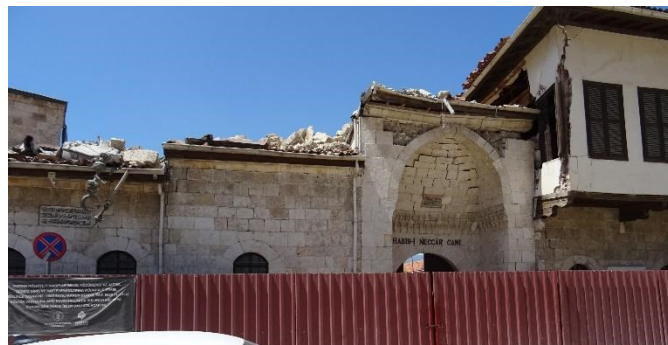
**Figure 5.6.39** Damage observed in the standing parts of the Habib-i Neccar Camii

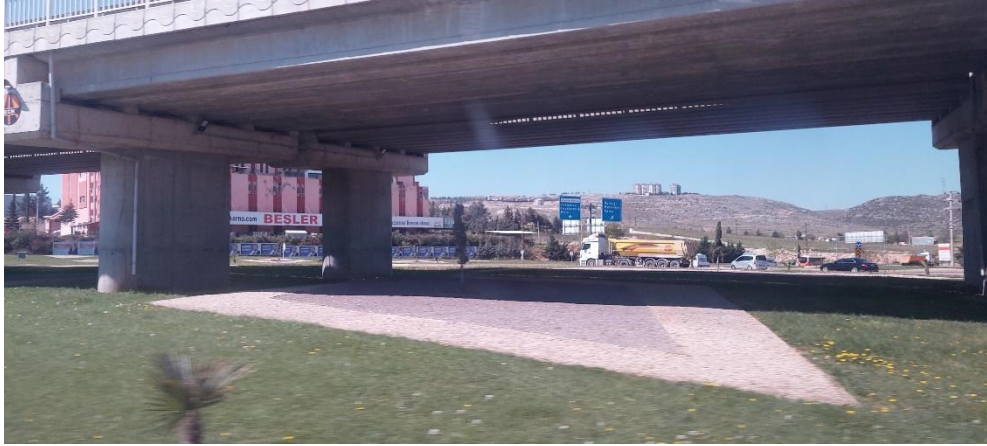
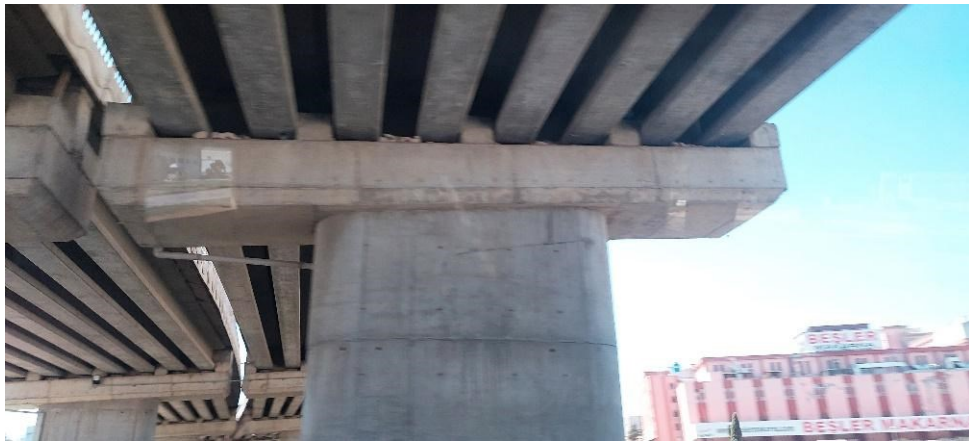
Two seismically isolated RC overpasses with simply supported and continuous decks respectively were inspected in Gaziantep and shown in Figures 6.3 and 6.4. Both bridges were not damaged and performed well during the earthquake events. In both cases, the wall-type and cylindrical piers performed elastically, while small permanent bearing deformations were inspected. No damage was observed at the abutments.

**Figure 6.3** Simply supported, isolated RC bridge (overpass) in Gaziantep.

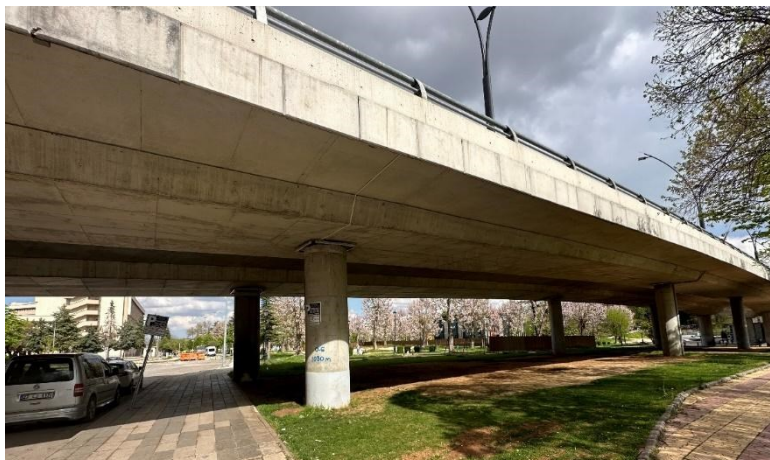
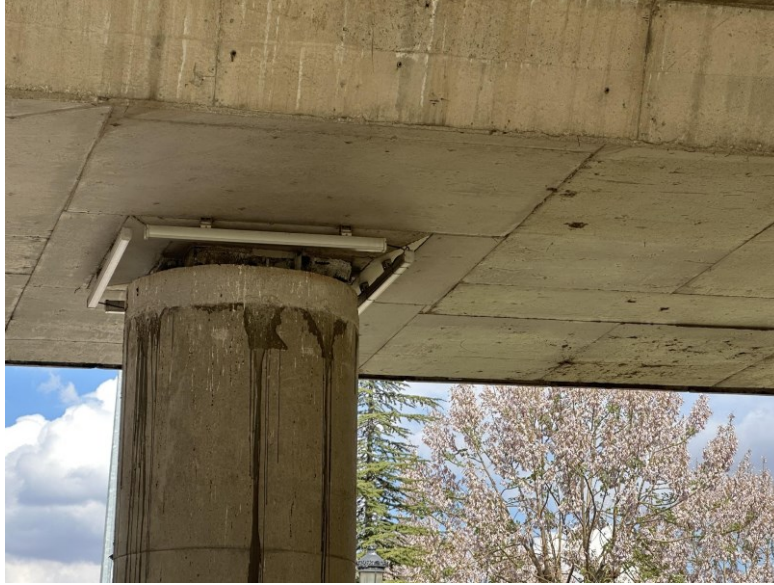
**Figure 6.4** Continuous, seismically isolated RC bridge (overpass) in Gaziantep.

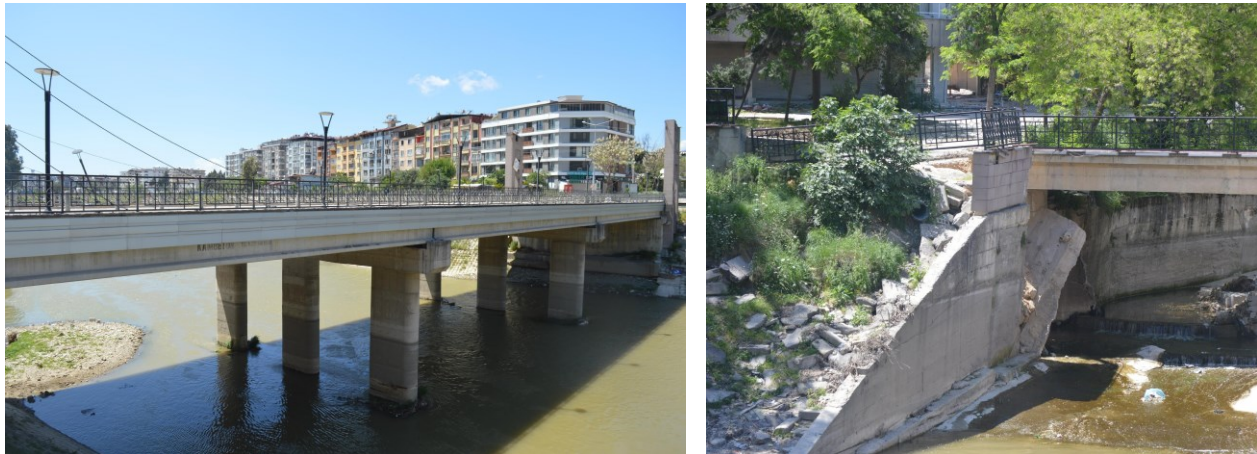
As already stated, damage as a proportion of total building/infrastructure stock was greatest in Hatay. The Greek reconnaissance group focused on building inspection in Hatay; however, a roadway and a pedestrian bridge of the urban network were also inspected (Figure 6.7 and 6.8, respectively). Both bridges performed well; minor to moderate damage was observed at the roadway RC simply supported the bridge due to permanent soil displacements, while no structural damage was observed at the pedestrian steel truss bridge inspected.

**Figure 6.7** Simply supported riverine bridge at Antakya

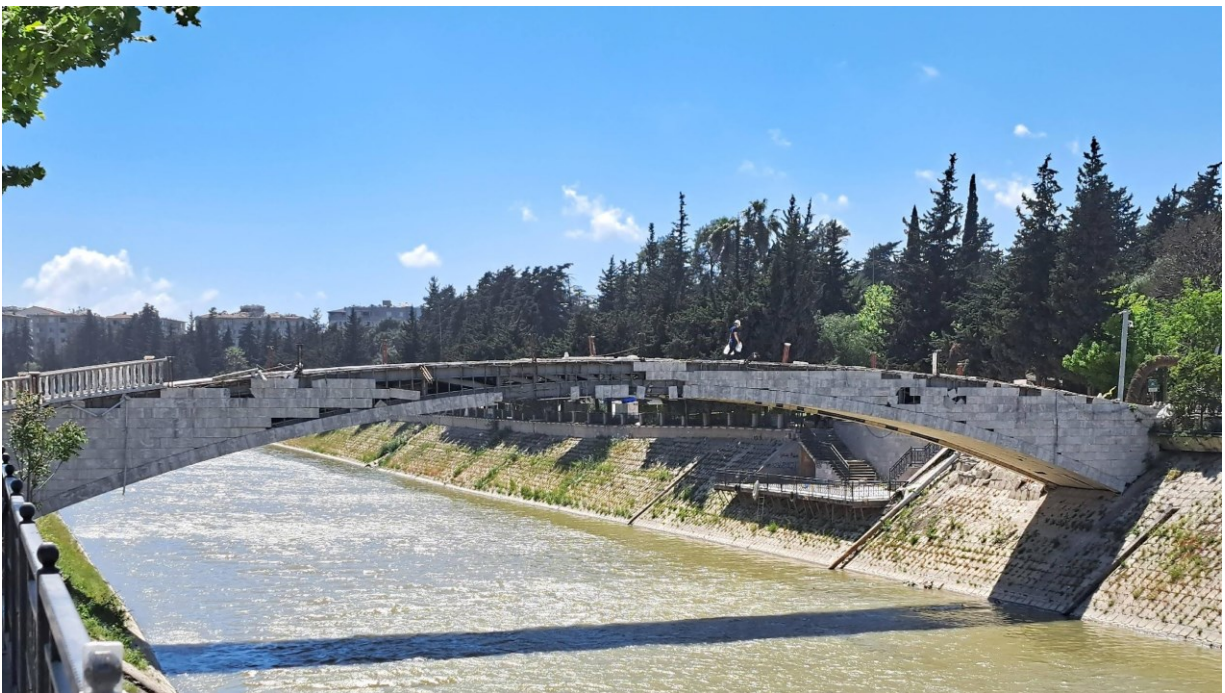
**Figure 6.8** Steel truss pedestrian bridge at Antakya

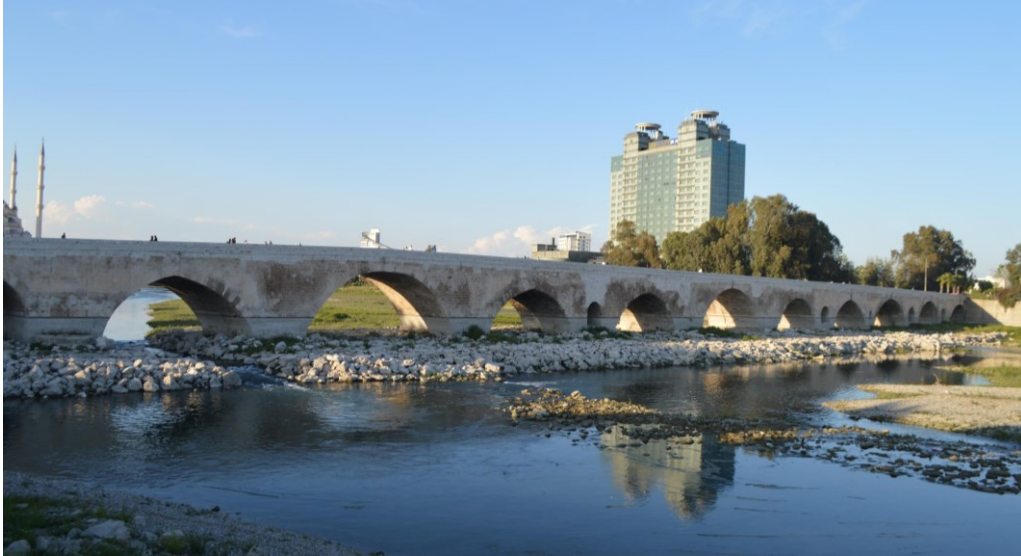
In Adana, building stock and infrastructure damage was not reported as extensive compared to the other areas inspected. An old masonry bridge inspected with no structural damage is shown in Figure 6.9, and a railway bridge with simply supported steel deck in full service is shown in Figure 6.10.

**Figure 6.9** Masonry bridge in Adana

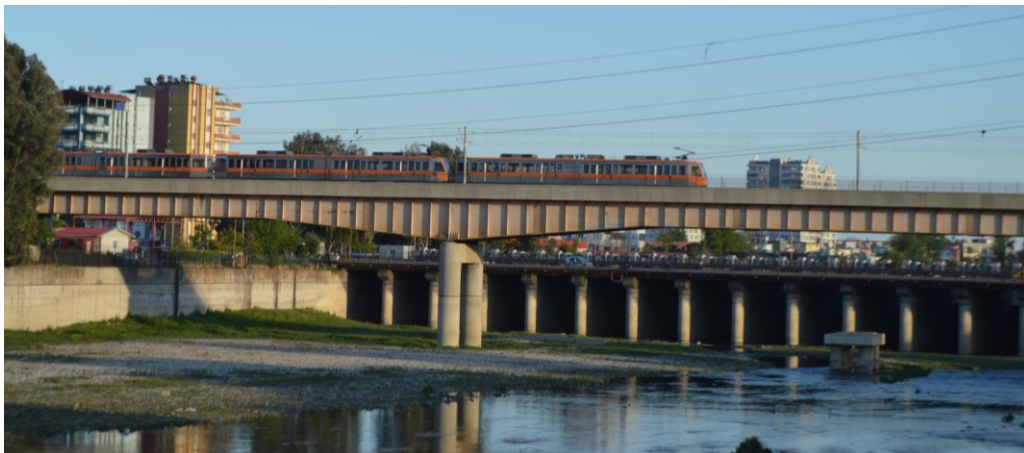
**Figure 6.10** Railway bridge with steel deck in normal service

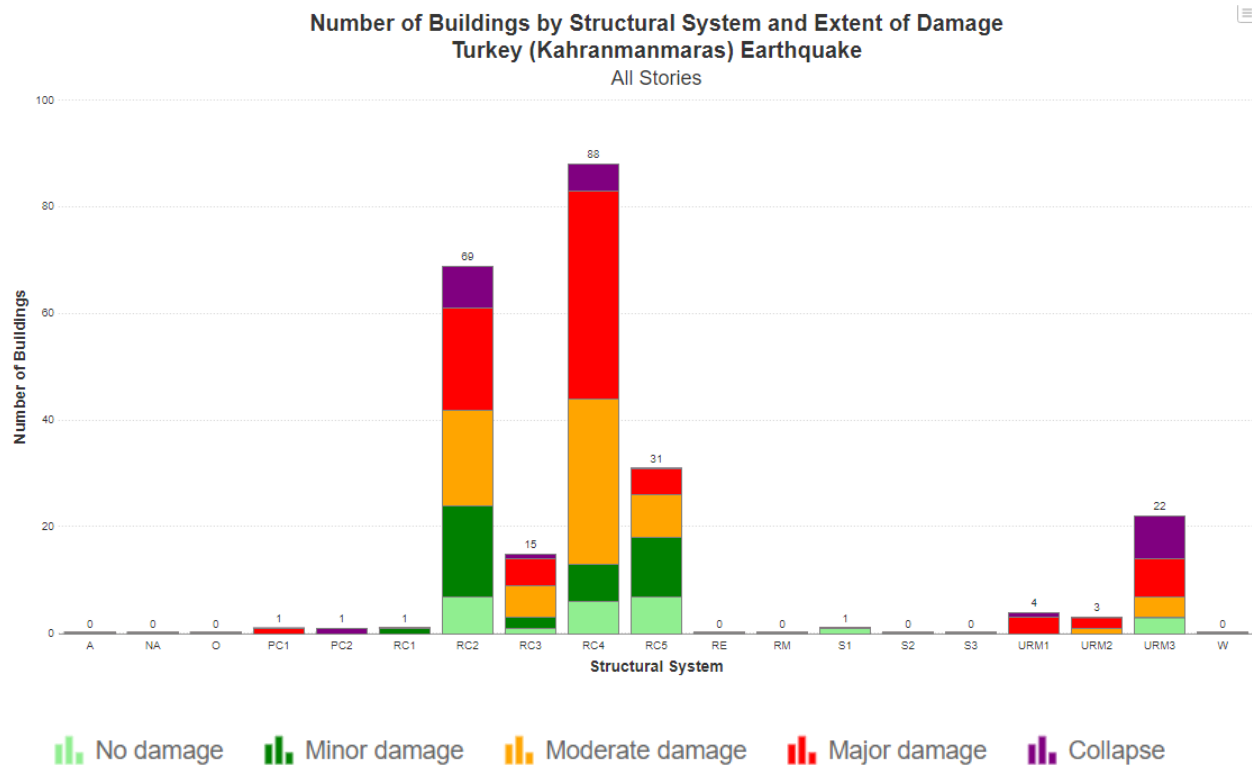
The distribution of damage level per structural typology of the inspected sample of buildings is depicted in Fig. 7.4. It is interesting to note that there were RC buildings designed to modern seismic codes (RC4) that collapsed and even buildings with a dual (MRF and shear wall) structures that suffered severe damage. In fairness, one needs to appreciate the very strong earthquake ground motions that the buildings experienced during the sequence of two mainshocks and dozens of aftershocks that, to some extent, explain the severity of damage. Equally, it is important to stress the need for close quality control in terms of ensuring capacity design, which is the ultimate mechanism for collapse prevention. Overall, most RC buildings designed with old codes (RC2) and unreinforced brick masonry (URM1) suffered severe damage.
